ENVIRONMENTAL MONITOR WEEKLY REPORT  
WEEK ENDING **August 25, 2017**

BRUCE FREEMAN RAIL TRAIL  
CONCORD, MA

# PHOTOGRAPH LOG

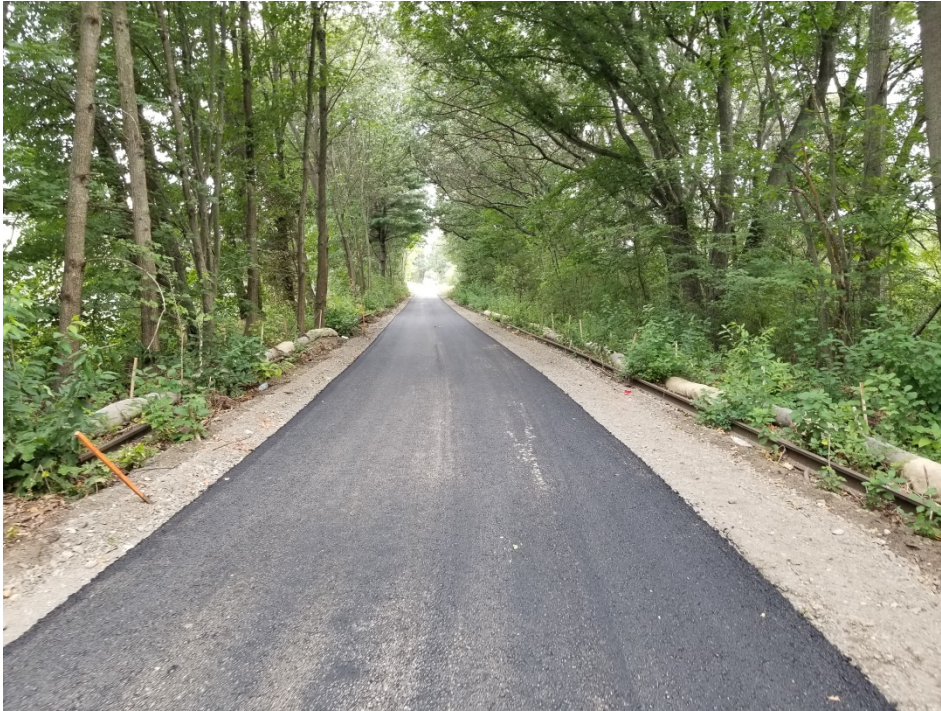
PORTIONS OF THE TRAIL HAVE BEEN PAVED

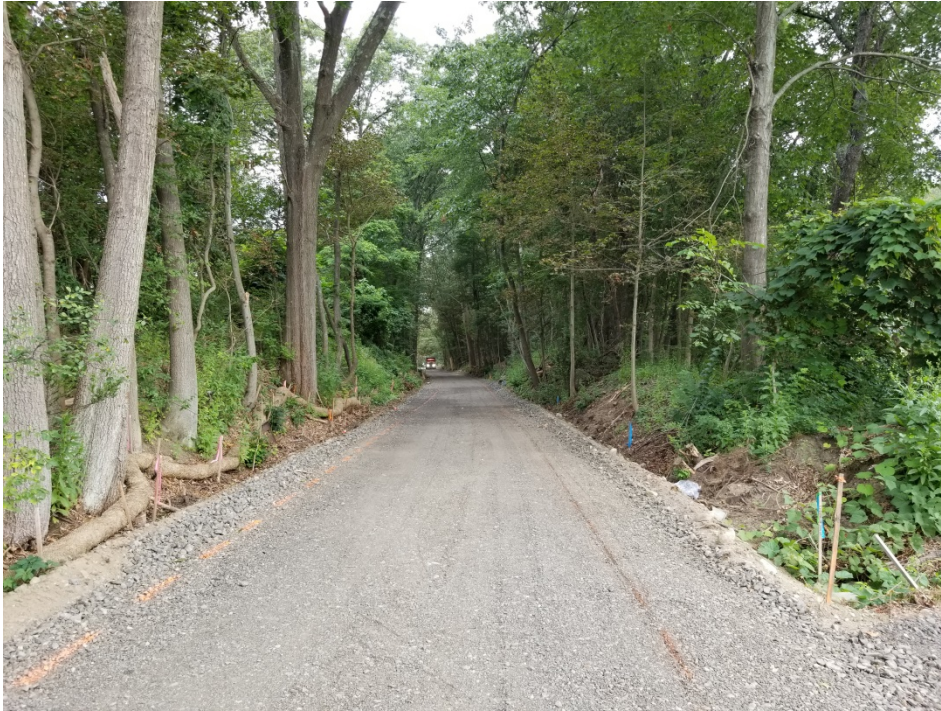
PAVEMENT LAYOUT ON SUBGRADE

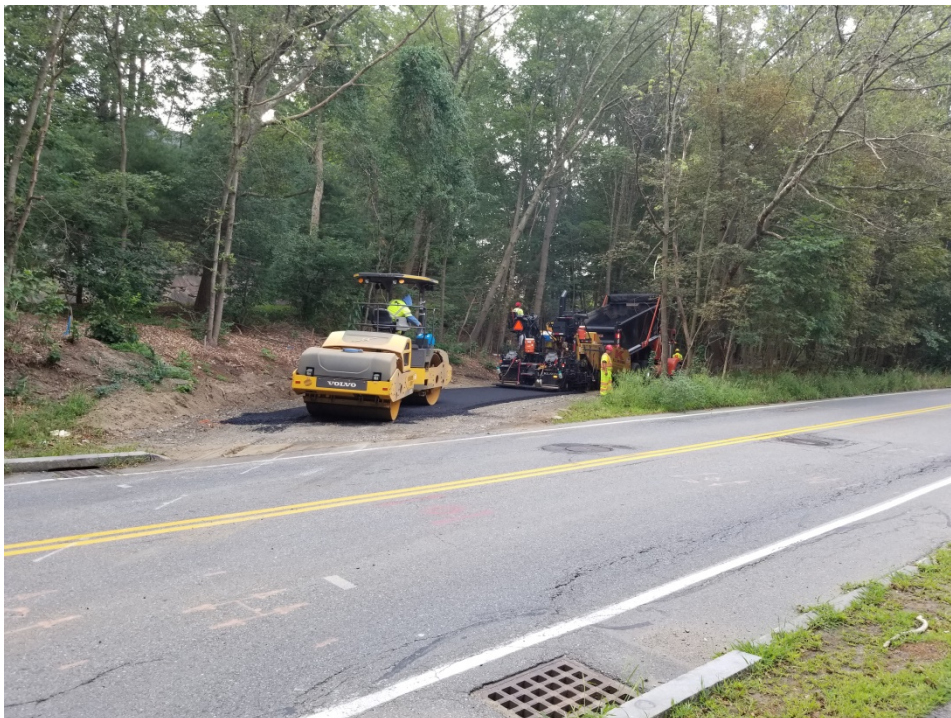
PAVING EQUIPMENT
