ENVIRONMENTAL MONITOR WEEKLY REPORT

WEEK ENDING **SEPTEMBER 22, 2017**

| General Information<br>(see reverse for instructions) | | | |
|---|---|---|---|
| Name of Project | Bruce Freeman Rail Trail | CGP Tracking No. | MAR10008B |

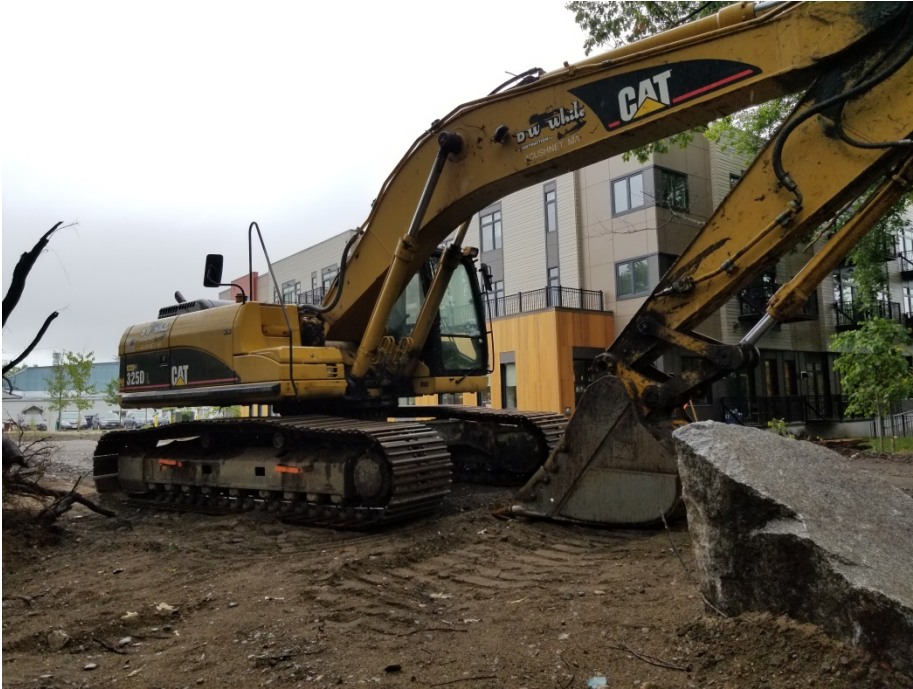
- The silt fence by the bridge over the Nashoba Brook was still undermined. The contractor was asked to repair this location and place a material such as crushed stone to prevent future erosion.
- Some excess concrete was washed out within a regulated area, adjacent to recent concrete work for the Assabet River bridge. The contractor was asked to provide a concrete washout area outside of regulated areas.
- A portable toilet was observed within a regulated area, north of the Assabet River. The contractor was asked to have the toilet moved closer to Main Street, next time the toilet is maintained in the next few days.
- Some of the erosion control was damaged behind Brookside Square. It was brought to the attention of the contractor and the repair was already scheduled to be repaired.
- Some equipment was stored within regulated area, which was brought to the attention of the contractor.

EQUIPMENT STORED WITHIN REGULATED AREA

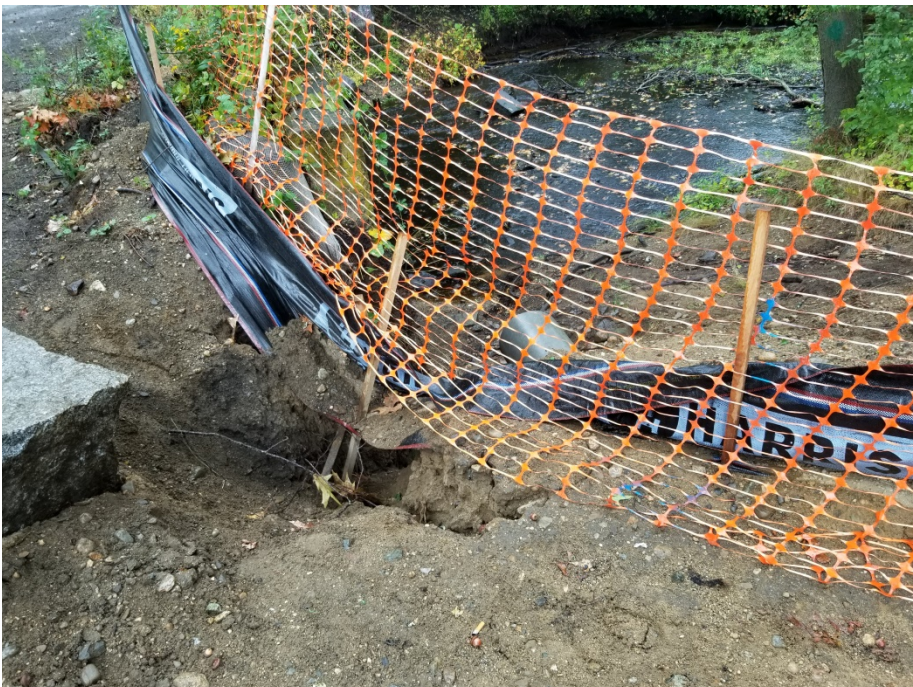
RECENT SEDIMENT WASHOUT

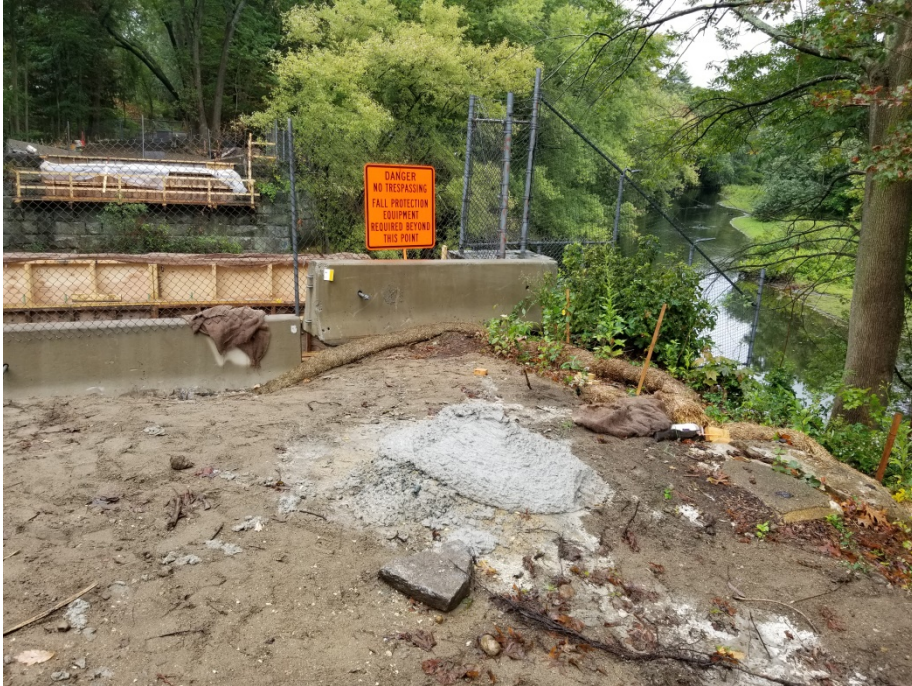
IMPROPER EXCESS CONCRETE DISPOSAL

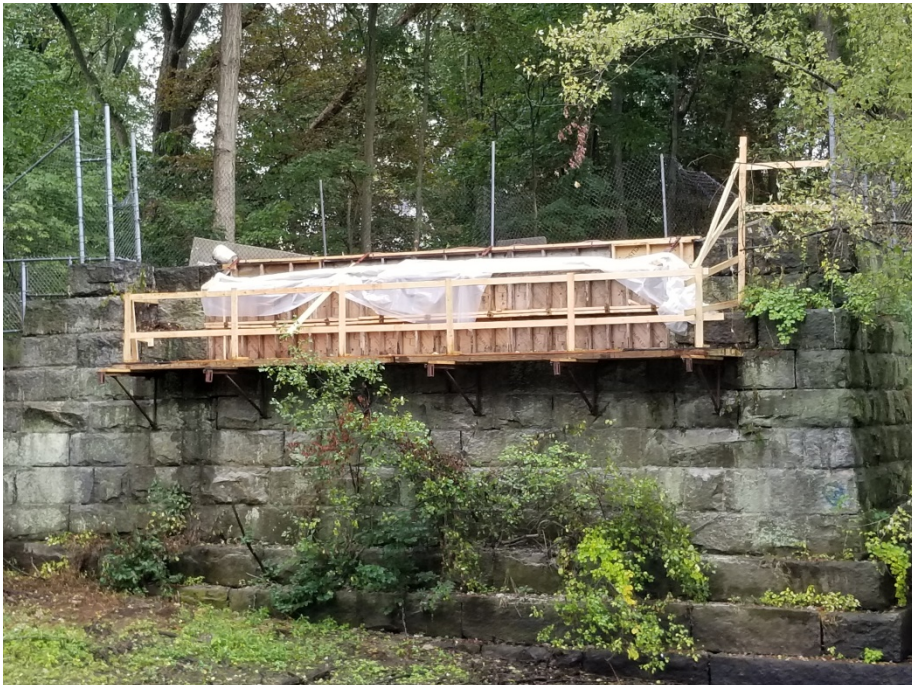
Earthwork continues behind Brookside Square, south of the Nashoba Brook. The concrete caps on Bridge #C-19-038 are currently poured in place and curing. The culvert located at station 81+10 is currently under construction. The stabilization at Powder Mill Road is underway with grass growing through the jute netting.

CURING ABUTTMENT

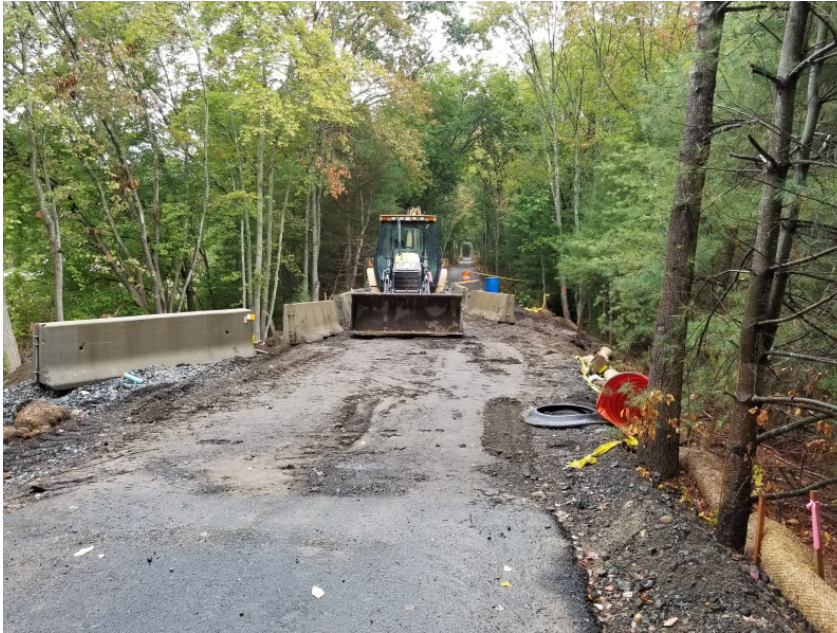
EQUIPMENT STORED WITHIN REGULATED AREA

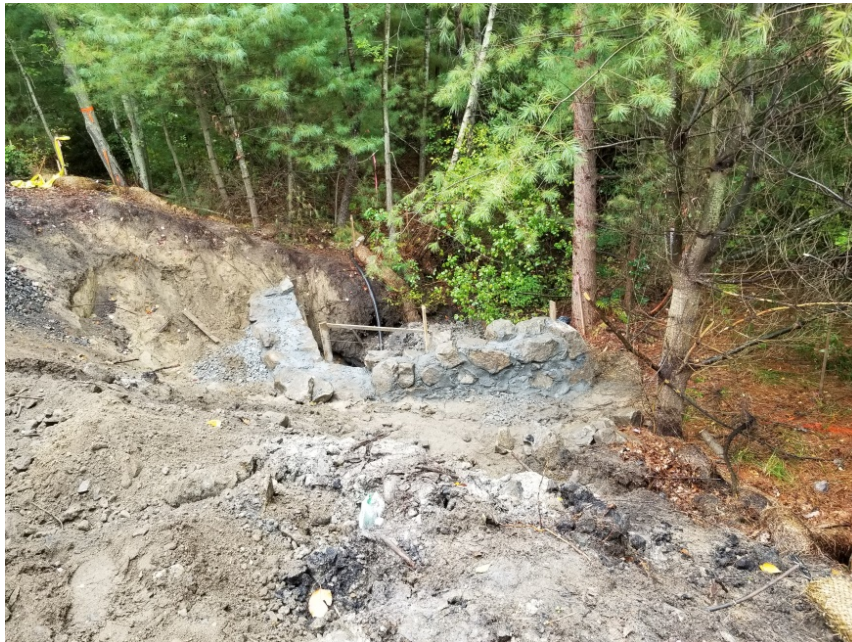
Condition 37: The culvert at station 81+10 has been installed prior to September 30<sup>th</sup>. The headwalls have yet to be installed.

STONE WORK AT CULVERT LOCATED AT STATION 81+10

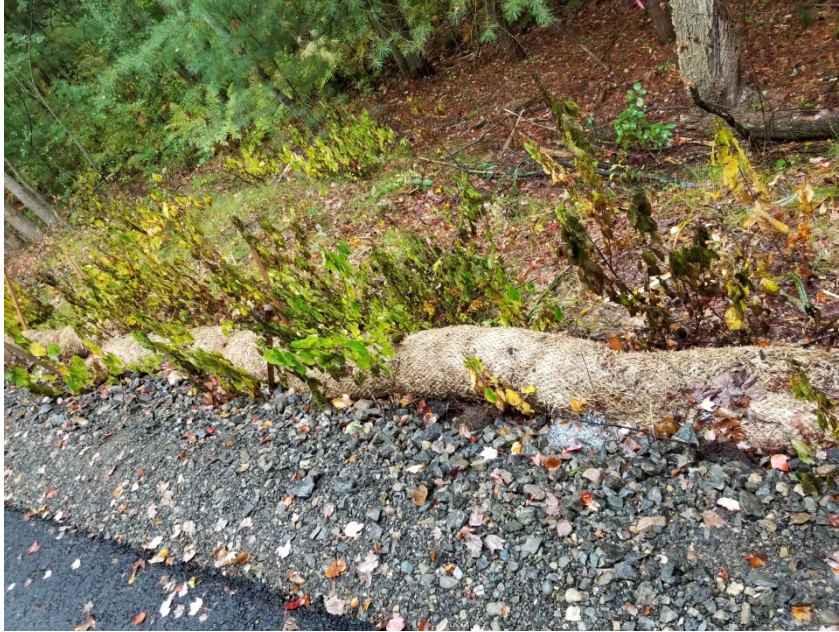
INVASIVE SPECIES THAT ARE CURRENTLY DYING

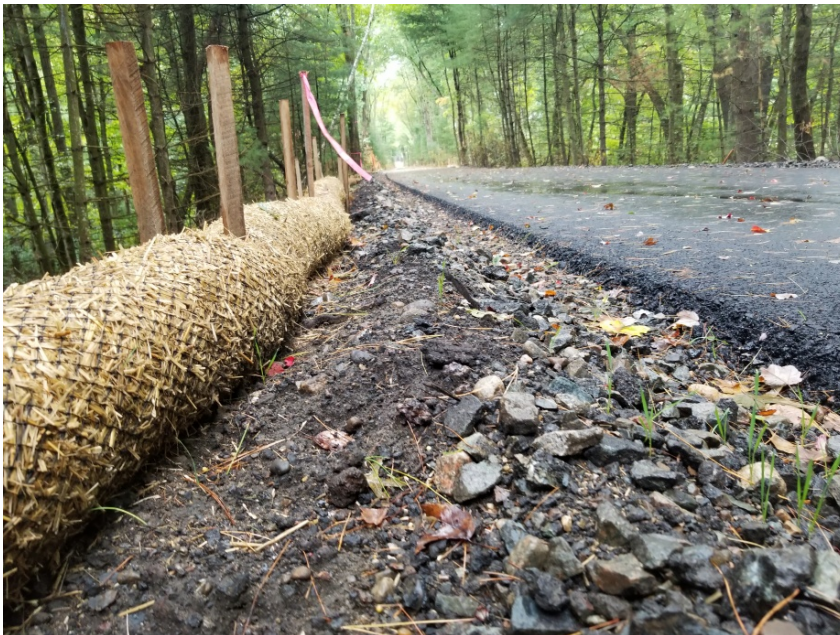
VIEW OF EROSION CONTROL AND CURRENT ROAD GRADE
