ENVIRONMENTAL MONITOR WEEKLY REPORT  
WEEK ENDING **SEPTEMBER 29, 2017** \*\*reissued with swppp reports\*\*

Earthwork continues behind Brookside Square, south of the Nashoba Brook. The placement of a prefabricated steel truss bridge on the newly poured caps on Bridge #C-19-038 is currently under construction. The culvert at station 81+10 is finished and backfilled. Powder Mill Road currently has earthwork under construction for the pathway leading the trail to the road.

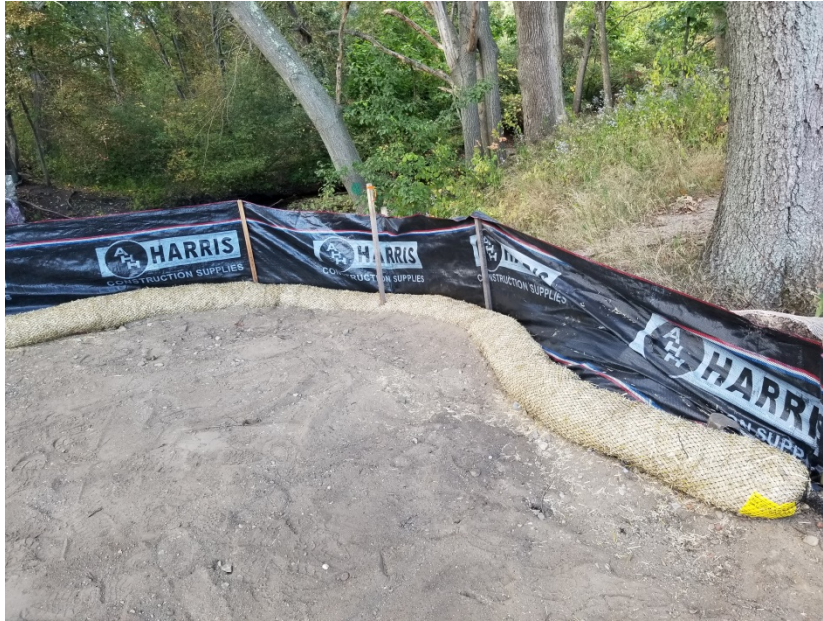
- The silt fence by the bridge over the Nashoba Brook was fixed.
- Some excess concrete washed out within a regulated area, has been removed.
- The portable toilet was moved outside of the regulated area.
- The erosion control damaged behind Brookside Square has been replaced.

SEDIMENT WASHOUT CORRECTED

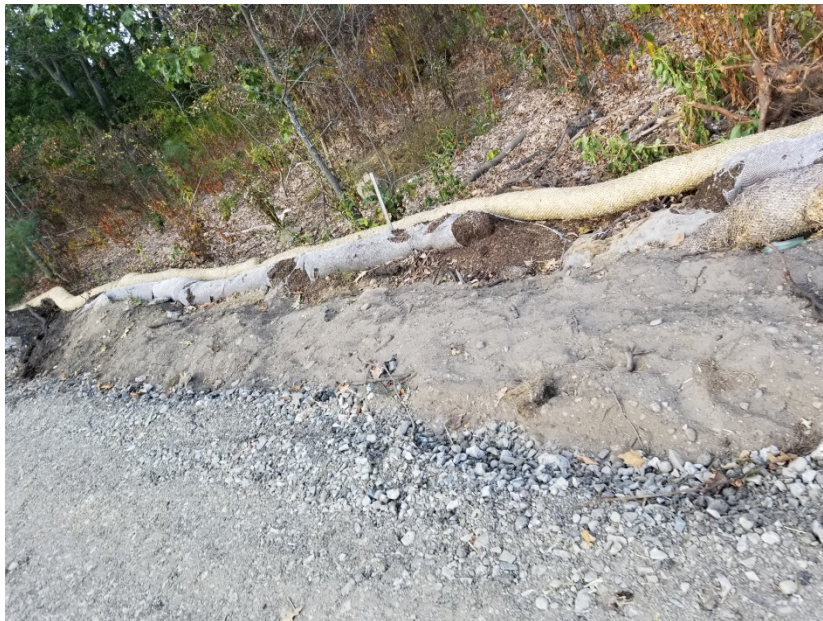
EROSION CONTROL CORRECTED

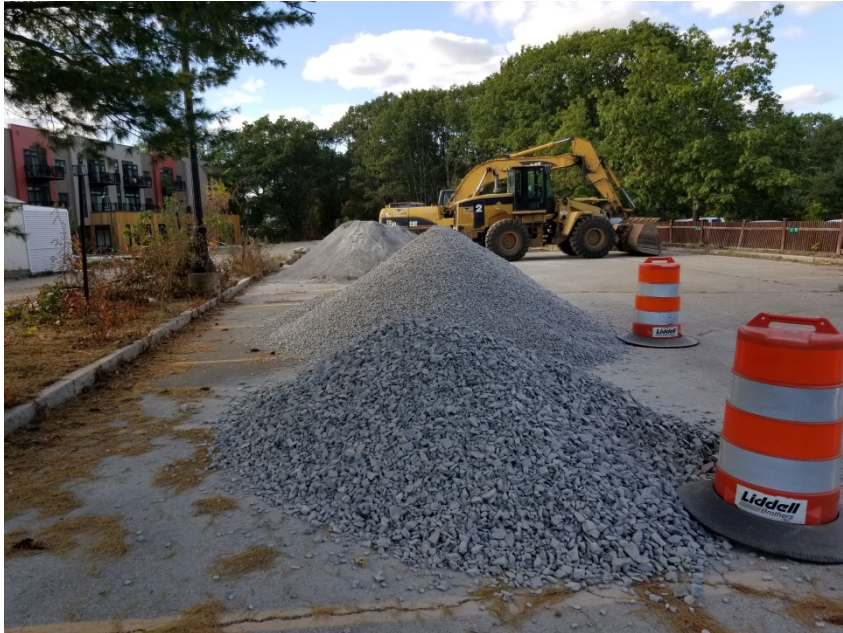
Condition 47: No machinery was observed being stored in the buffer zone.

STORAGE OF MATERIAL AND EQUIPMENT

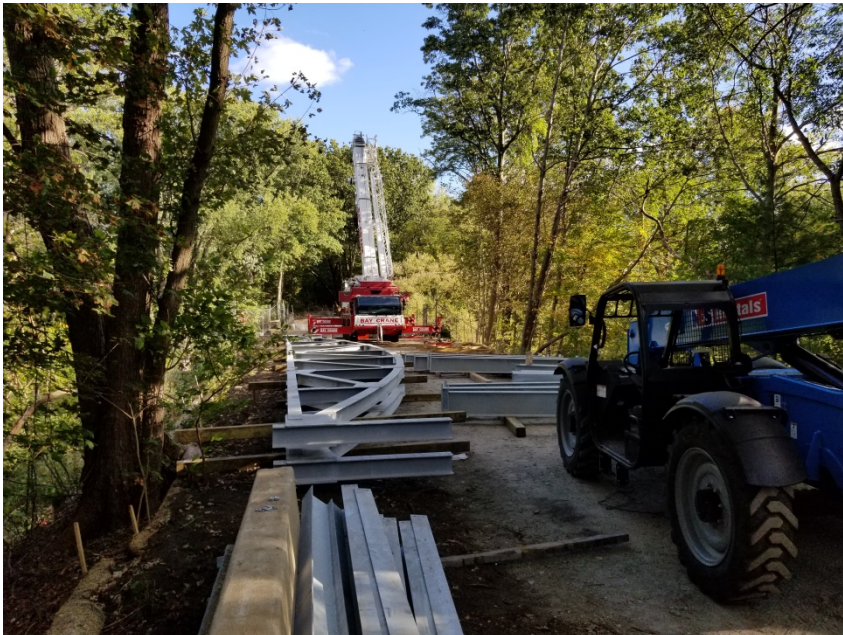
PREPERATION OF BRIDGE #C-19-038

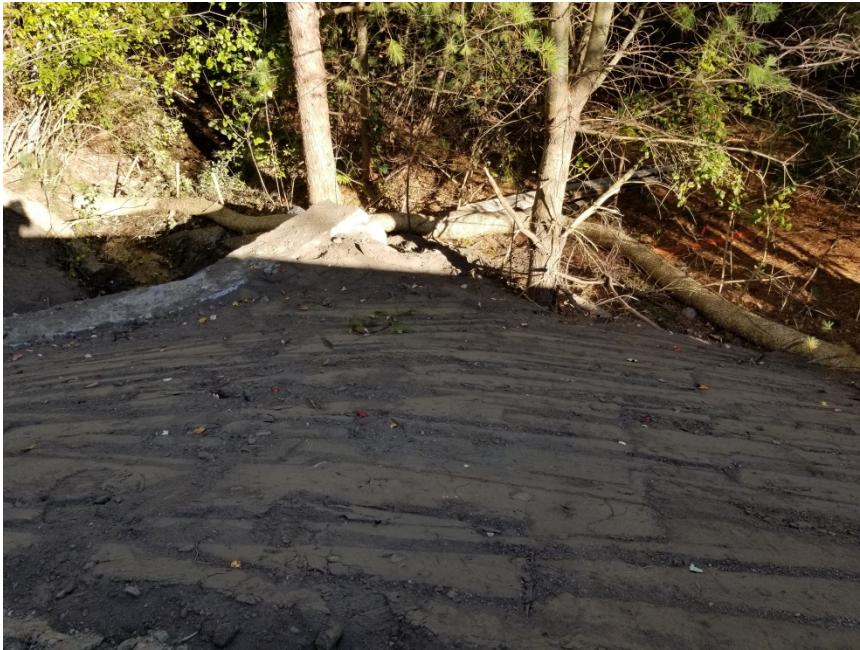
Condition 37: The culvert at station 81+10 has been installed prior to September 30<sup>th</sup>. The headwalls are installed and backfilled.

BACKFILL FOR CULVERT LOCATED AT STATION 81+10

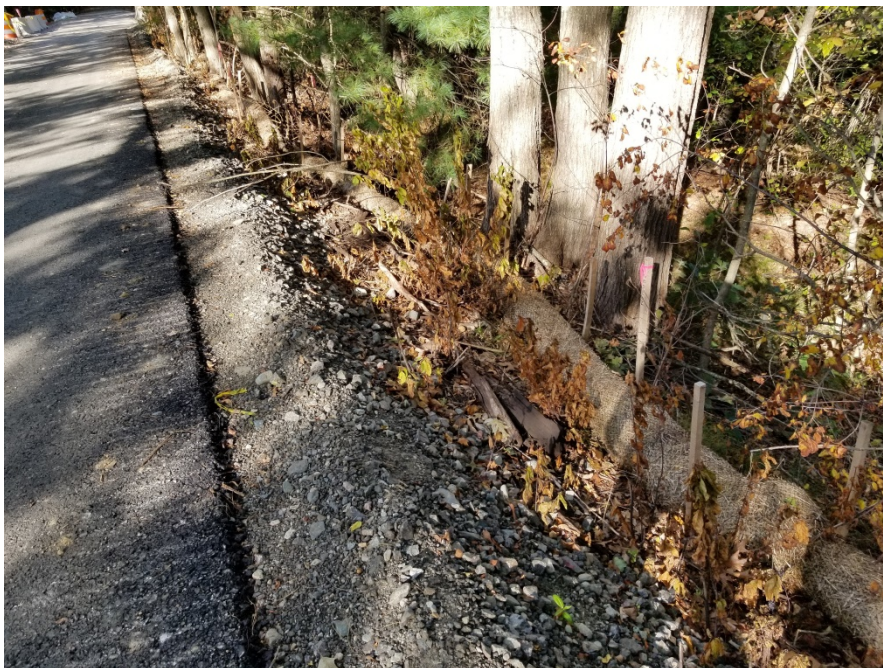
INVASIVE SPECIES DYING

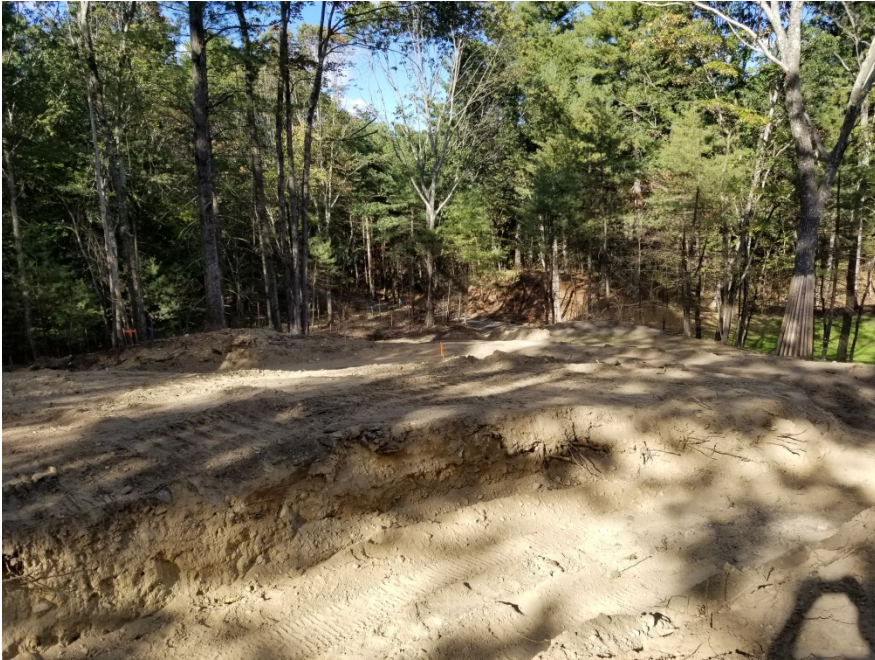
CONSTRUCTION OF PATHWAY BETWEEN TRAIL AND POWDER MILL ROAD

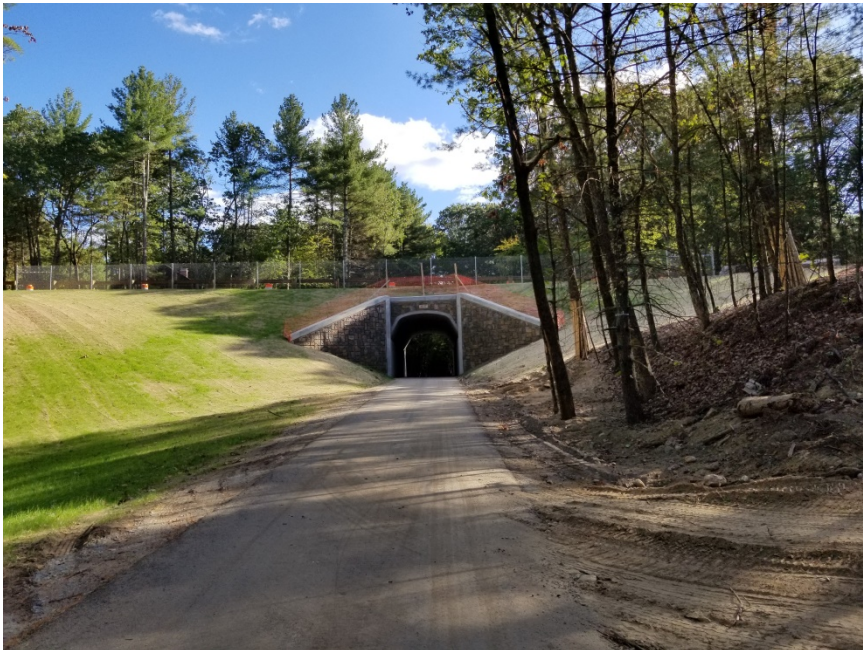
POWDER MILL ROAD CULVERT AND STABILIZATION STATUS
