Project Name: 110 Walden Street Preservation Archutectural Design Project. Follow-on to Historic Structure Report

Project Location/Address: 110 Walden Street, Concord, MA 01742

APPLICATION FOR A GRANT TO PERFORM ARCHITECTURAL DESIGN WORK FOR IMPLEMENTATION OF RECOMMENDATIONS OF THE HISTORIC STRUCTURE REPORT

III. CONDITIONS ASSESSMENT AND RECOMMENDATIONS

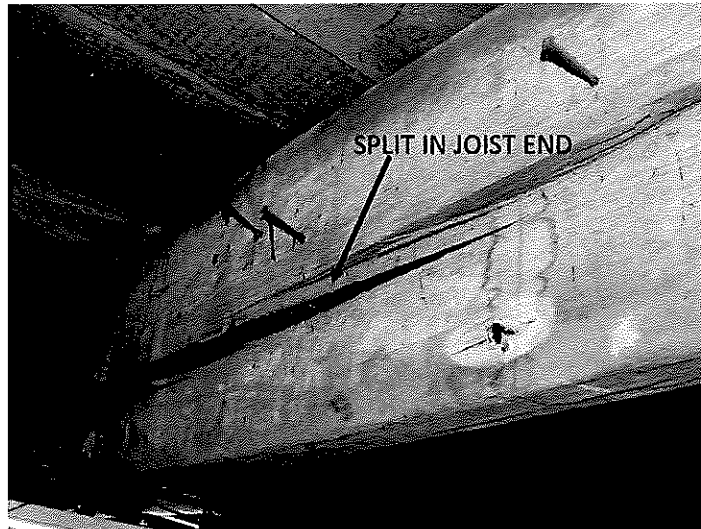
Structural repairs: Reinforce several first-floor joists (ceiling of cellar) that are split at the ends that drop into cogs in beams. Jack the end of joist to close the open split, and install a joist hanger secured to the support beam. Glue and screw 1/2-inch thick preservative-treated plywood gusset to either side of joist. Gussets shall be same depth of joist and as long as the split.

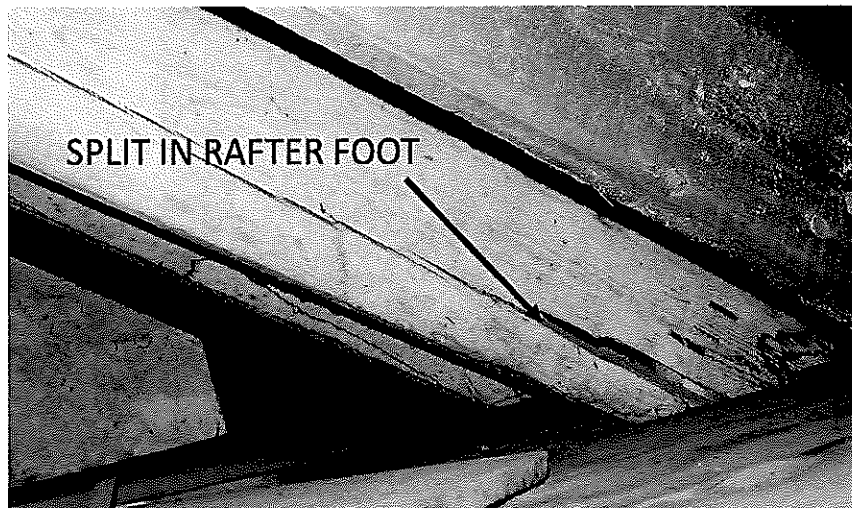
One rafter is split at its lower end where it seats on the wall plate. It is visible in the eaves space at the northeast corner of the attic. A small access door may allow a person to squeeze into the eaves space to screw a plywood gusset to either side of the rafter where it is split.

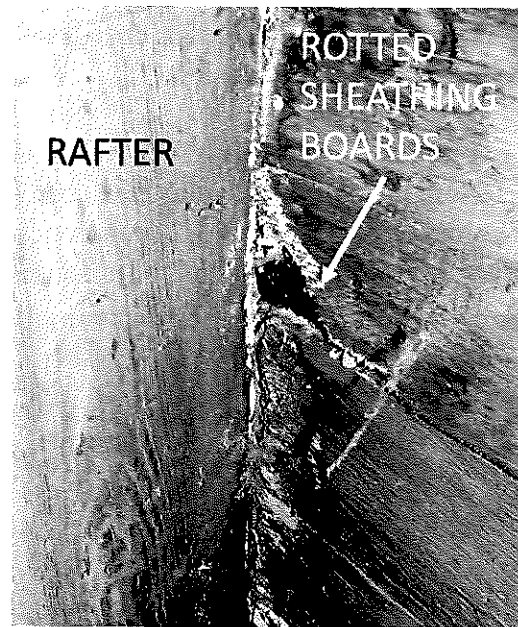
There are areas of past rot in roof sheathing near the rafter on the west slope, adjacent to the north side of the chimney (visible in attic eaves space). It is recommended that a preservative-treated 2 x 4 be sistered to the side of the rafter, at the top, to provide support for the deteriorated sheathing ends. The rot was likely caused by leaking around the chimney flashing. There does not appear to be active leaking at the present time.

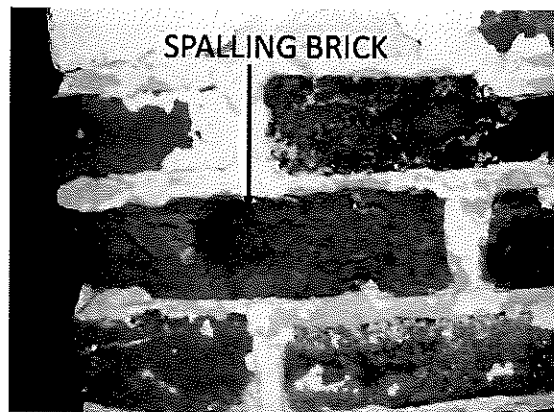
TYPICAL SPALLING BRICK IN BRICK PIERS AND CHIMNEY FOUNDATIONS

Recommended masonry repairs: Original brick piers and chimney foundations in the cellar should be repointed, and badly spalled bricks removed and replaced. Replacement bricks shall match as closely as possible the size, surface texture and color of the original bricks. In preparation for repointing, all friable mortar shall be carefully hand-chiseled from brick joints using a cold chisel of same width as joint. Repointing mortar shall be lime-based with a small amount of Portland cement added for strength. It is recommended that the pointing mortar be type K, consisting of: 3 parts hydrated lime / 1 part white Portland cement / 10-12 sand (by volume).

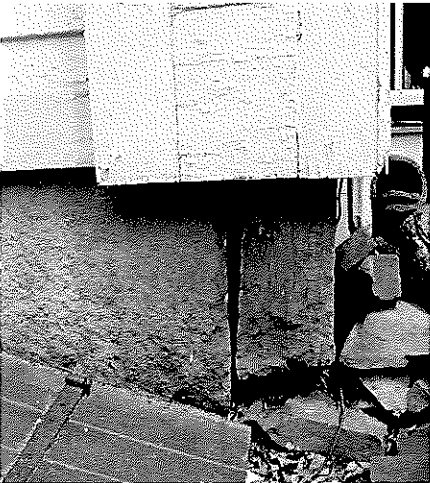
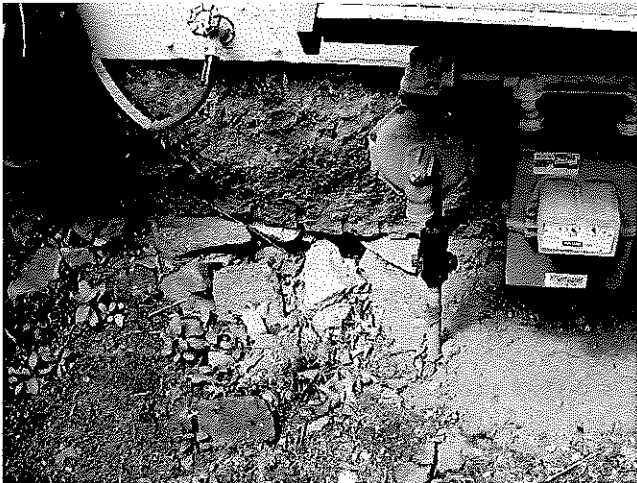
OPEN JOINTS IN FOUNDATION STONES

Open joints in granite block and fieldstone foundation walls, portico steps, and bulkhead walls and steps shall be repointed with Type N mortar consisting of : 1 part hydrated lime / 1 part light gray Portland cement / 5-6 parts sand (by volume). Reset/straighten granite steps to portico that have moved out of alignment. Remove old mortar pointing that is poorly executed and breaking away from stone and joints. A section of stone foundation wall at the west side of the shed, near the northwest corner, where there is an opening to a fox den under the building, should be filled in as part of this work.

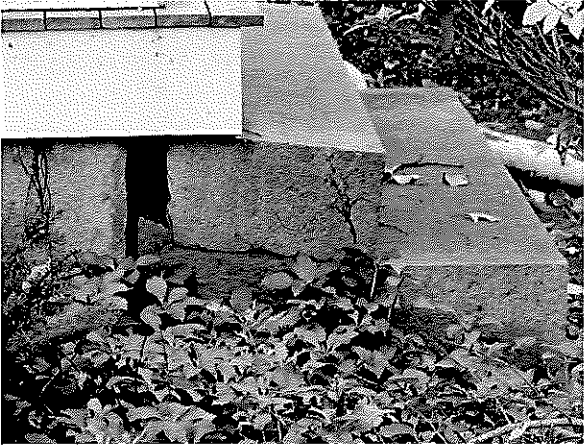
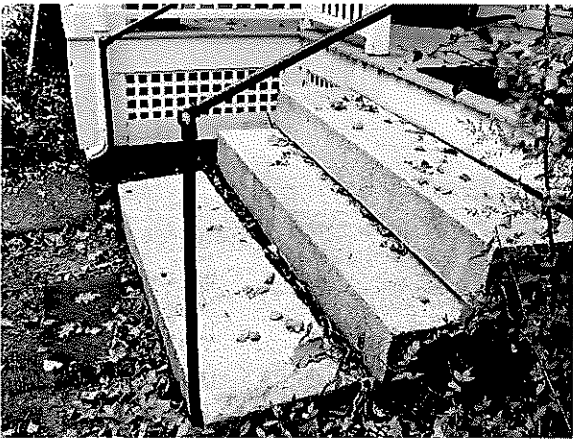
GRANITE STEPS TO PORTICO, OUT OF ALIGNMENT

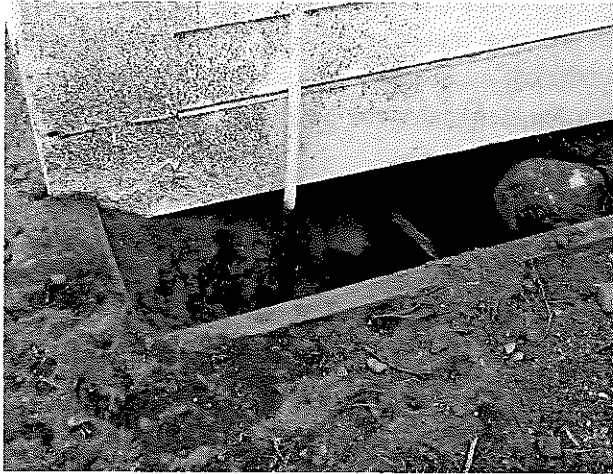
FOX HOLE IN FOUNDATION UNDER SHED

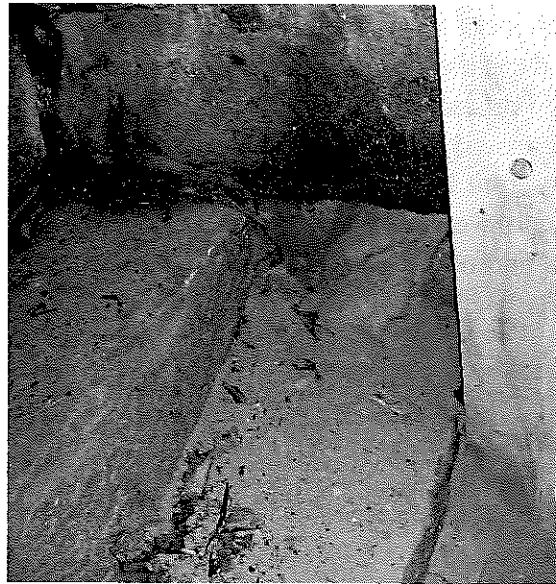
BULKHEAD STAIRS, OPEN JOINT

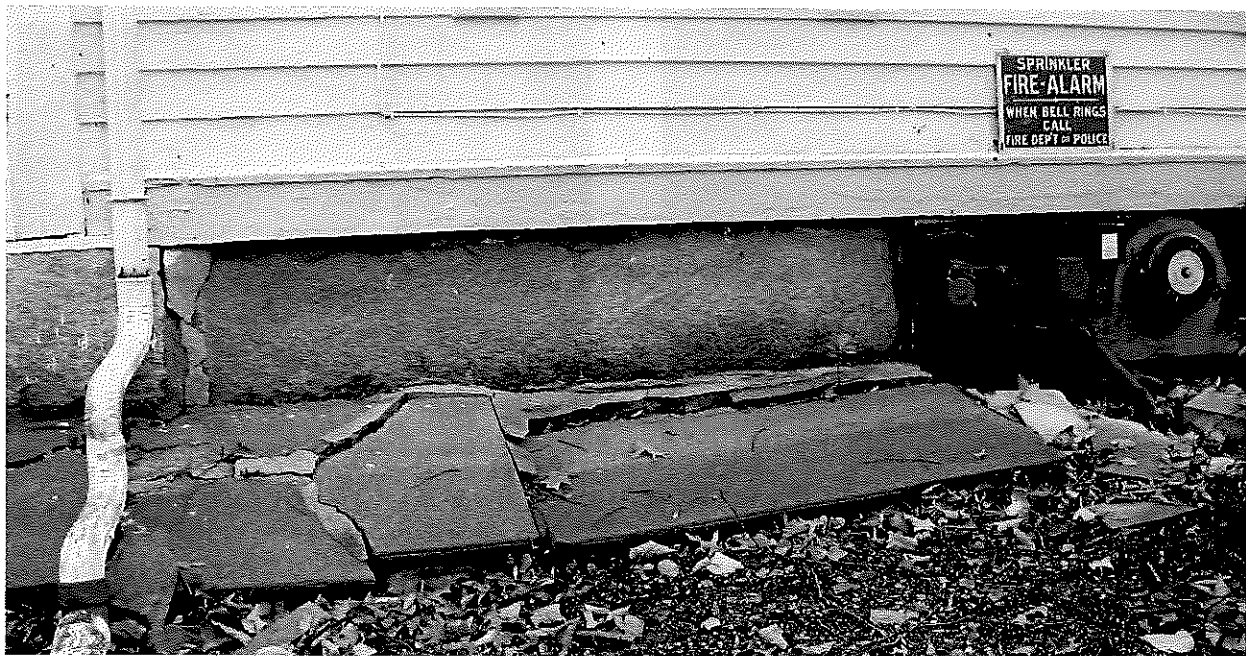
CONCRETE APRON ALONG WEST FOUNDATION WALL TO BE REMOVED

Remove broken-up concrete apron along west foundation of the house that is broken up. After removal of apron, dig down below grade next to foundation approximately 16 inches deep by 16 inches wide in order to re-point joints between granite foundation blocks and rubble stone below. After repointing, fill trench with crushed stone (maximum sieve size of $\frac{3}{4}$ inch) around a perforated drain pipe wrapped in filter fabric. Regrade beyond trench drain with loam to slope away from foundation and seed.

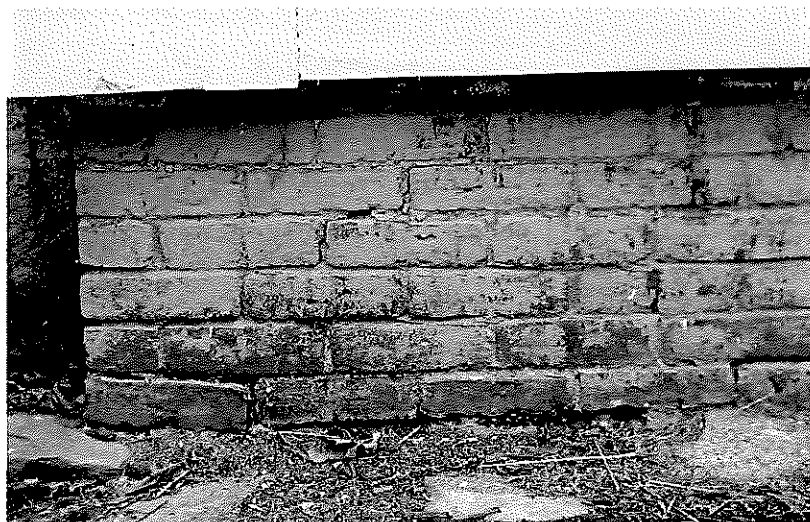
OPEN JOINTS AND MISALIGNED BRICK IN FOUNDATION

Open and friable mortar joints in brick foundation under portions of back, one-story addition shall be raked out and pointed with type N mortar (see above).

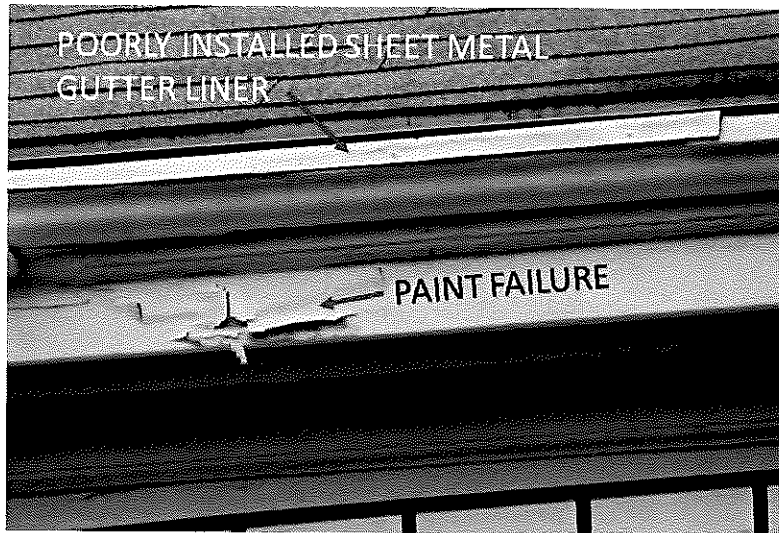
Roof gutters, eaves and rake trim: A major concern for the stewards of the Home for the Aged has been the frequent occurrence of ice dams at the roof eaves during winter months and the damage they have caused. A remedy involves both providing insulation within the exterior walls and roof structures (to be discussed below), and rehabilitating the gutters along the roof eaves. The gutters on the main house and ell are built-in, with sheet metal liners. As such, they are not easily removed and replaced by traditional wood gutters that are attached to the eaves fascia. It was not within the scope of this report to access the roof eaves with a ladder or lift, so a conditions assessment of the gutter liners will need to be accomplished by whomever prepares contract documents for future repairs. What can be seen from the ground indicates that the original gutter liners have been replaced, as evinced by the poorly executed, wrinkled fold-over of a later sheet metal liner (probably aluminum) that was bent over with a hammer (rather than professionally and neatly bent using a metal brake), and tacked to the molded front face of the wood gutter box.

It is recommended that a total rehabilitation of the gutter boxes and liners be undertaken in coordination with roof shingle replacement. New sheet metal gutter liners should be fabricated from lead-coated (or tin/zinc-coated) copper and fit into the gutter boxes along all the eaves of the main house and ell. The fabrication of the metal liners must be executed by a mechanic with proven skill and experience in the forming (with proper equipment) and soldering of sheet metal. The metal liner must be bent over the top of the molded wood face of the gutter box, and then bent down with a folded drip edge seam that catches onto sheet-metal cleats fastened to the wood box. Unlike the tacking of the metal liner directly to the wood box face that exists now in an improper installation, the use of a hem in conjunction with underlying attached cleats allows for free expansion and contraction of the metal liner. The liner must also extend up the roof slope over the roof sheathing about 6 inches where its edge can be hemmed and fastened with sheet metal clips nailed to the sheathing. Since it is impractical to install a long, single length of liner, it will be necessary to install it in two or three pieces with ends overlapped and soldered. The ends of the liners must not be installed tight to the ends of the gutter box, leaving room to allow for expansion. The liner ends must be flashed properly to prevent overspill of water from getting under the liner. New gutter outlet tubes with flanges soldered to the gutter liners should be placed in the same locations as the originals.

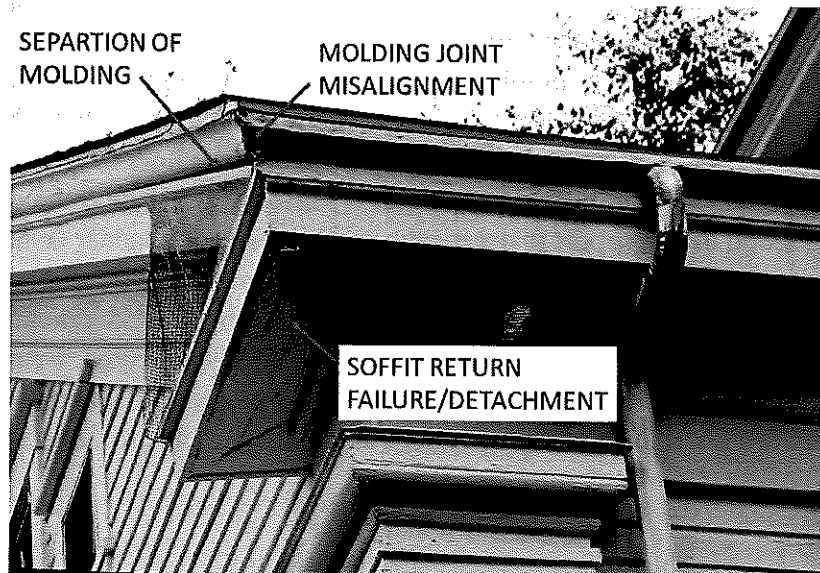
There are outlet tubes (made of lead) of relatively small diameter at the bottom of the gutters that channel the water into downspouts around the building. The face of the gutter boxes read as a cornice molding along the eaves, and is mitered at their ends to join with a similarly-profiled raking cornice molding applied to the sloped gable roof projection. In most all cases, this meeting of the rake cornice molding and the face molding of the gutter box is deteriorated and is patched by covering with sheet metal patches or heavily caulked to fill a significant gap at this joint. It is likely that the ends of the gutter liners have failed in the past and water allowed to leak out into the wood joint causing the wood to rot. Leaking gutter liners would allow water to sit on the soffit board under the overhang providing a damp condition that will lead to fungal decay of the wood.

JOINT BETWEEN BUILT-IN GUTTER AND RAKE TRIM

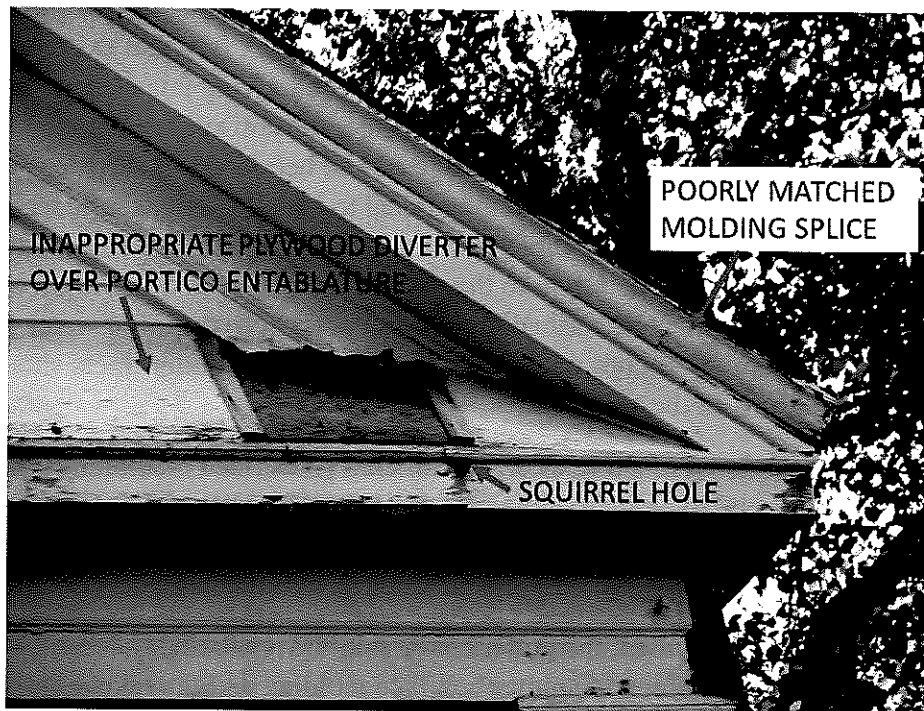
SLOPED PLYWOOD OVER PORTICO CORNICE, TO BE REMOVED

Clapboards will need to be removed to accomplish this. A new lead-coated copper cap shall be fabricated and installed over the original (or replaced) wood cap, bent down over its face-edge with a hemmed drip edge fastened in place with sheet metal cleats. The metal cap should extend up the vertical face of the gable wall at least 6 inches behind the clapboards, with a hemmed edge, fastened with metal cleats. After installation of membrane and metal cap, new clapboards shall be applied to replace those removed.

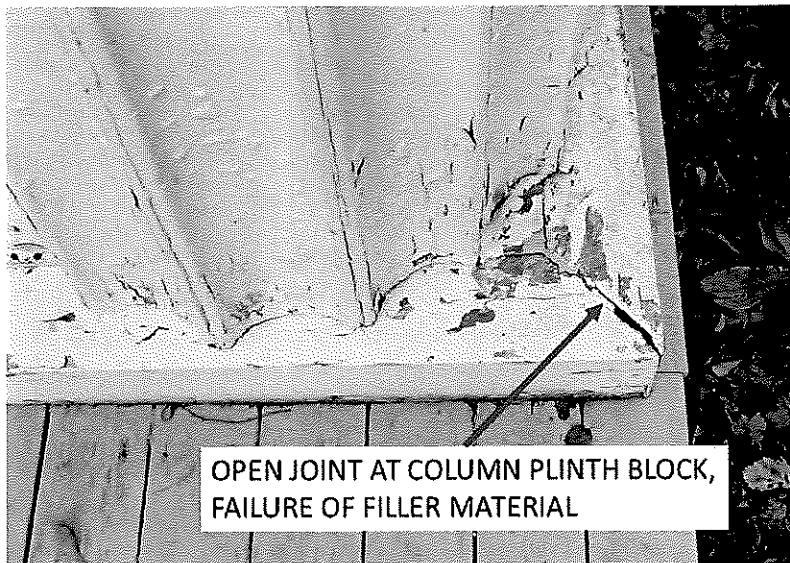
OPEN JOINT AT COLUMN PLINTH BLOCK,
FAILURE OF FILLER MATERIAL

Other areas of trim rot: There are miscellaneous trim elements around the building that show areas of rot and deterioration. When the area of rot is relatively small, it may be possible to dig out the affected portion and use an epoxy filler to rebuild the profile. For such repairs, it is recommended that Advanced Repair Technology's *ART 401 Flex-tec HV* primer and epoxy filler be used, as it retains flexibility after curing allowing it to move compatibly with the expansion and contraction of wood rather than breaking away.

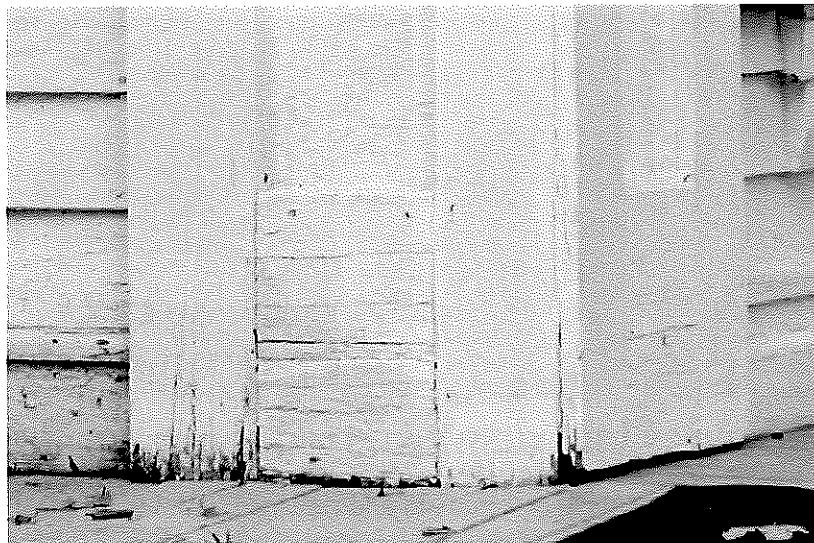
BOTTOM OF CORNER PILASTER WITH DECAY EVIDENT

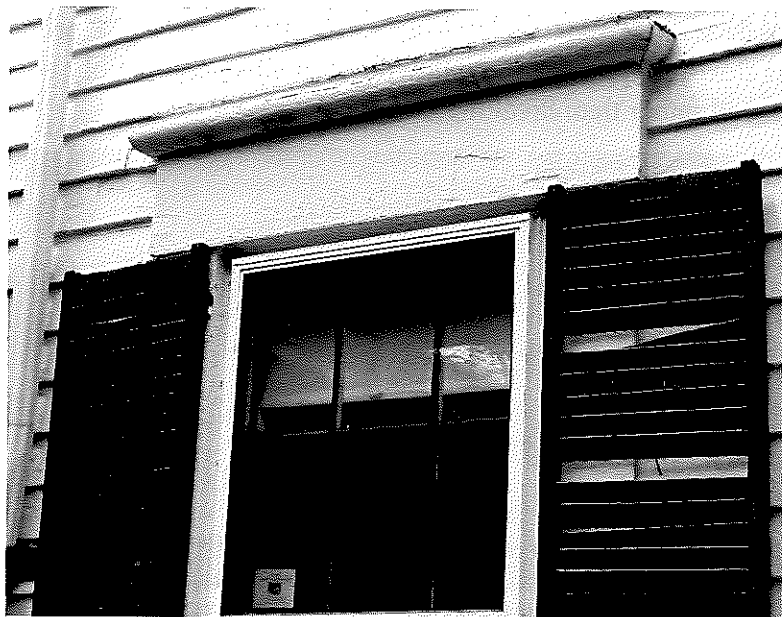
LOUVERS FALLING OUT OF BLIND FRAMES

Deteriorating blinds: All efforts should be made to repair any wood window blinds that have failed joints and fallen-out louver slats. Areas of rot can be removed and filled with epoxy, and failed corner joints reinforced with stainless steel angles screwed to the back (hidden) side of the blinds. If necessary, replace slats with reproductions milled from cedar, mahogany, or other rot-resistant species of wood. New, off-the-shelf blinds from lumber stores are made from pine or fir, with glued joints and poor rot resistance. Few companies make high quality custom blinds, and the cost is high.

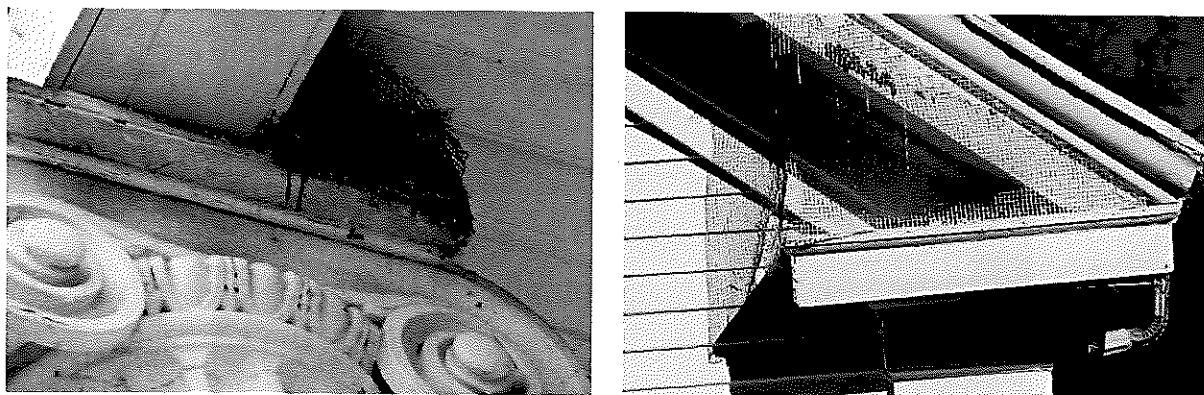
Bird control: Currently, bird control has been addressed with limited success by adding wire mesh to ledges and areas on the buildings where birds nest and roost.

UNSIGHTLY WIRE MESH INSTALLED TO DETER BIRDS

It is recommended that the wire mesh be removed and replaced with bird control products available on the market such as: strips of stainless steel spikes in various configurations, and multi-sensory repellents that come in shallow dishes that can be discretely glued to horizontal ledge surfaces. The latter have no visual impact from the ground, but must be replaced every 2
