# **HISTORIC STRUCTURE REPORT FOR CONCORD'S HOME FOR THE AGED**

Timothy Wheeler House/ Concord's Home for the Aged

Anne McCarthy Forbes, Architectural Historian  
Karle Packard, AIA, Red Hawk Studio Architects, Inc.  
Lawrence A. Sorli, Historical Architect

Date: September 7, 2018

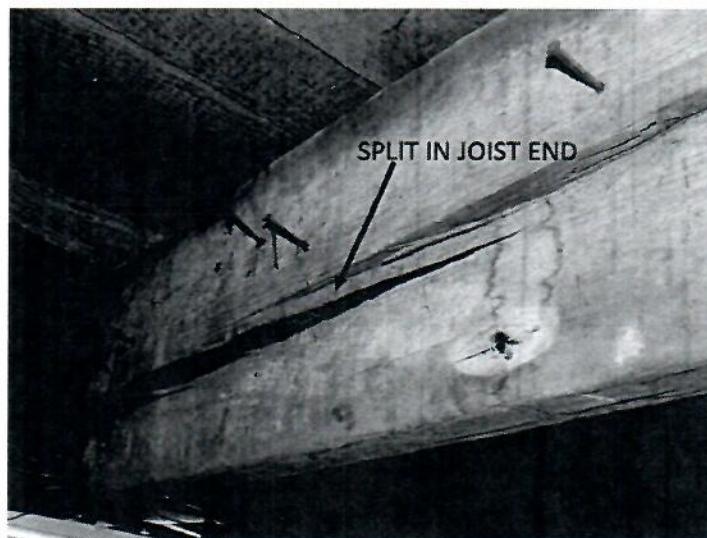
**Structural repairs:** Reinforce several first-floor joists (ceiling of cellar) that are split at the ends that drop into cogs in beams. Jack the end of joist to close the open split, and install a joist hanger secured to the support beam. Glue and screw 1/2-inch thick preservative-treated plywood gusset to either side of joist. Gussets shall be same depth of joist and as long as the split.

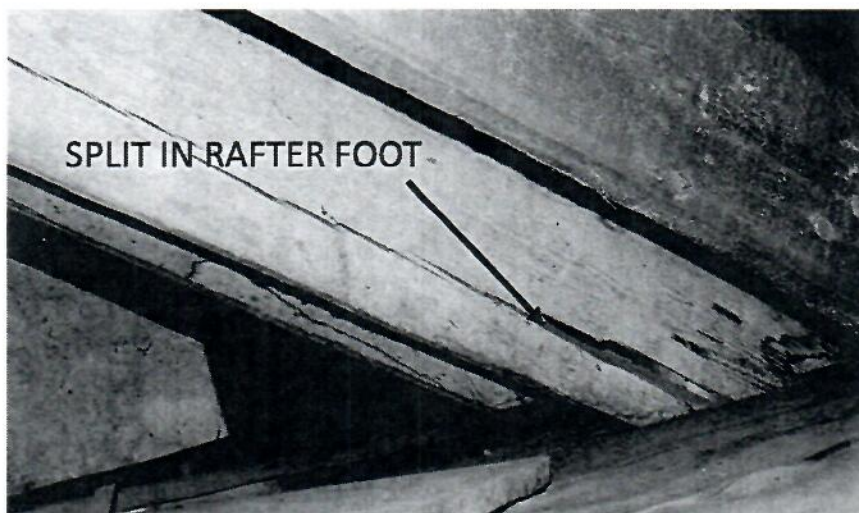
One rafter is split at its lower end where it seats on the wall plate. It is visible in the eaves space at the northeast corner of the attic. A small access door may allow a person to squeeze into the eaves space to screw a plywood gusset to either side of the rafter where it is split.

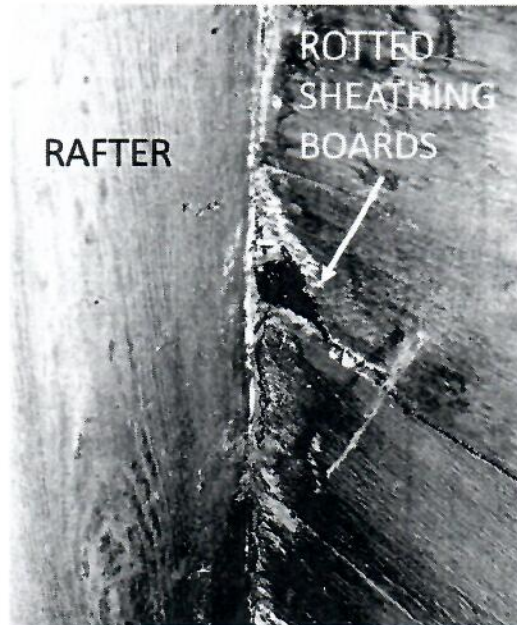
There are areas of past rot in roof sheathing near the rafter on the west slope, adjacent to the north side of the chimney (visible in attic eaves space). It is recommended that a preservative-treated 2 x 4 be sistered to the side of the rafter, at the top, to provide support for the deteriorated sheathing ends. The rot was likely caused by leaking around the chimney flashing. There does not appear to be active leaking at the present time.

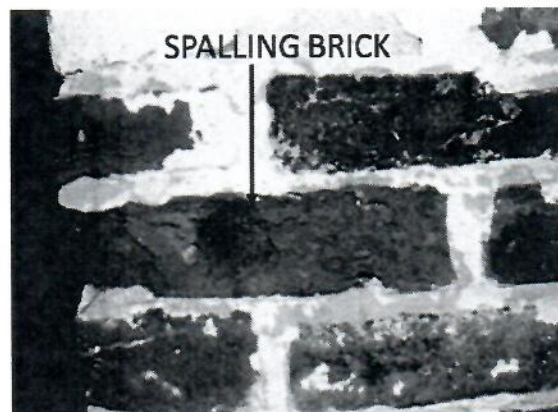
TYPICAL SPALLING BRICK IN BRICK PIERS AND CHIMNEY FOUNDATIONS

**Recommended masonry repairs:** Original brick piers and chimney foundations in the cellar should be repointed, and badly spalled bricks removed and replaced. Replacement bricks shall match as closely as possible the size, surface texture and color of the original bricks. In preparation for repointing, all friable mortar shall be carefully hand-chiseled from brick joints using a cold chisel of same width as joint. Repointing mortar shall be lime-based with a small amount of Portland cement added for strength. It is recommended that the pointing mortar be type K, consisting of: 3 parts hydrated lime / 1 part white Portland cement / 10-12 sand (by volume).

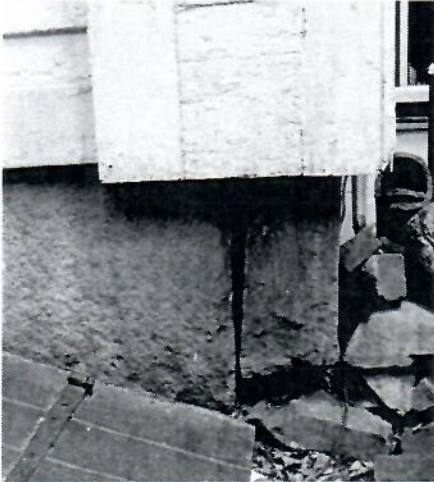
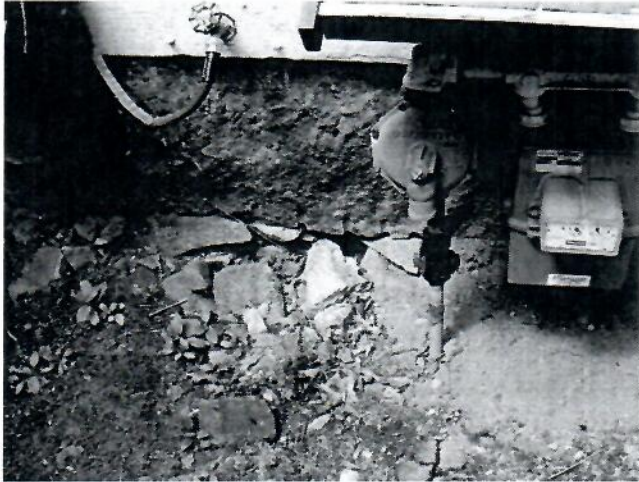
OPEN JOINTS IN FOUNDATION STONES

Open joints in granite block and fieldstone foundation walls, portico steps, and bulkhead walls and steps shall be repointed with Type N mortar consisting of : 1 part hydrated lime / 1 part light gray Portland cement / 5-6 parts sand (by volume). Reset/straighten granite steps to portico that have moved out of alignment. Remove old mortar pointing that is poorly executed and breaking away from stone and joints. A section of stone foundation wall at the west side of the shed, near the northwest corner, where there is an opening to a fox den under the building, should be filled in as part of this work.

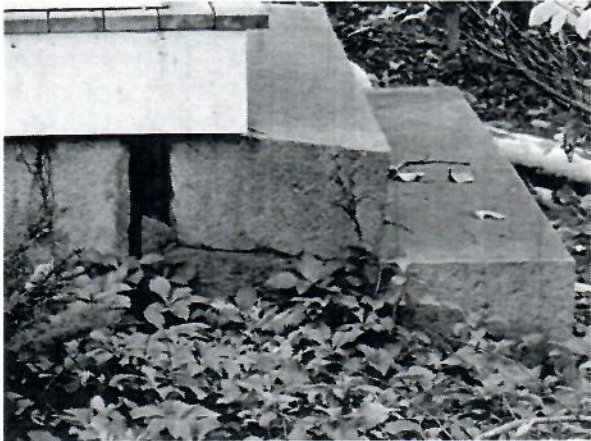
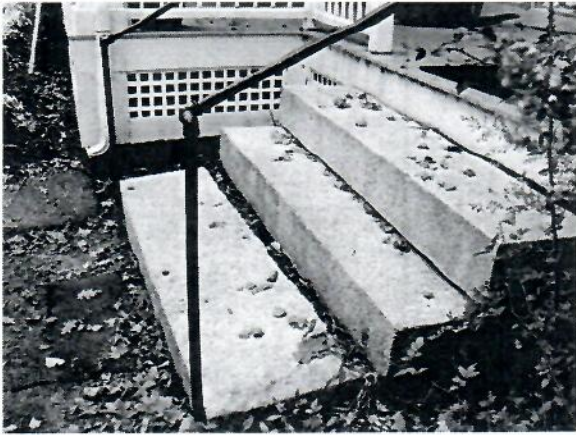
GRANITE STEPS TO PORTICO, OUT OF ALIGNMENT

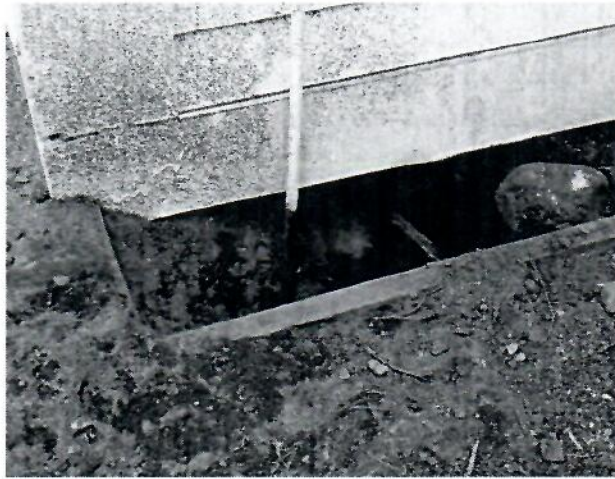
FOX HOLE IN FOUNDATION UNDER SHED

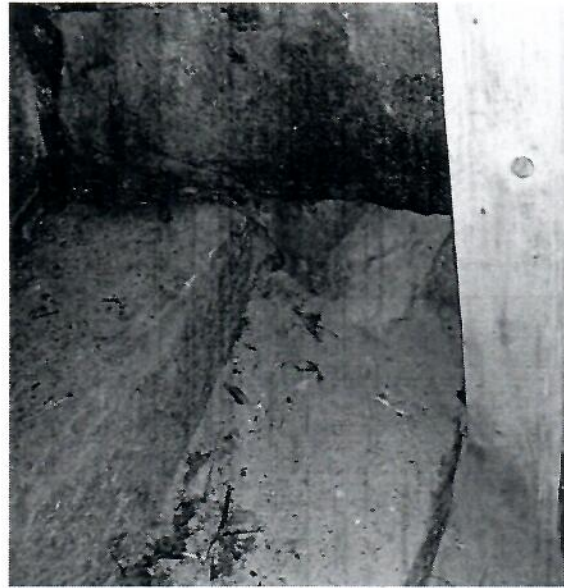
BULKHEAD STAIRS, OPEN JOINT

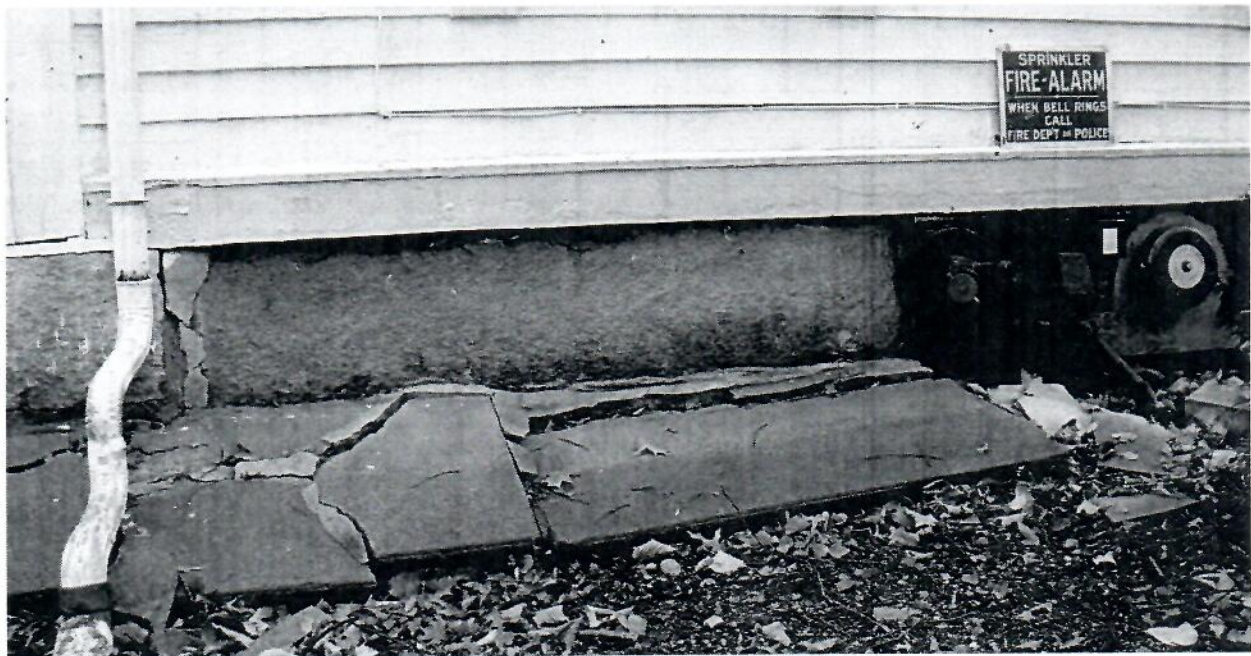
CONCRETE APRON ALONG WEST FOUNDATION WALL TO BE REMOVED

Remove broken-up concrete apron along west foundation of the house that is broken up. After removal of apron, dig down below grade next to foundation approximately 16 inches deep by 16 inches wide in order to re-point joints between granite foundation blocks and rubble stone below. After repointing, fill trench with crushed stone (maximum sieve size of  $\frac{3}{4}$  inch) around a perforated drain pipe wrapped in filter fabric. Regrade beyond trench drain with loam to slope away from foundation and seed.

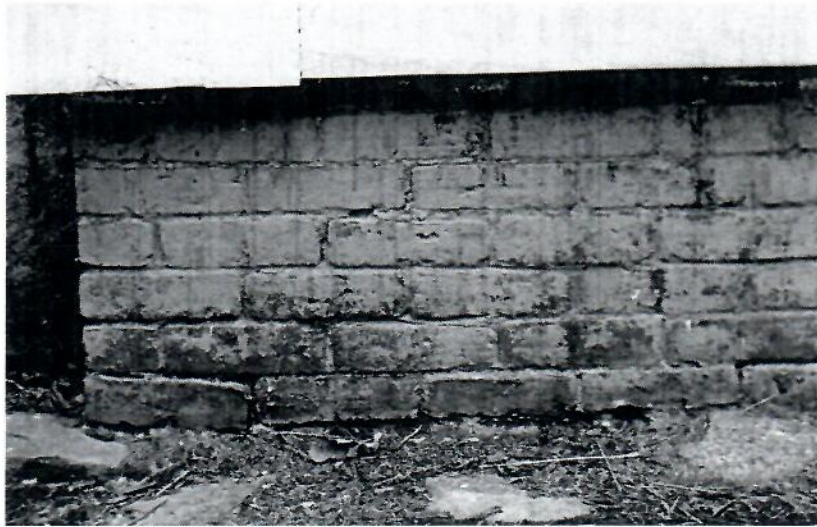
OPEN JOINTS AND MISALIGNED BRICK IN FOUNDATION

Open and friable mortar joints in brick foundation under portions of back, one-story addition shall be raked out and pointed with type N mortar (see above).

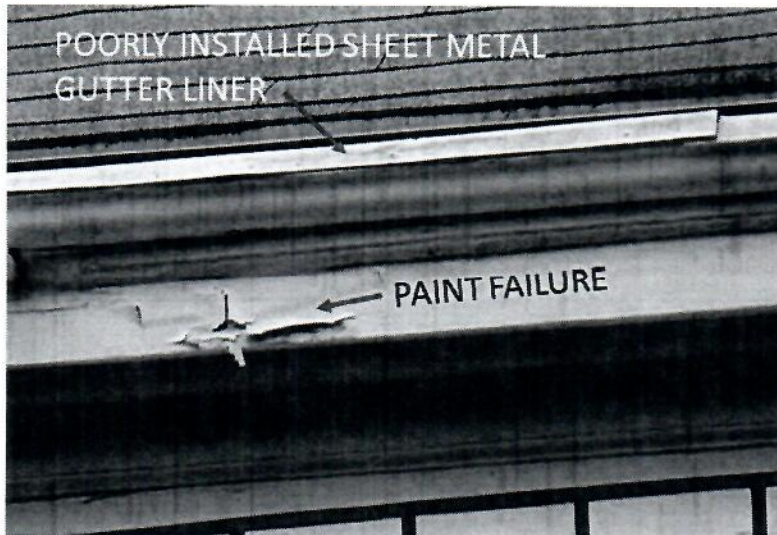
**Roof gutters, eaves and rake trim:** A major concern for the stewards of the Home for the Aged has been the frequent occurrence of ice dams at the roof eaves during winter months and the damage they have caused. A remedy involves both providing insulation within the exterior walls and roof structures (to be discussed below), and rehabilitating the gutters along the roof eaves. The gutters on the main house and ell are built-in, with sheet metal liners. As such, they are not easily removed and replaced by traditional wood gutters that are attached to the eaves fascia. It was not within the scope of this report to access the roof eaves with a ladder or lift, so a conditions assessment of the gutter liners will need to be accomplished by whomever prepares contract documents for future repairs. What can be seen from the ground indicates that the original gutter liners have been replaced, as evinced by the poorly executed, wrinkled fold-over of a later sheet metal liner (probably aluminum) that was bent over with a hammer (rather than professionally and neatly bent using a metal brake), and tacked to the molded front face of the wood gutter box.

It is recommended that a total rehabilitation of the gutter boxes and liners be undertaken in coordination with roof shingle replacement. New sheet metal gutter liners should be fabricated from lead-coated (or tin/zinc-coated) copper and fit into the gutter boxes along all the eaves of the main house and ell. The fabrication of the metal liners must be executed by a mechanic with proven skill and experience in the forming (with proper equipment) and soldering of sheet metal. The metal liner must be bent over the top of the molded wood face of the gutter box, and then bent down with a folded drip edge seam that catches onto sheet-metal cleats fastened to the wood box. Unlike the tacking of the metal liner directly to the wood box face that exists now in an improper installation, the use of a hem in conjunction with underlying attached cleats allows for free expansion and contraction of the metal liner. The liner must also extend up the roof slope over the roof sheathing about 6 inches where its edge can be hemmed and fastened with sheet metal clips nailed to the sheathing. Since it is impractical to install a long, single length of liner, it will be necessary to install it in two or three pieces with ends overlapped and soldered. The ends of the liners must not be installed tight to the ends of the gutter box, leaving room to allow for expansion. The liner ends must be flashed properly to prevent overspill of water from getting under the liner. New gutter outlet tubes with flanges soldered to the gutter liners should be placed in the same locations as the originals.

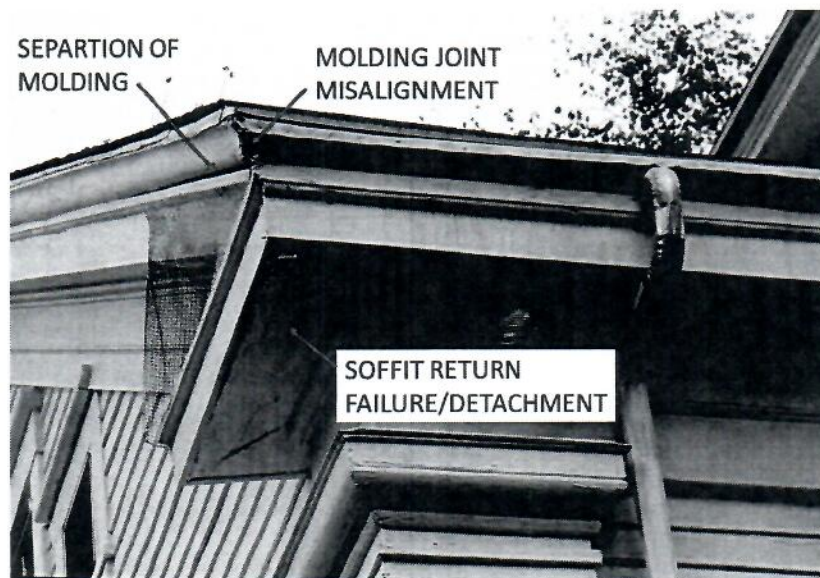
There are outlet tubes (made of lead) of relatively small diameter at the bottom of the gutters that channel the water into downspouts around the building. The face of the gutter boxes read as a cornice molding along the eaves, and is mitered at their ends to join with a similarly-profiled raking cornice molding applied to the sloped gable roof projection. In most all cases, this meeting of the rake cornice molding and the face molding of the gutter box is deteriorated and is patched by covering with sheet metal patches or heavily caulked to fill a significant gap at this joint. It is likely that the ends of the gutter liners have failed in the past and water allowed to leak out into the wood joint causing the wood to rot. Leaking gutter liners would allow water to sit on the soffit board under the overhang providing a damp condition that will lead to fungal decay of the wood.

JOINT BETWEEN BUILT-IN GUTTER AND RAKE TRIM

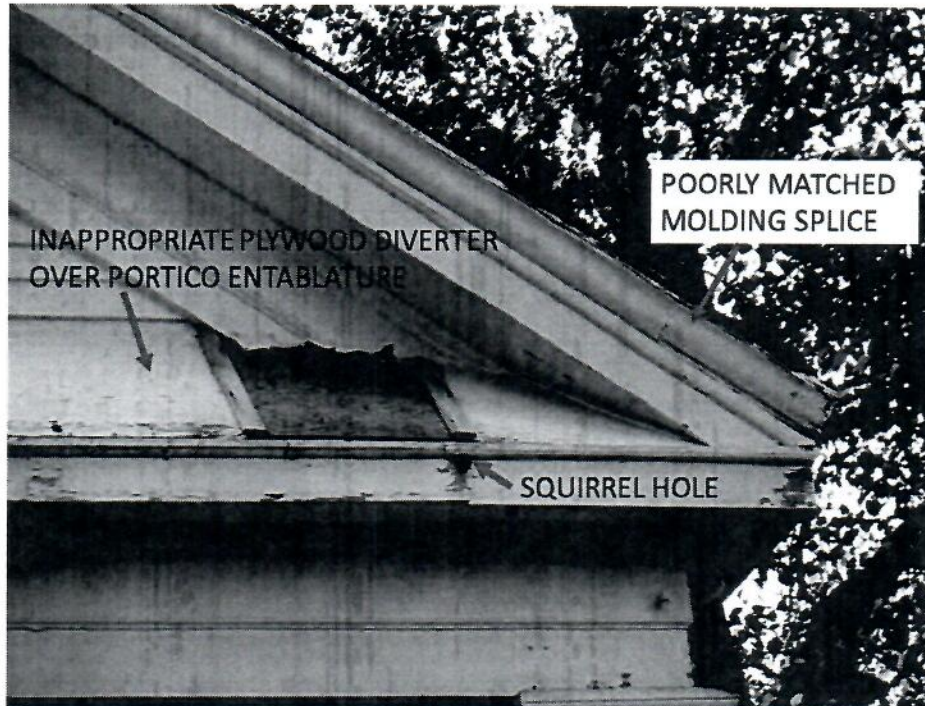
SLOPED PLYWOOD OVER PORTICO CORNICE, TO BE REMOVED

Clapboards will need to be removed to accomplish this. A new lead-coated copper cap shall be fabricated and installed over the original (or replaced) wood cap, bent down over its face-edge with a hemmed drip edge fastened in place with sheet metal cleats. The metal cap should extend up the vertical face of the gable wall at least 6 inches behind the clapboards, with a hemmed edge, fastened with metal cleats. After installation of membrane and metal cap, new clapboards shall be applied to replace those removed.

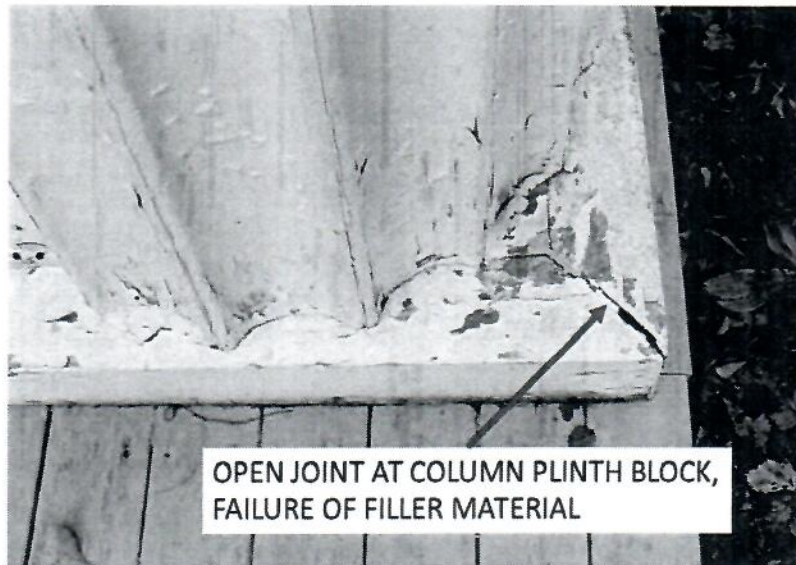
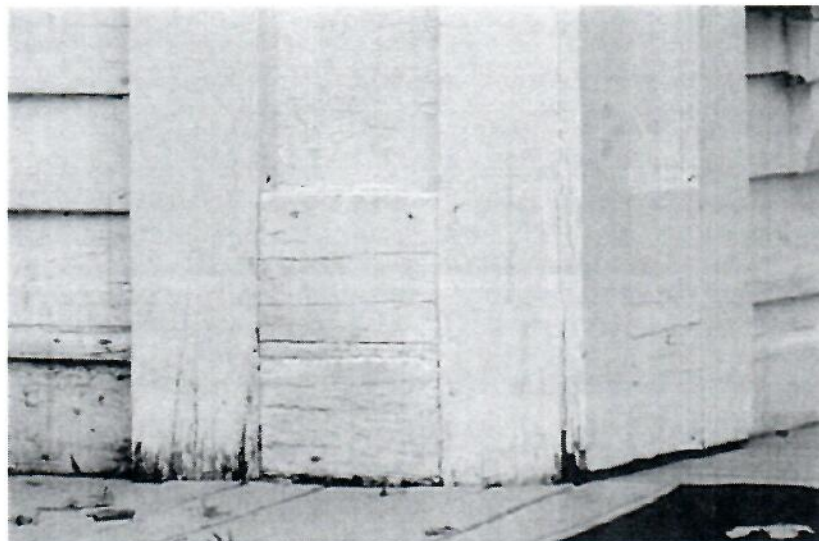
BOTTOM OF CORNER PILASTER WITH DECAY EVIDENT

**Other areas of trim rot:** There are miscellaneous trim elements around the building that show areas of rot and deterioration. When the area of rot is relatively small, it may be possible to dig out the affected portion and use an epoxy filler to rebuild the profile. For such repairs, it is recommended that Advanced Repair Technology's *ART 401 Flex-tec HV* primer and epoxy filler be used, as it retains flexibility after curing allowing it to move compatibly with the expansion and contraction of wood rather than breaking away.

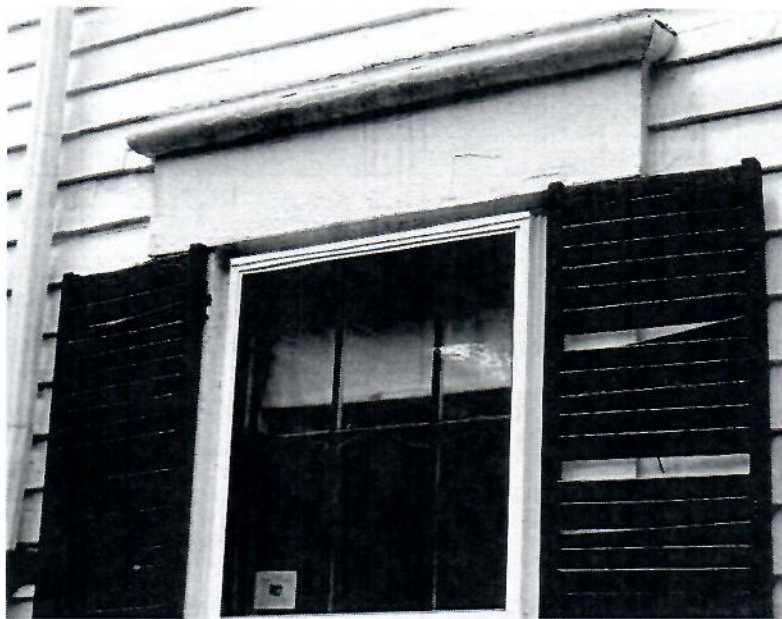
LOUVERS FALLING OUT OF BLIND FRAMES

**Deteriorating blinds:** All efforts should be made to repair any wood window blinds that have failed joints and fallen-out louver slats. Areas of rot can be removed and filled with epoxy, and failed corner joints reinforced with stainless steel angles screwed to the back (hidden) side of the blinds. If necessary, replace slats with reproductions milled from cedar, mahogany, or other rot-resistant species of wood. New, off-the-shelf blinds from lumber stores are made from pine or fir, with glued joints and poor rot resistance. Few companies make high quality custom blinds, and the cost is high.

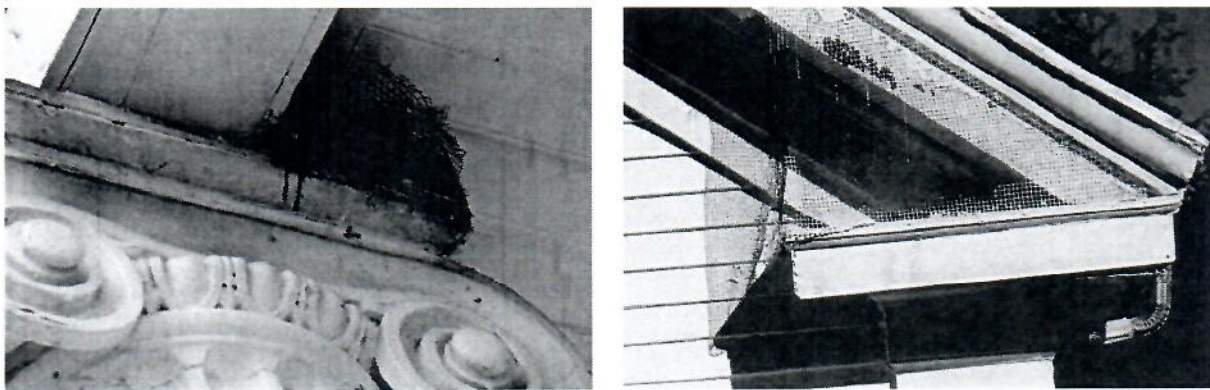
**Bird control:** Currently, bird control has been addressed with limited success by adding wire mesh to ledges and areas on the buildings where birds nest and roost.

UNSIGHTLY WIRE MESH INSTALLED TO DETER BIRDS

It is recommended that the wire mesh be removed and replaced with bird control products available on the market such as: strips of stainless steel spikes in various configurations, and multi-sensory repellents that come in shallow dishes that can be discretely glued to horizontal ledge surfaces. The latter have no visual impact from the ground, but must be replaced every 2
