HILLS BROTHERS CONSTRUCTION INC.
Po Box 1563
PEPPERELL, MA 01463

Re: 13 Chestnut Street Demolition Review Application – Exhibit A

This document serves to provide detailed photos and documentation of construction materials used on the current home as well as the home's current state.

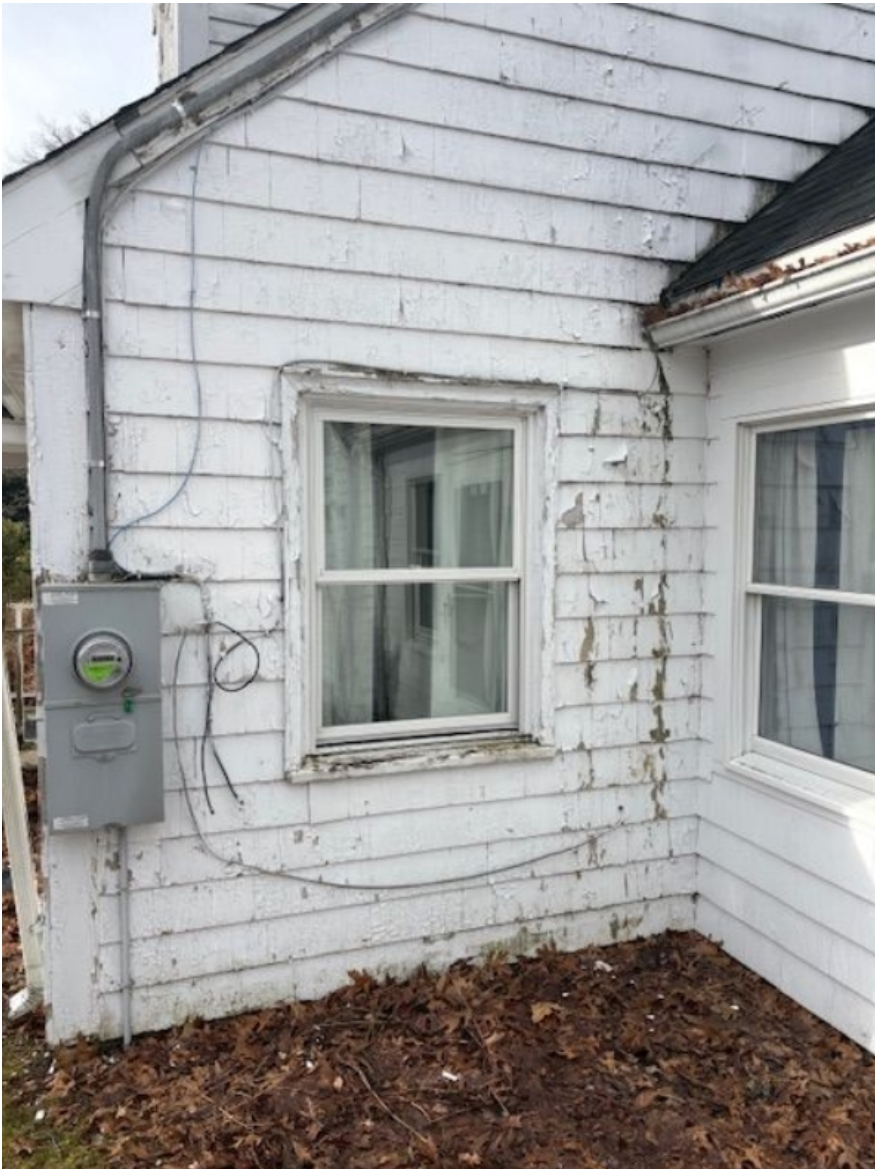
Note: Front Left Corner of Main house Box – exterior sill rot due to home installed on concrete slab and exterior grade at or above interior slab level. This is evident around the entire home.

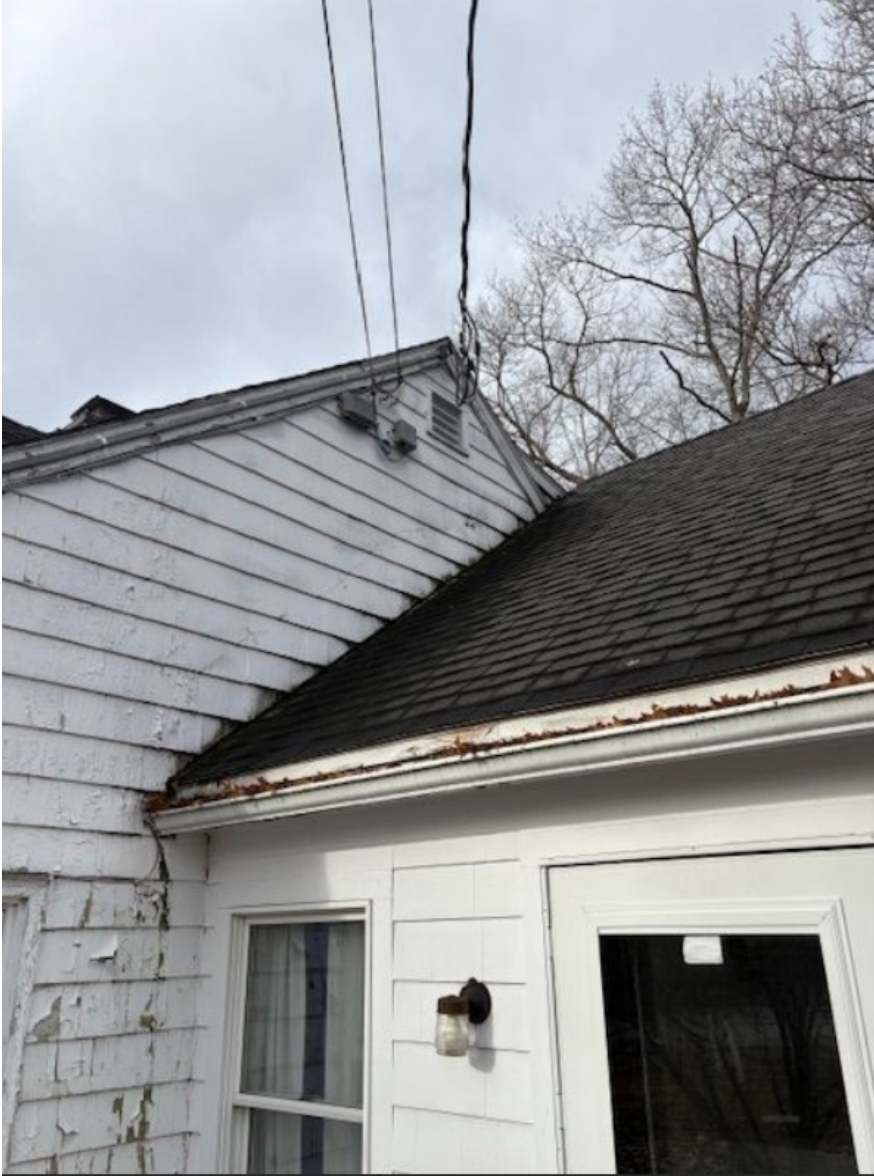
Note: Front left corner of home where breezeway addition attaches to main house. Inside corner of home rotten and sheathing abutting roof is rotten. Breezeway Addition was constructed in 1988.

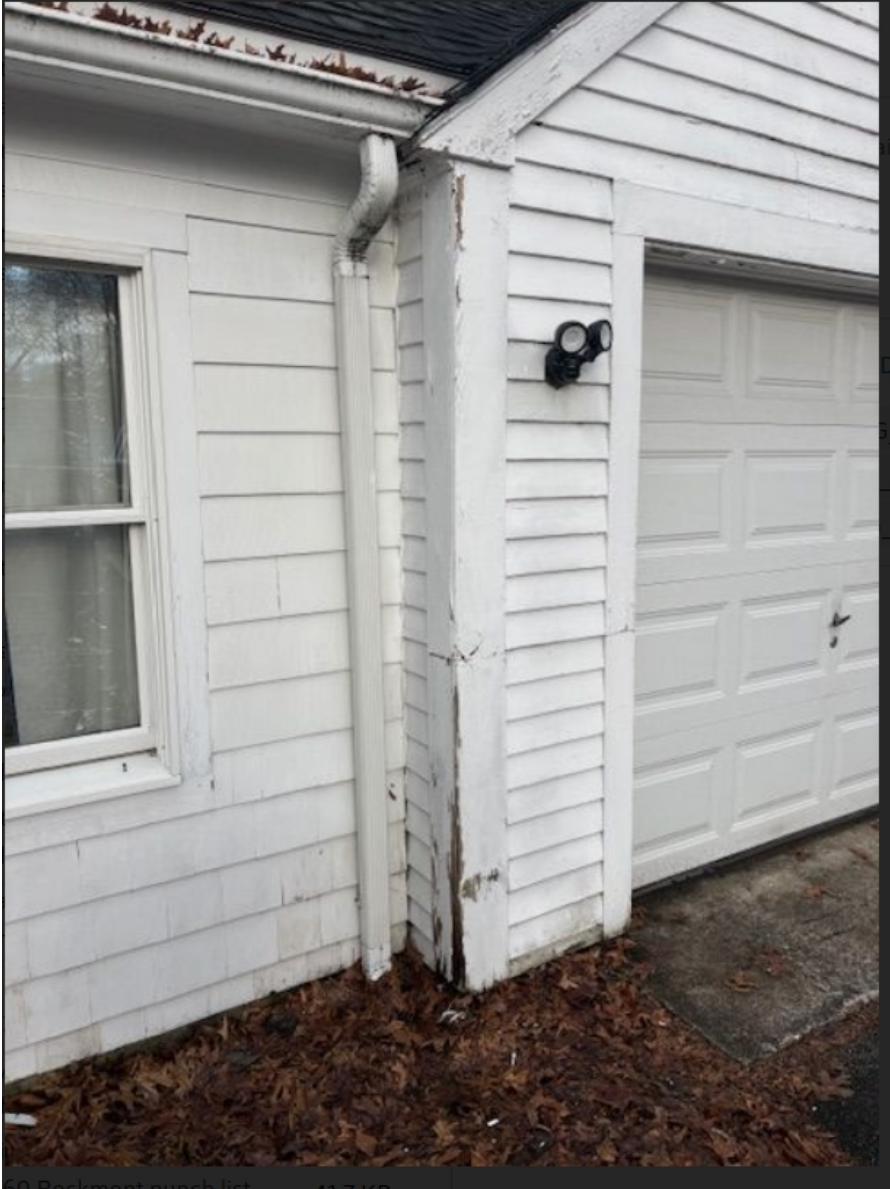
Note: Front Left Corner of Garage – Inside corner of home rotten due to exterior grade at or above the slab level of the home.

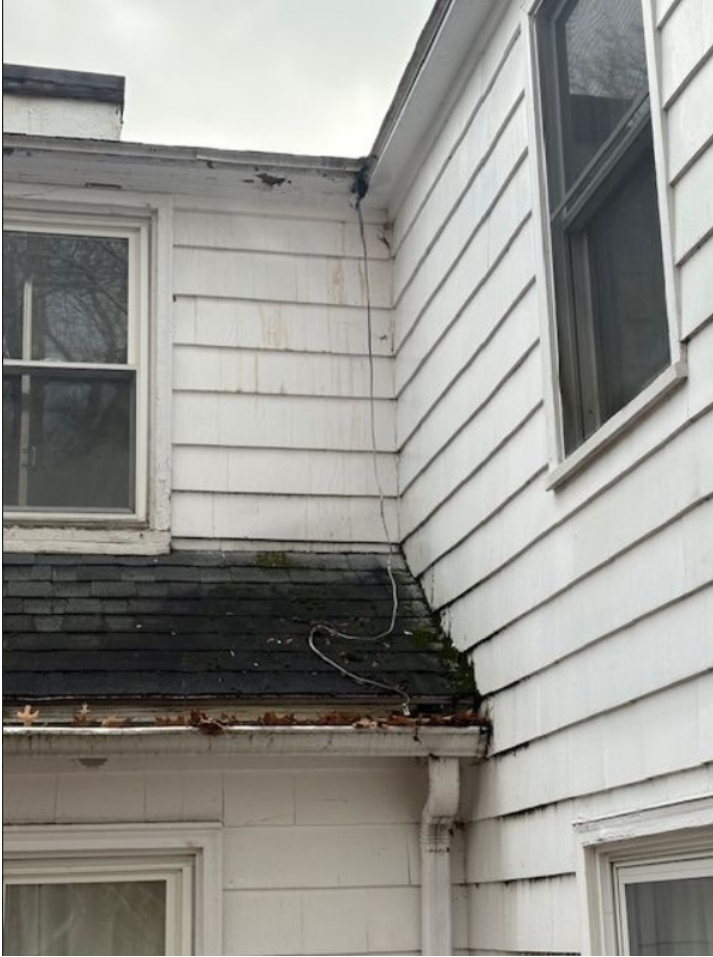
Note: Rear of House – Evidence of ice dams under soffit due to inadequate insulation and roof ventilation. Rotten Soffits, wall sheathing behind siding, and trim boards.

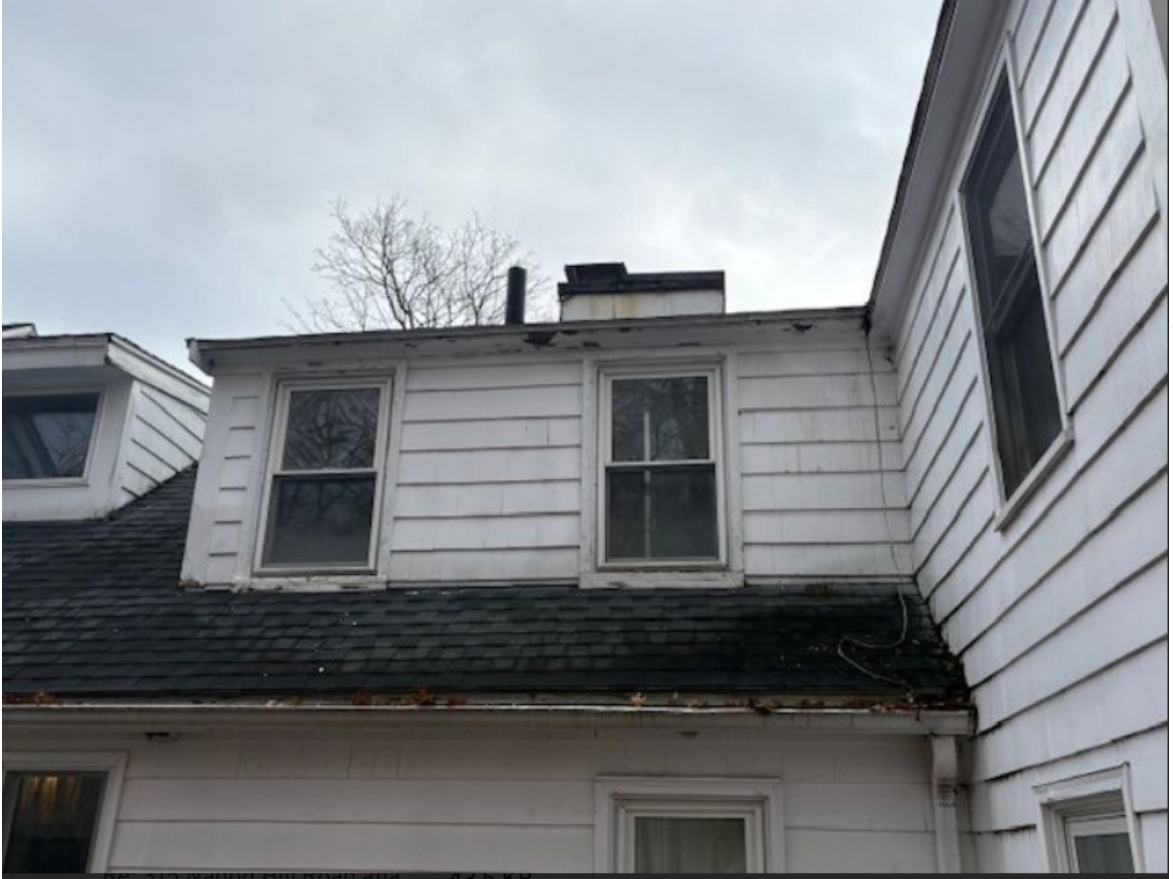
Note: Supplemental photo of rear of home. Dormer to on top and second floor on right were part of the 1979 Addition and Renovation Project.

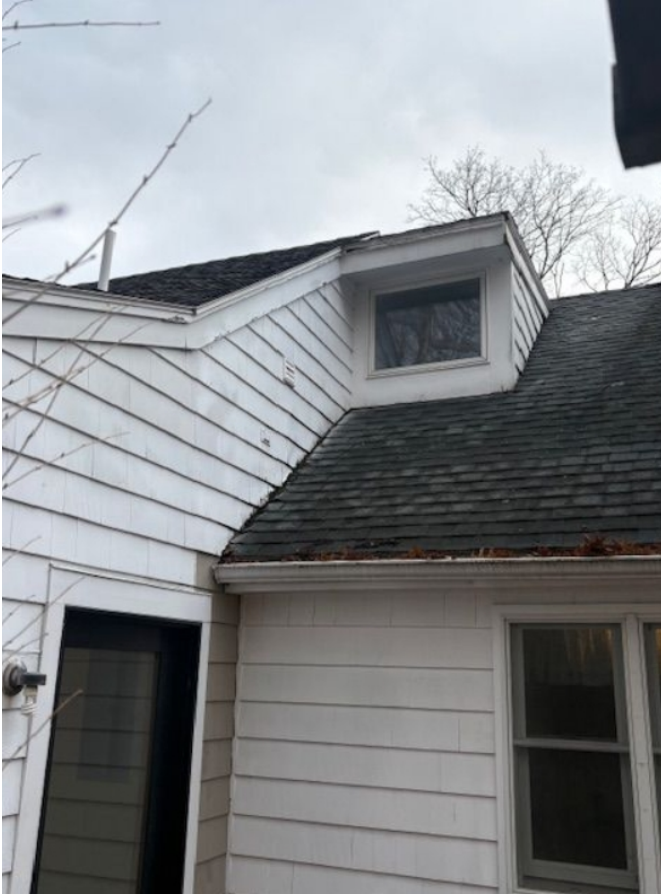
Note: Photo of rear of home – shows rot replacement against inside corner of house. Sheathing and siding rotten along roofline.

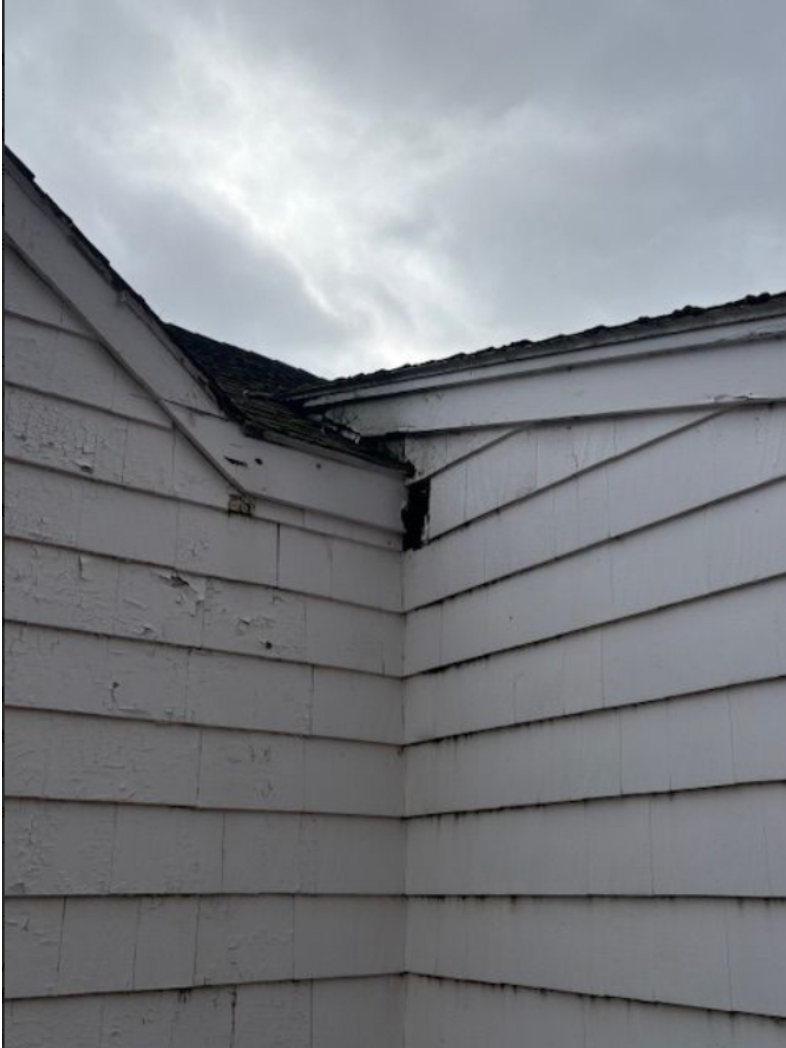
Note: Rear of Home – Inside corner of entire wall is rotten due to inadequate/improper flashing requirements at roof.

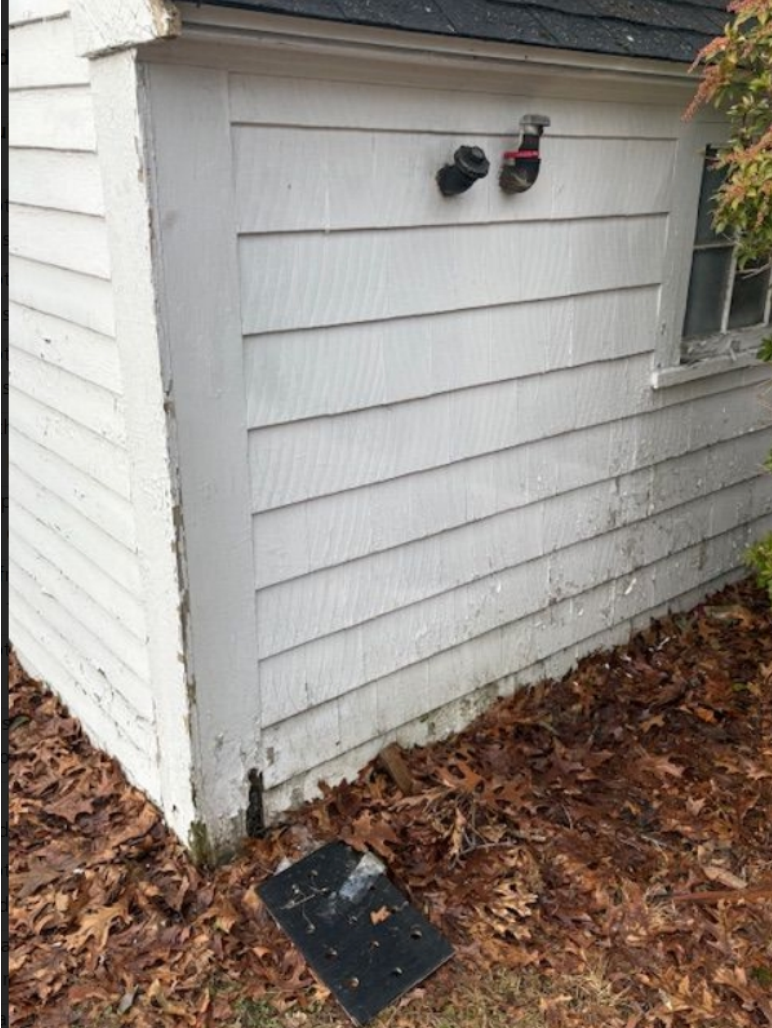
Note: Front right corner / right side of garage – Note House is on slab and the grade around the entire home is at or above the slab level. Home has substantial rot located on all exterior sill plates and sheathing.

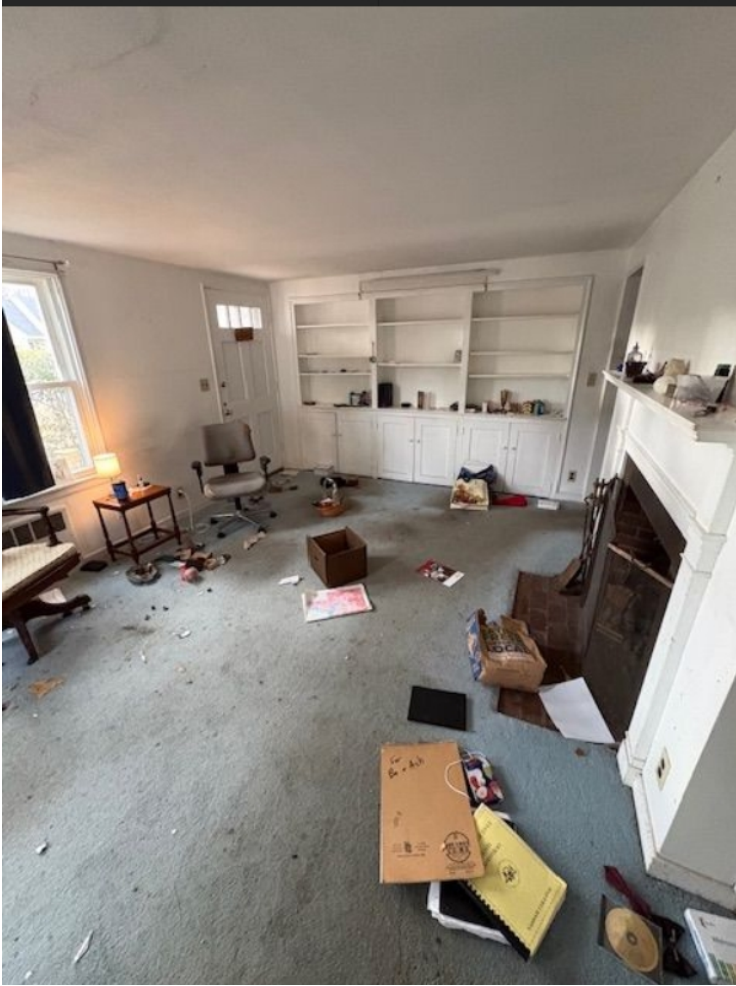
Interior of the home – Family Room with carpet installed over standard 3 ¼”
Hardwood flooring. No apparent historical features are present.

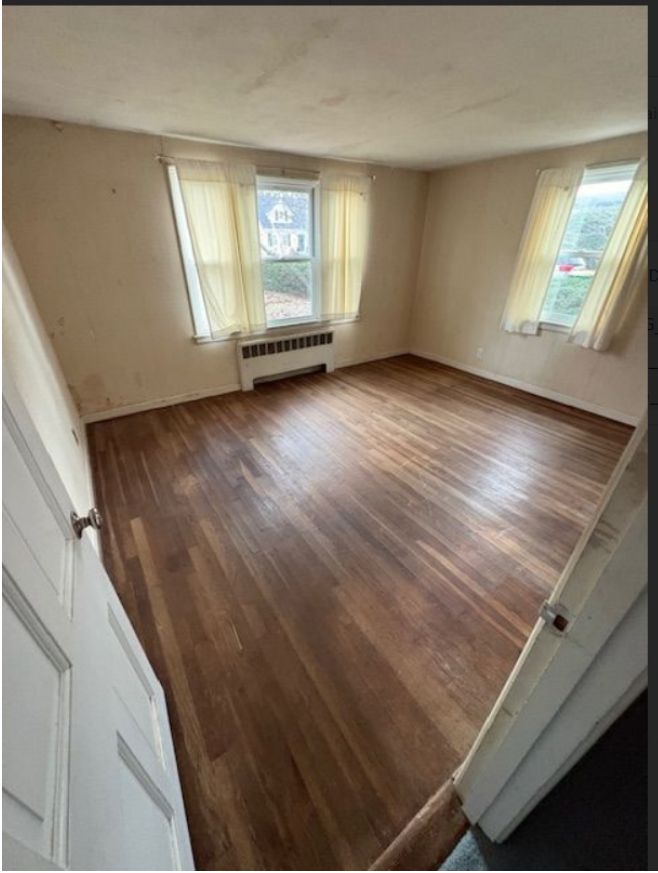
Interior of Home – First Floor Bedroom with 3 ¼” Red Oak Hardwood Flooring.
Exterior walls and ceiling show visible signs of water damage.

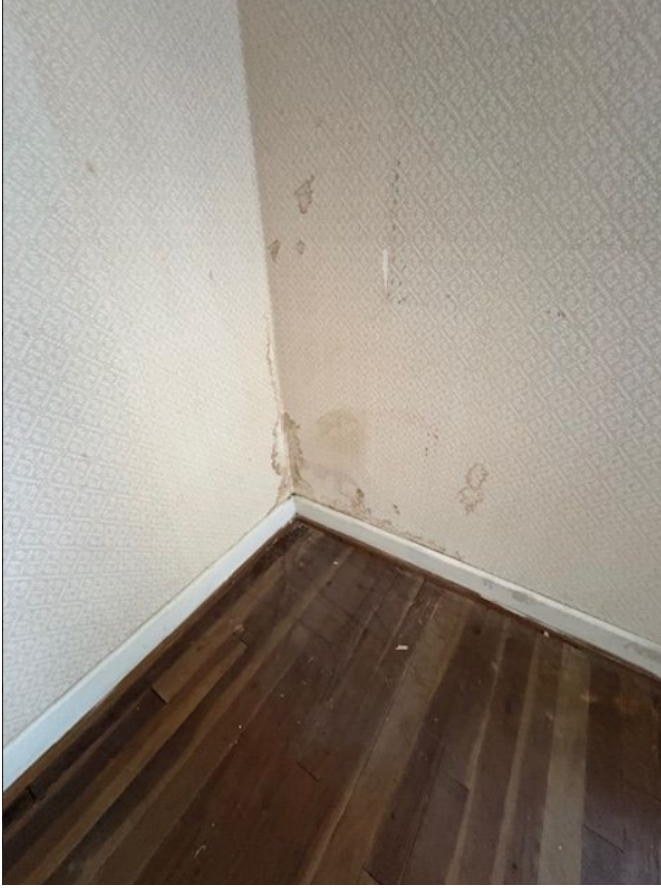
Interior of Home – First Floor bedroom exterior corner of house shows visible signs of water damage.

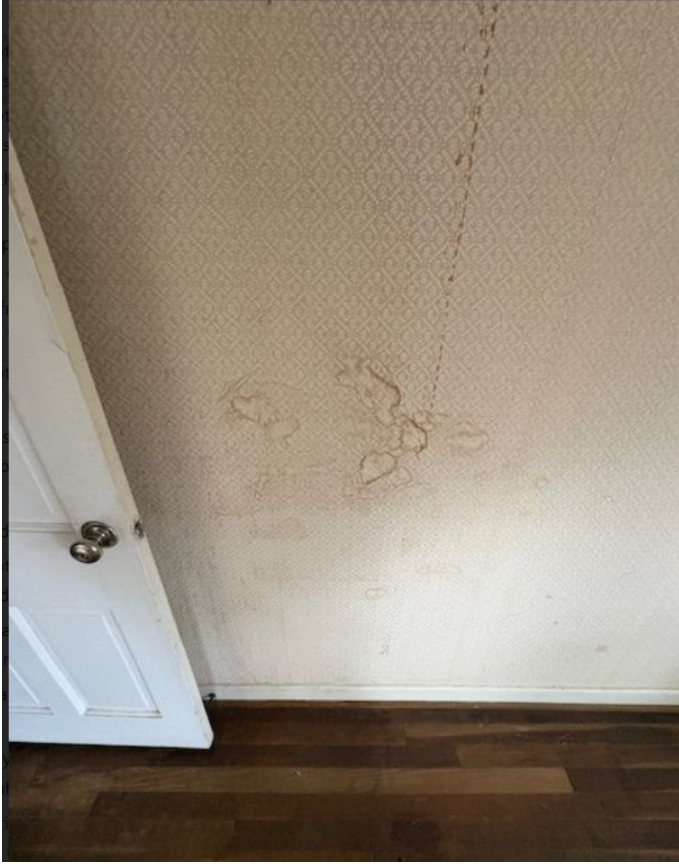
Interior of Home – First Floor Bedroom visible signs of water damage

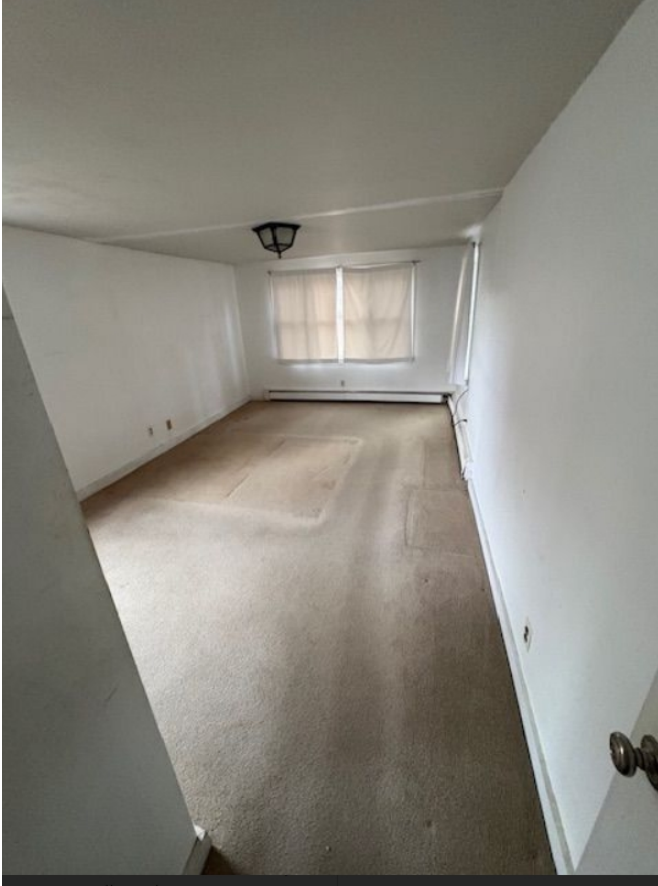
Interior of Home – First Floor Bedroom with carpet over subfloor and baseboard heat.

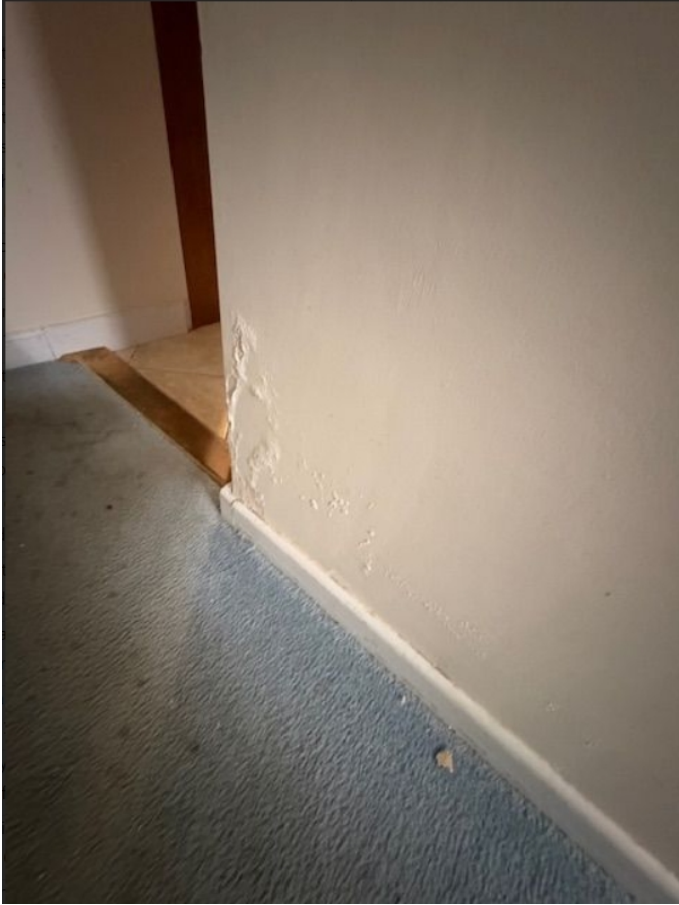
First Floor of Home – Entrance to kitchen shows signs of water damage.

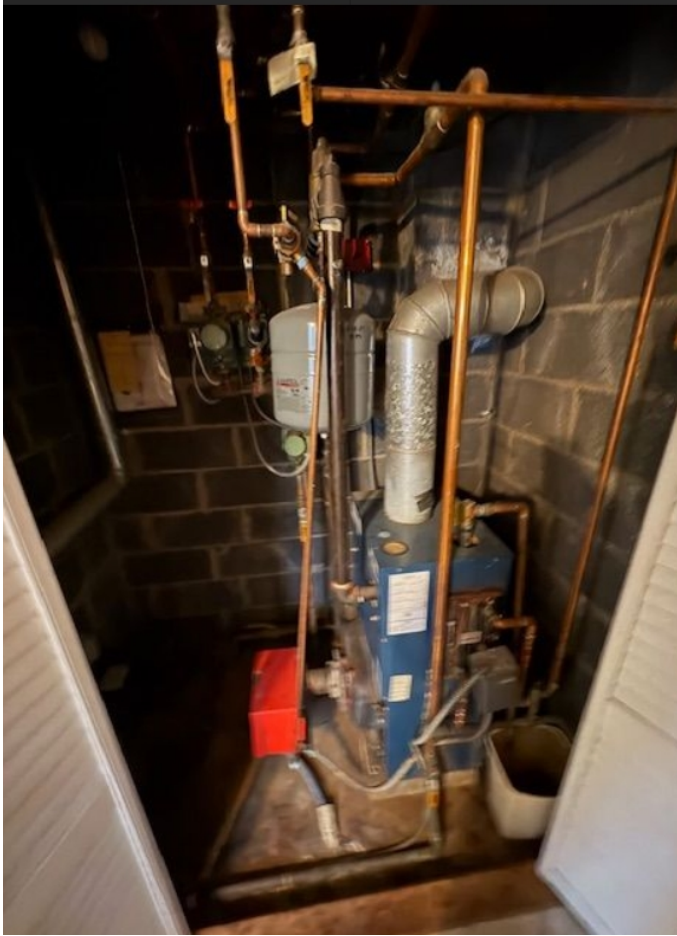
Current extremely inefficient heating system is actively leaking causing water damage to surrounding rooms.

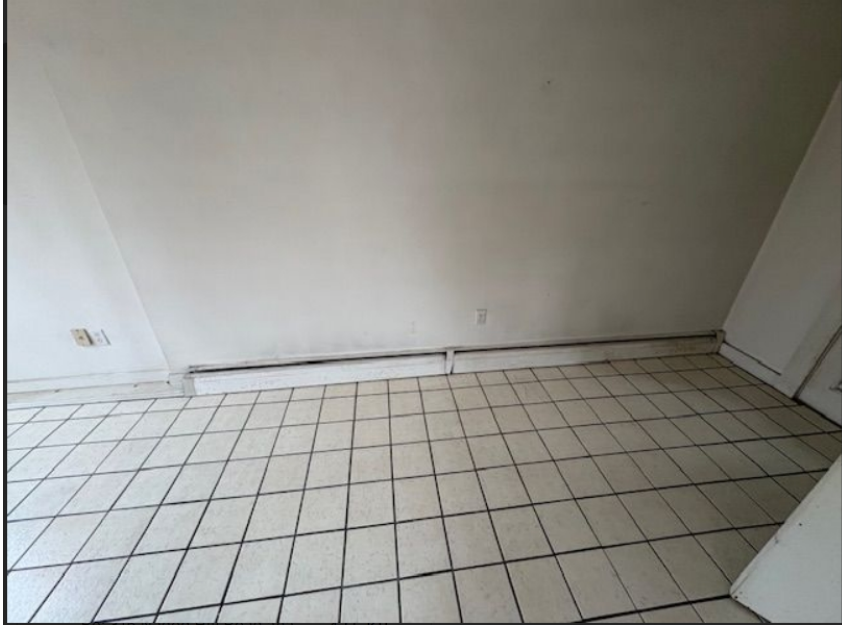
Interior of Home - Rear Additon that was permitted and constructed in 1988 with tiled floor and baseboard heat.

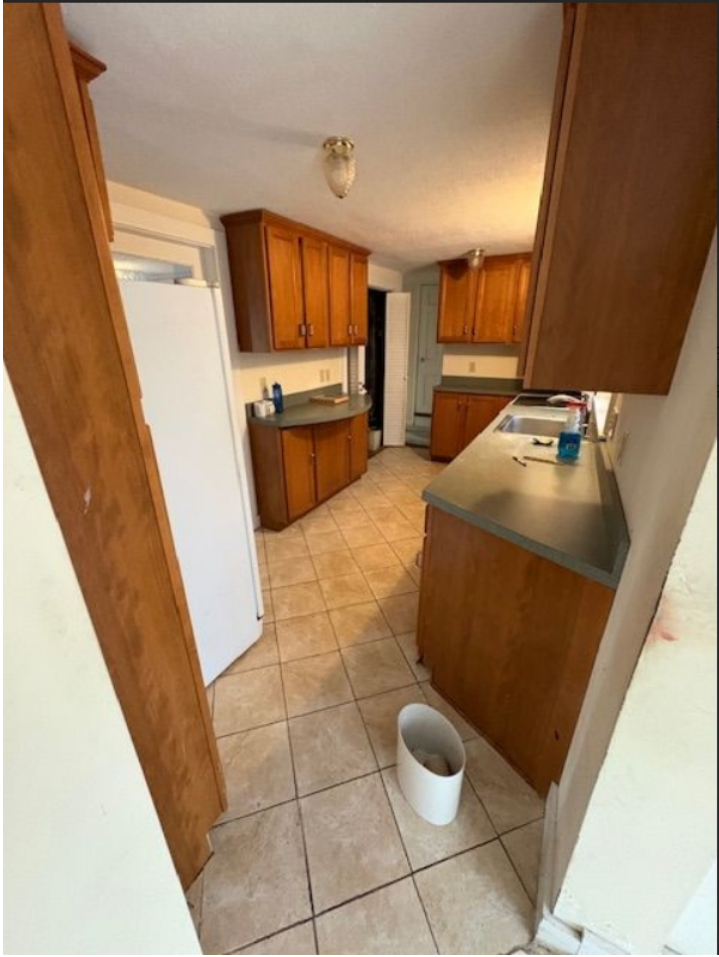
Interior of Home – Kitchen with tiled floor, cabinets, and laminate counter tops completed during a 2009 Renovation.

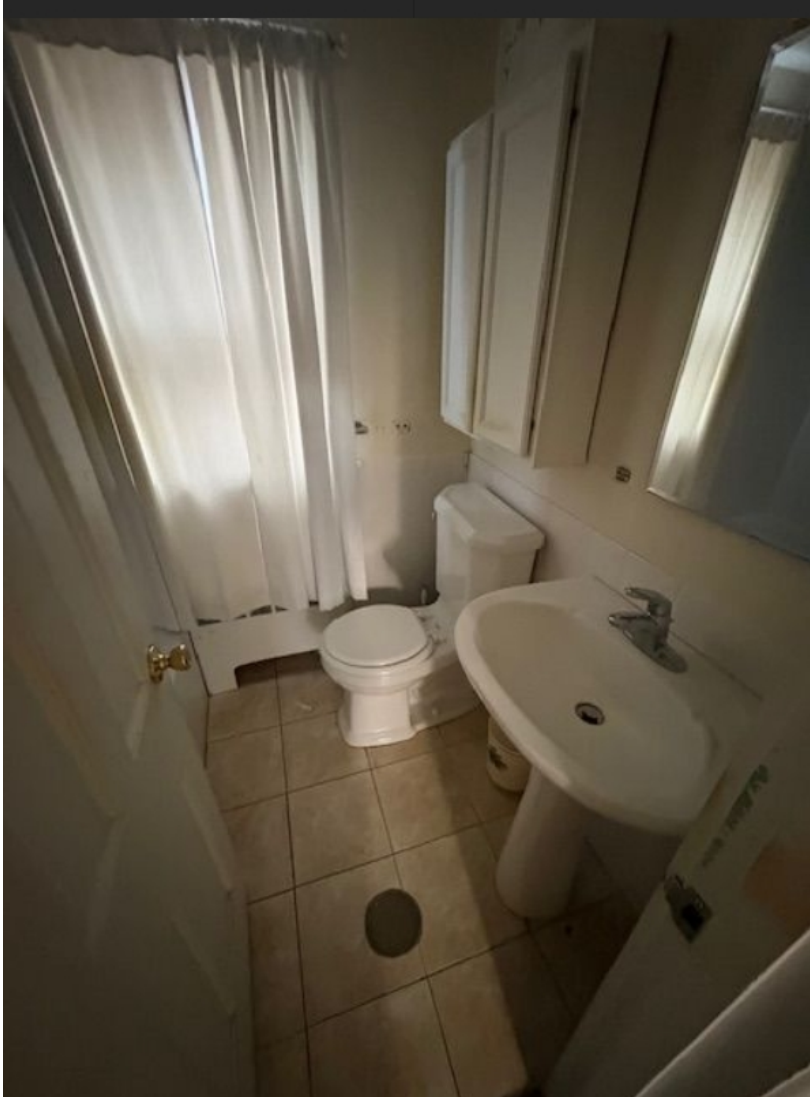
Interior of Home – First Floor Bathroom with tiled floor. Appears to have been renovated at some point in time although no documentation within the Building Departments File.

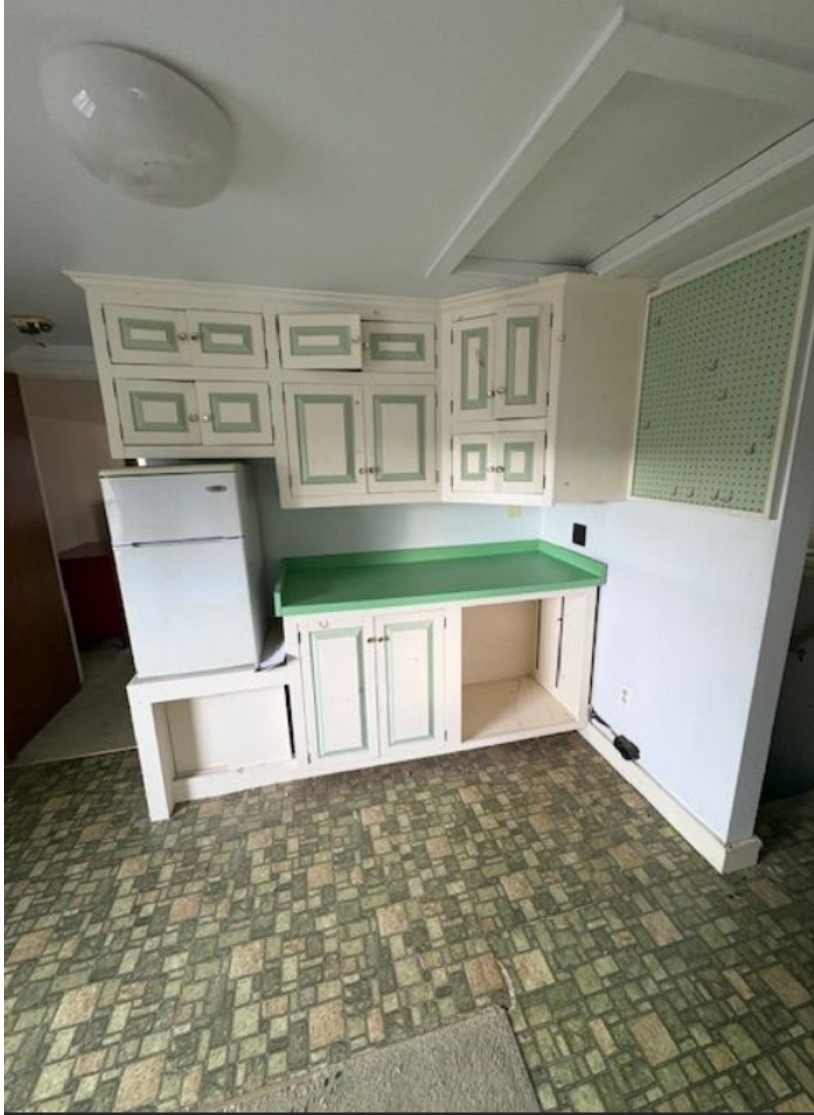
Interior of Home – Second Floor “Kitchen Area” that was an issue between the Town of Concord and the Homeowners as documented within the Building Department File. This was part of the renovation project from 1979. Photo shows laminated flooring and cabinets with laminated countertops. No Second Oven present at this time.

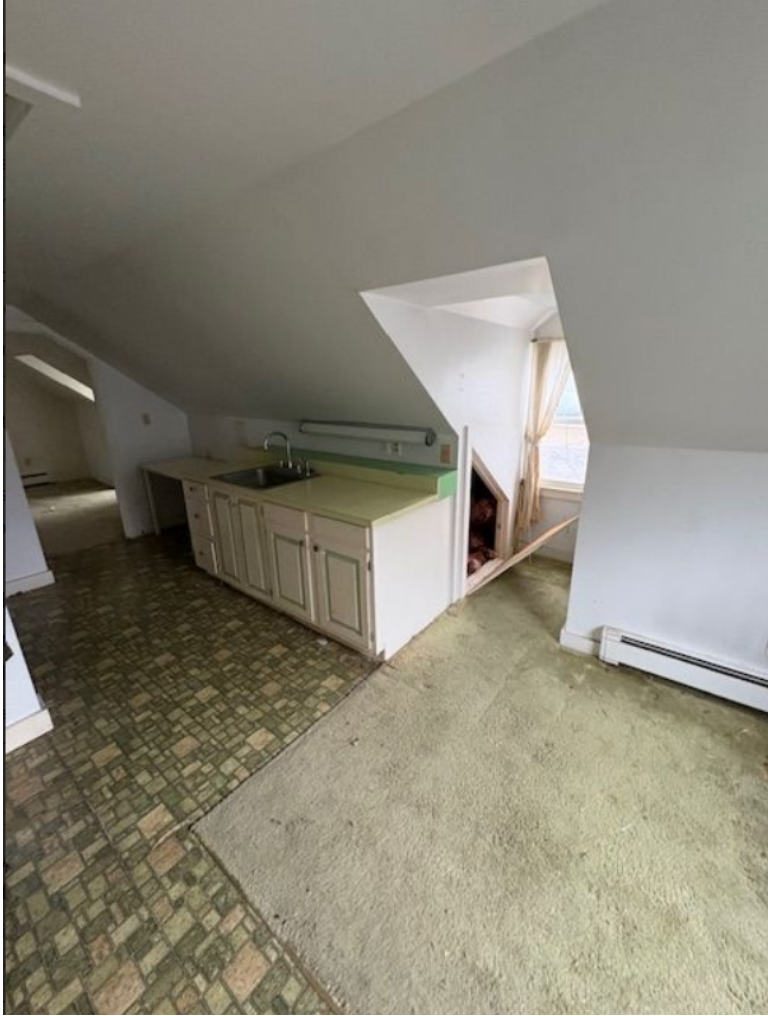
Interior of home – Second Photo showing second floor kitchen area with vinyl and carpet flooring.

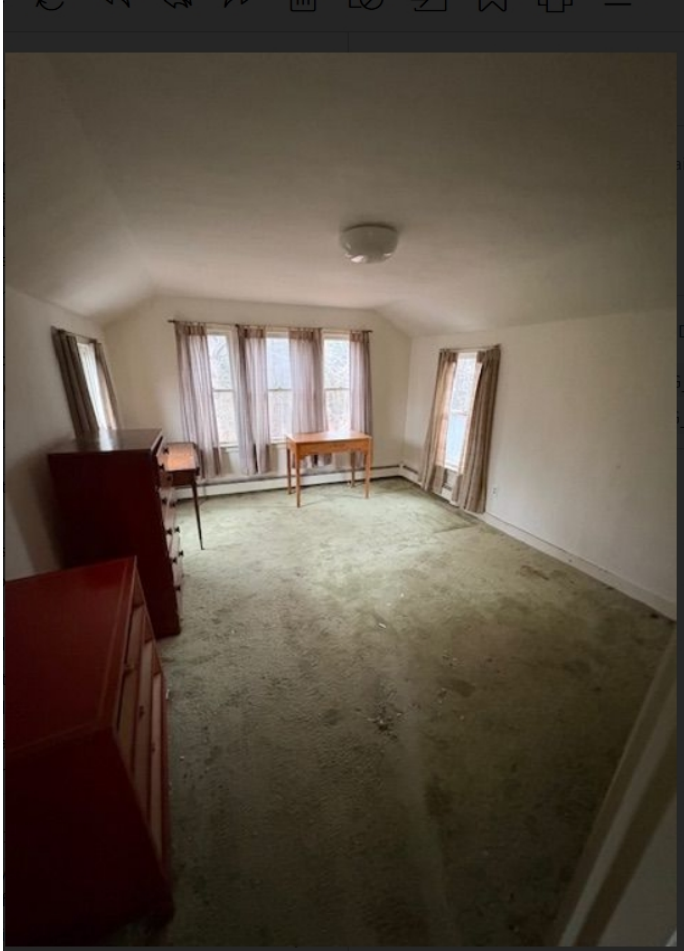
Interior of Home – Second Floor Bedroom with wall-to-wall carpet and baseboard heat. This was part of the addition and renovation project from 1979.

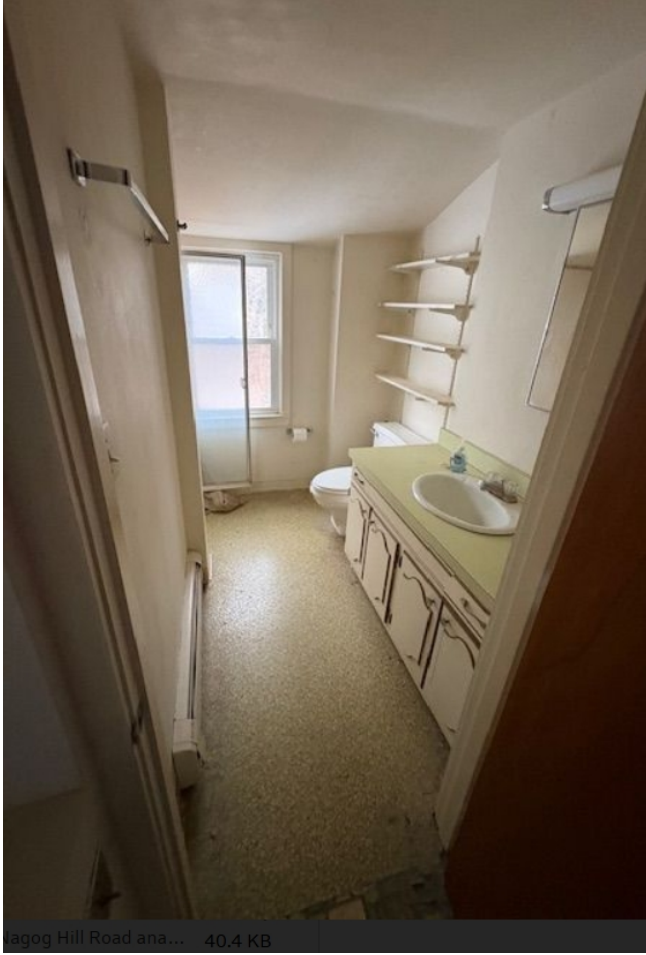
Interior of Home – Second Floor Bathroom with laminated flooring, countertop, and baseboard heat. This was part of the 1979 Addition and Renovation Project.

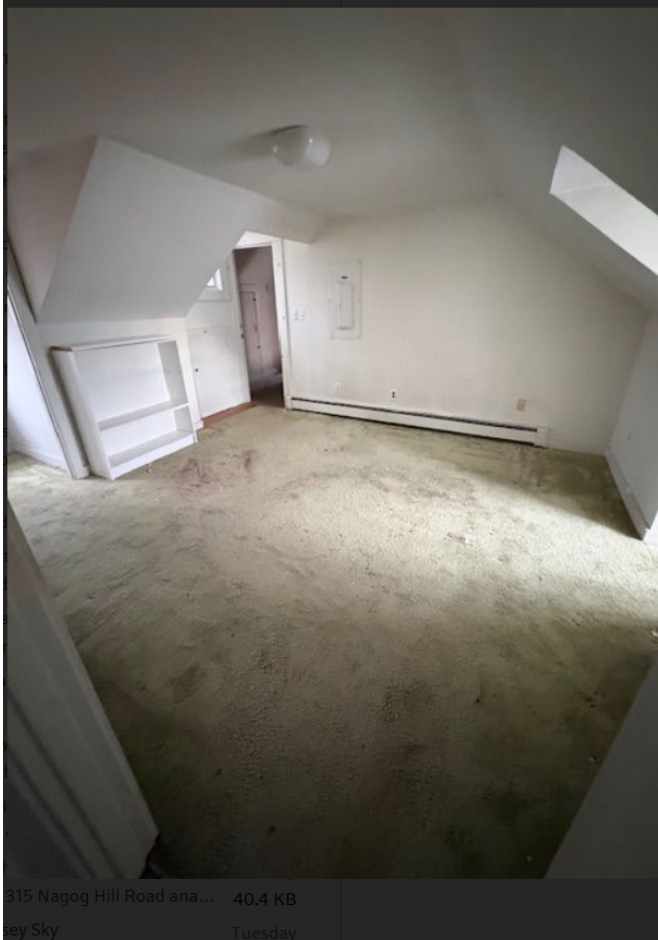
Interior of Home – Second Floor Bedroom #2 with wall-to-wall carpet. This part of the 1979 Addition and Renovation Project.

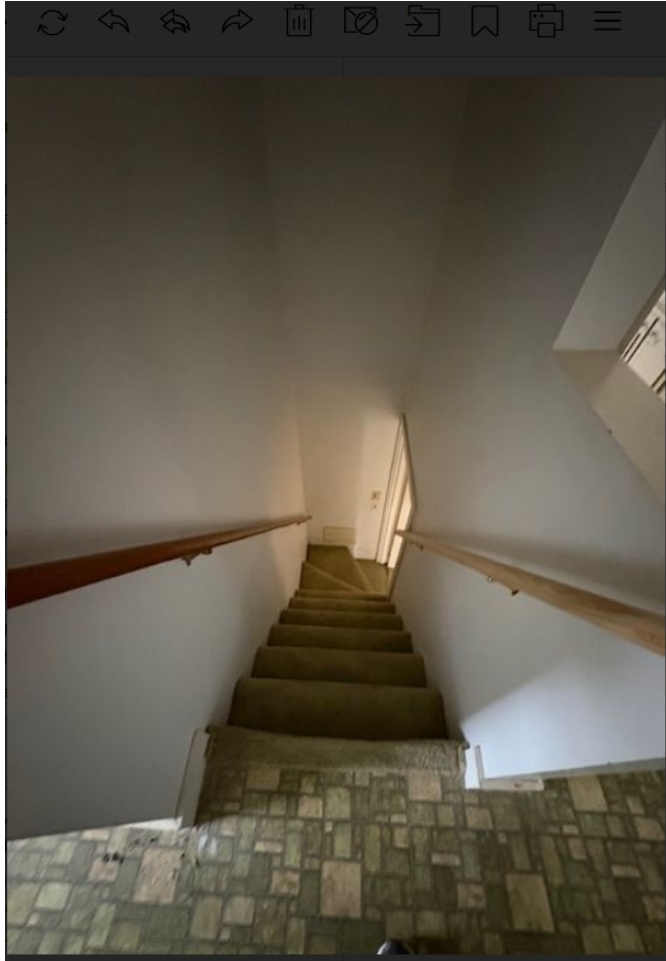
Interior of Home – Staircase from finished second floor kitchen area to the first-floor kitchen area.
Staircase does not meet current building code requirements.
