White Pond Watershed Management Plan

Concord, Massachusetts

Final Revision May 29, 2015

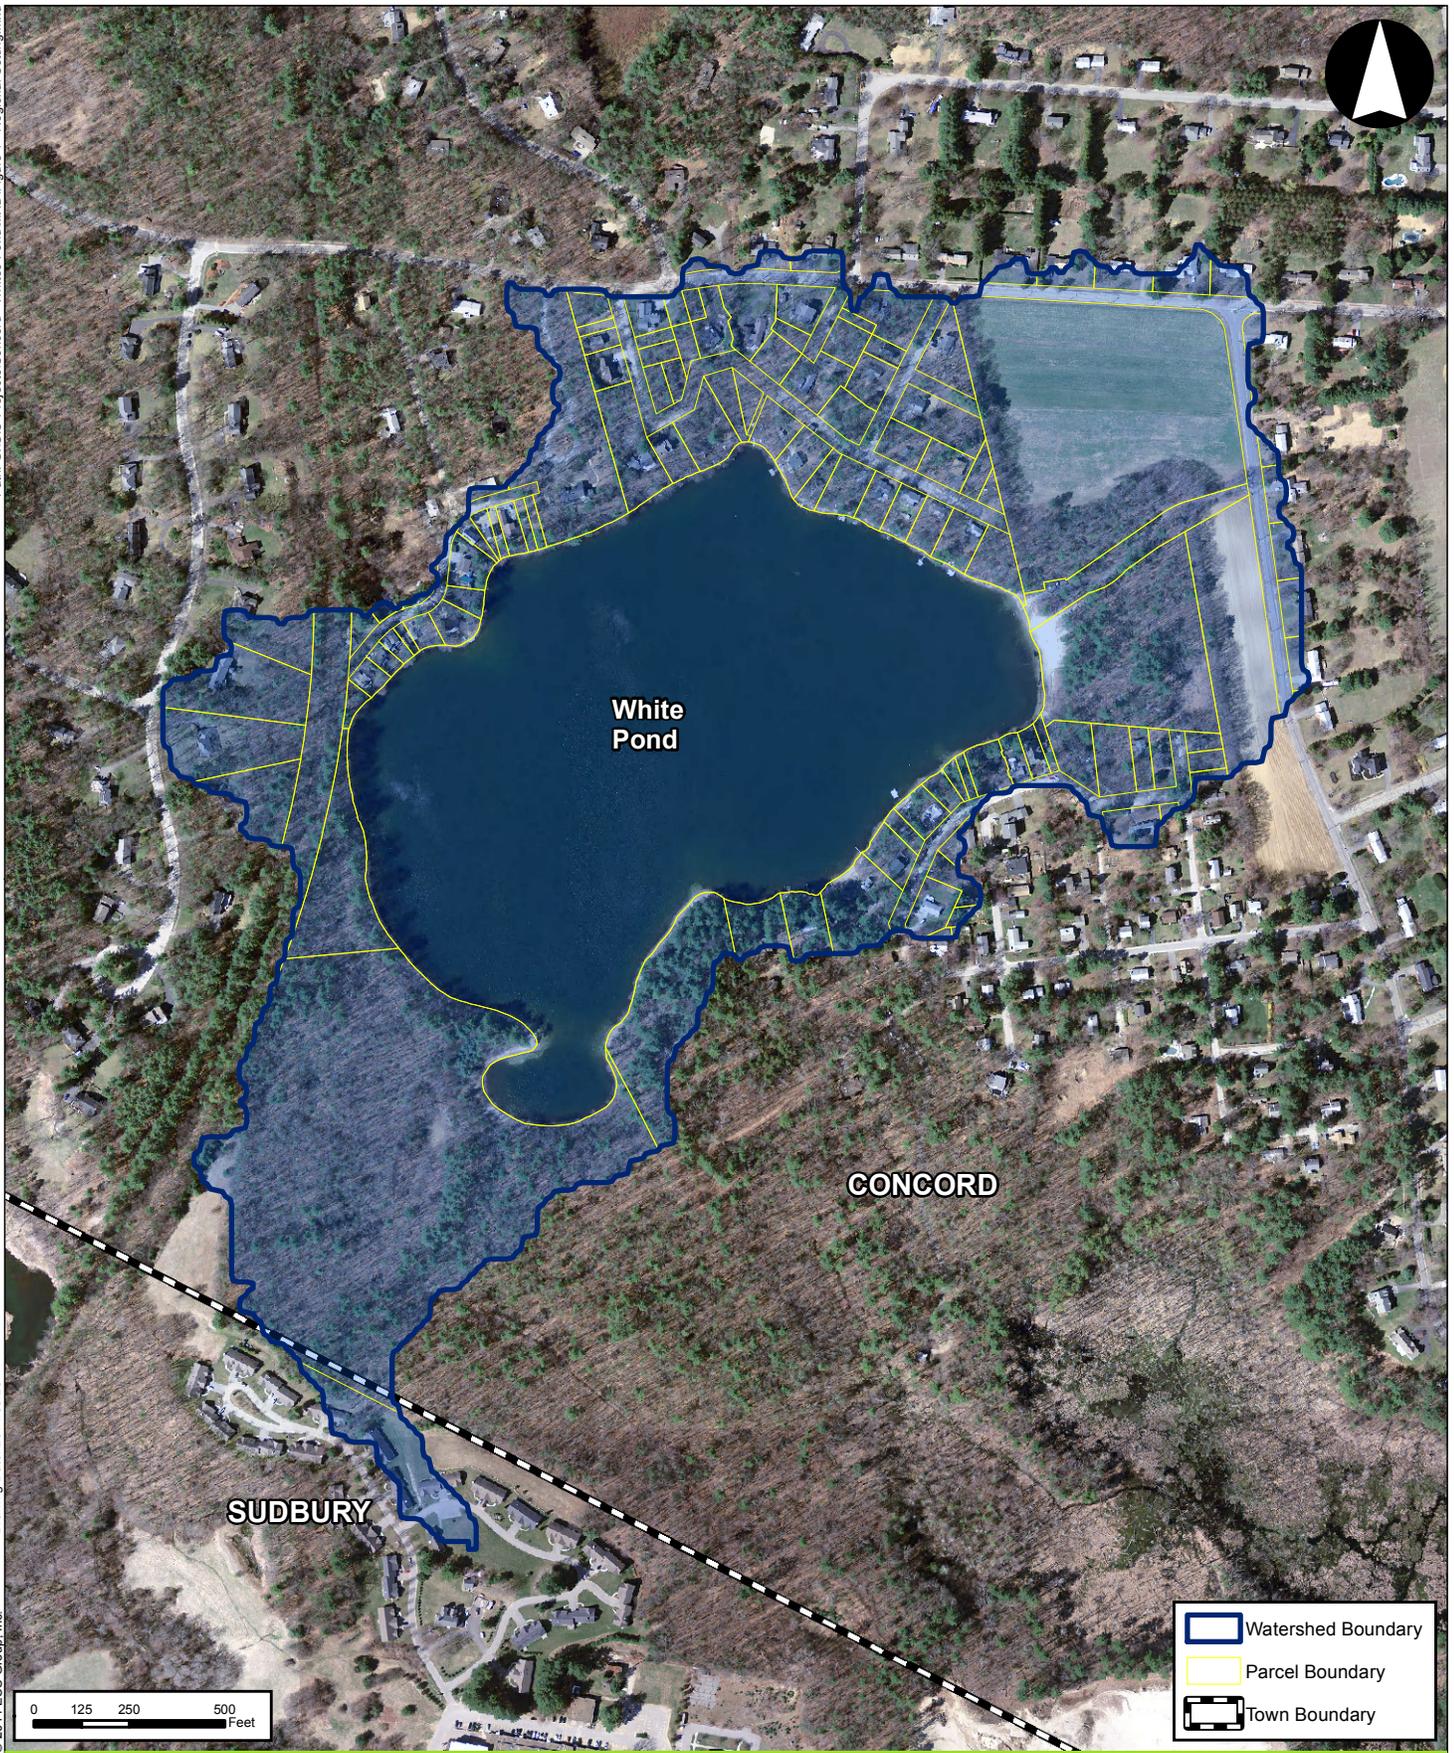
Figure 1

White Pond
Concord, Massachusetts

White Pond is an approximately 40-acre Great Pond located entirely within the southern portion of Concord (Figure 1). The pond was briefly described by Henry David Thoreau in *Walden*, where he characterized the somewhat smaller pond as "the lesser twin of Walden." Like Walden, White Pond is a natural kettle pond with no perennial surface inlets or outlets. Water levels in White Pond regularly rise and fall several feet over multiple year periods but maximum water depths are typically in excess of 50 feet.

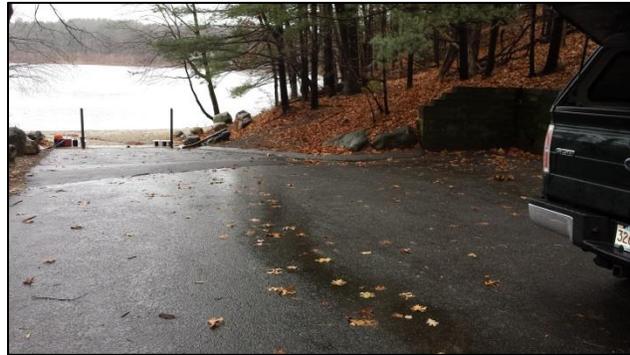
Stormwater flowing down the public access boat launch is partially captured by infiltrating catch basins. Water not captured by these catch basins is able to flow straight down to the pond.

White Pond’s shoreline is essentially devoid of stormwater infrastructure. The primary exception is the presence of two leaching catch basins designed to capture and infiltrate stormwater runoff from the road leading to the public access boat launch.

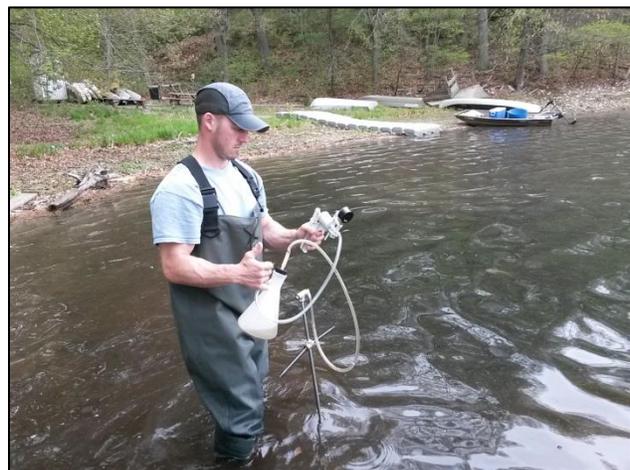
Collection of shallow groundwater with a littoral interstitial porewater sampler.

Seepage sampling events consisted of the installation of seepage meters to estimate the rate of in-seepage to and out-seepage from the pond within six shoreline areas. A littoral interstitial porewater sampler was also used to extract shallow groundwater for water

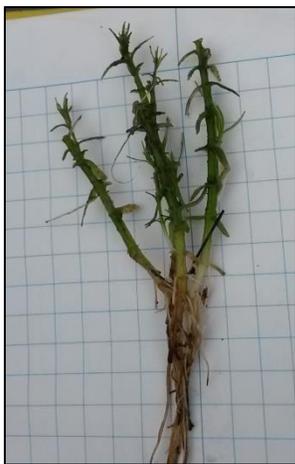
Golden hedge-hyssop is common along the shoreline of White Pond.

Aquatic macrophytes in White Pond were restricted almost entirely to narrow strips along shallow shoreline areas. In these areas, only two low-growing native taxa, including spikerush (*Eleocharis* sp.) and golden hedge-hyssop (*Gratiola aurea*) were encountered. Although these taxa can locally form dense mats of growth, neither is considered to be problematic from an ecological or recreational point of view. Small emergent patches of plant growth were present along the shoreline, primarily in Sachem's Cove, but continuous stands of larger emergents, such as the blue flag iris noted by Thoreau, were not present.

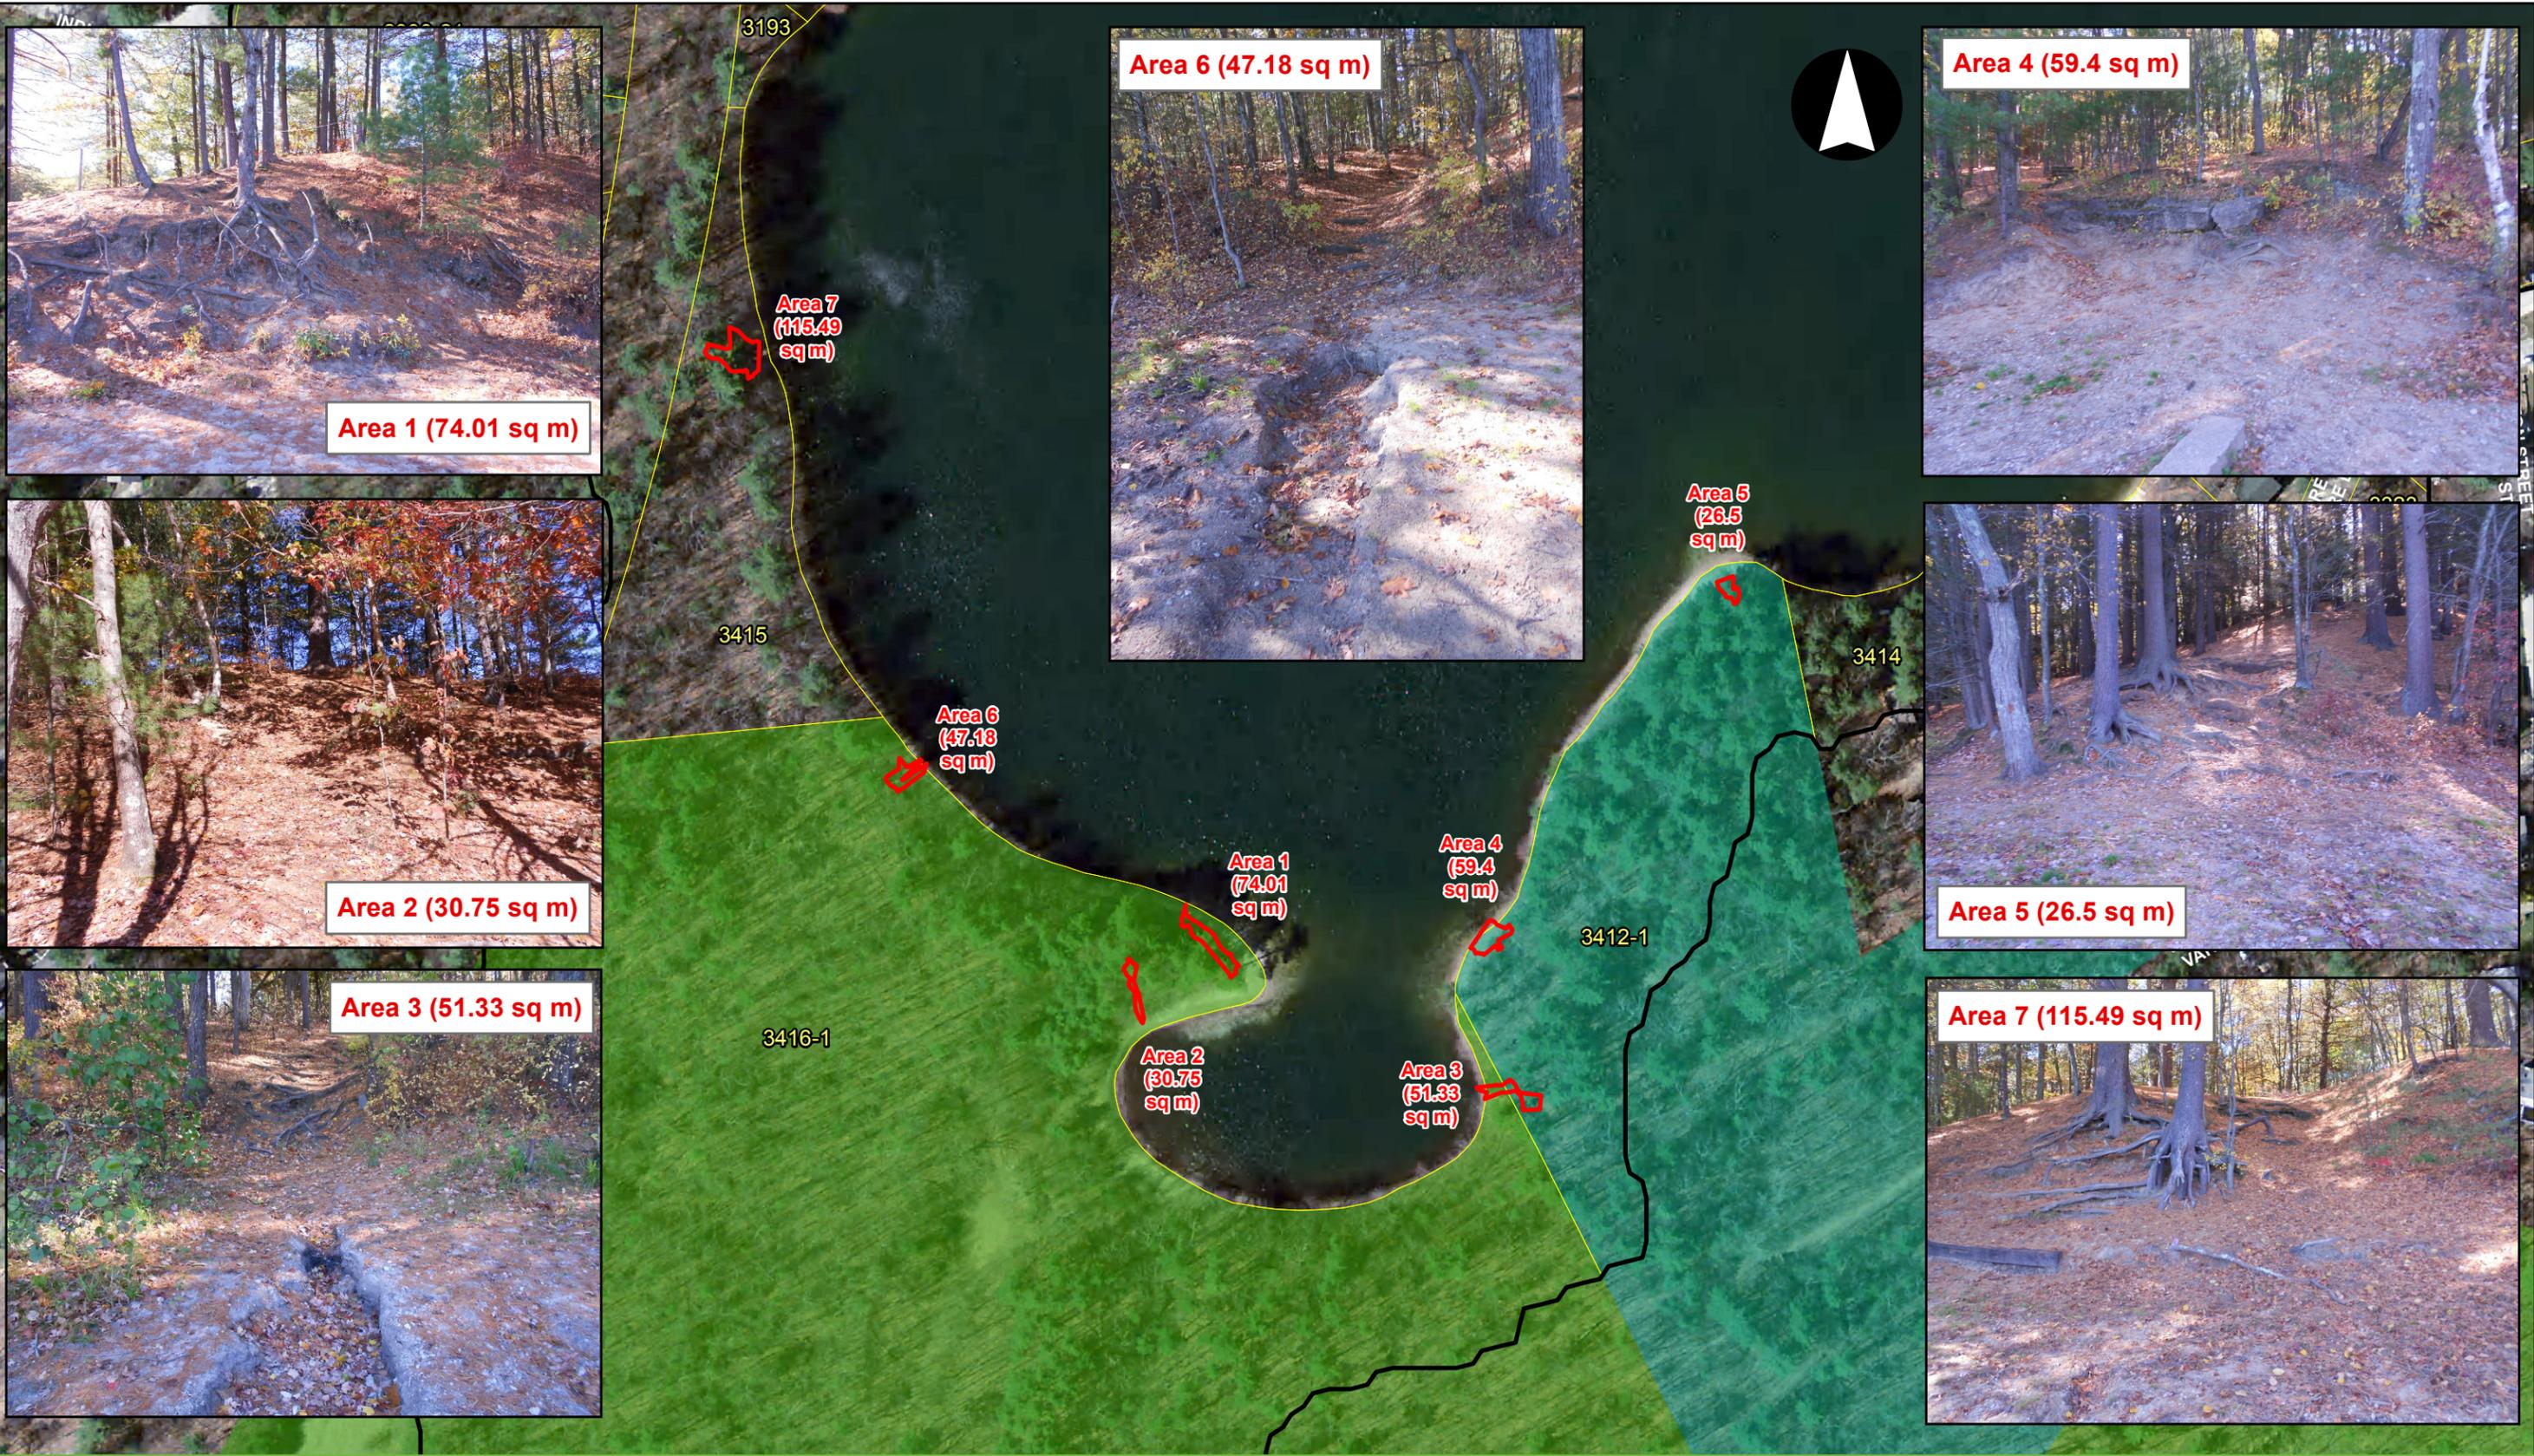
Total Area of Shoreline Erosion = 404.66 square meters

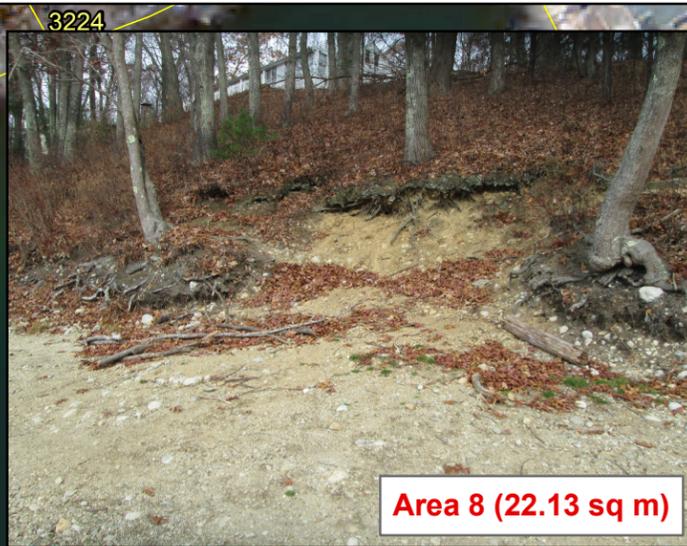
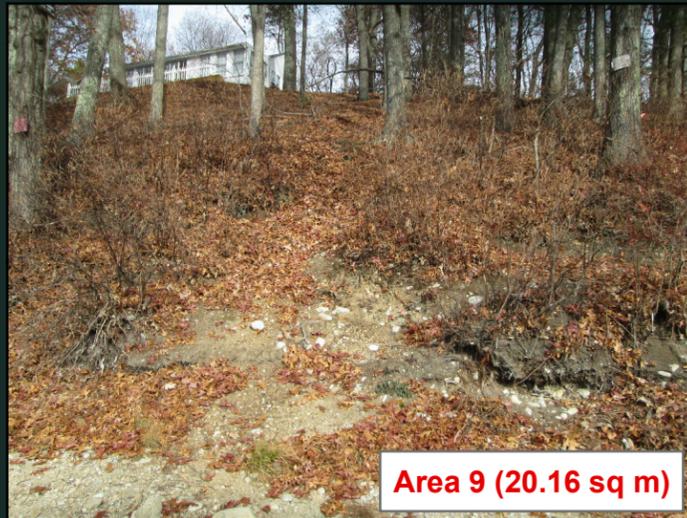
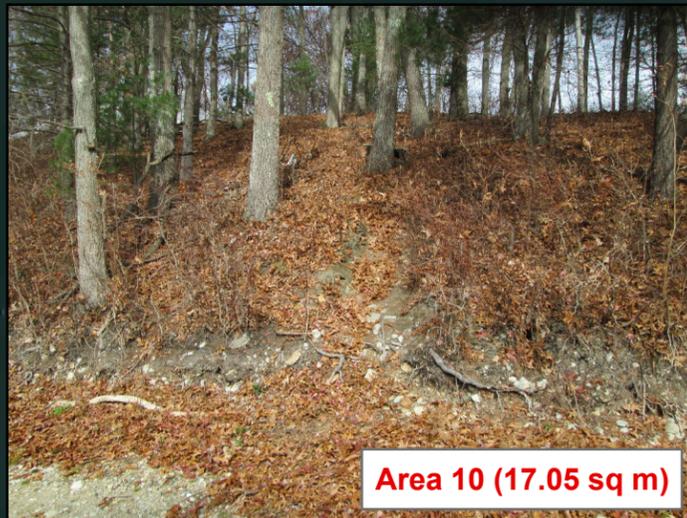
Total Area of Shoreline
Erosion = 59.34 square meters

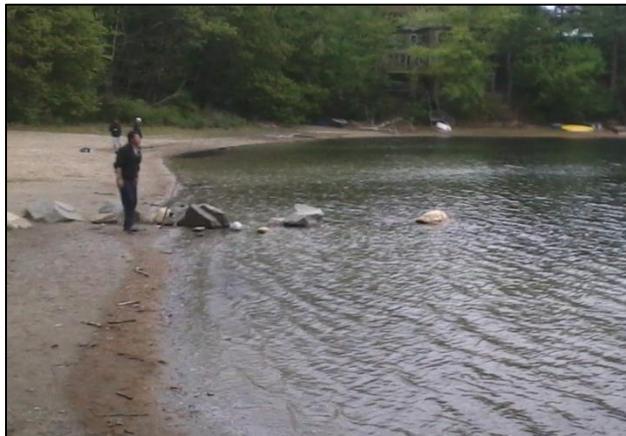
Shoreline fishing from the public access boat launch and White Pond Associates, Inc. beach is a popular activity outside of swimming season.

As a Great Pond, public access for fishing is provided at the state boat ramp on the eastern side of the pond. During this study, anglers were observed fishing from many different shoreline locations. However, shoreline fishing activity was mainly concentrated near the public access ramp. The shoreline areas of Town lands on the western end of the pond also attract some activity. Typically, no more than four or five anglers were observed to be using a given shoreline area at any one time.

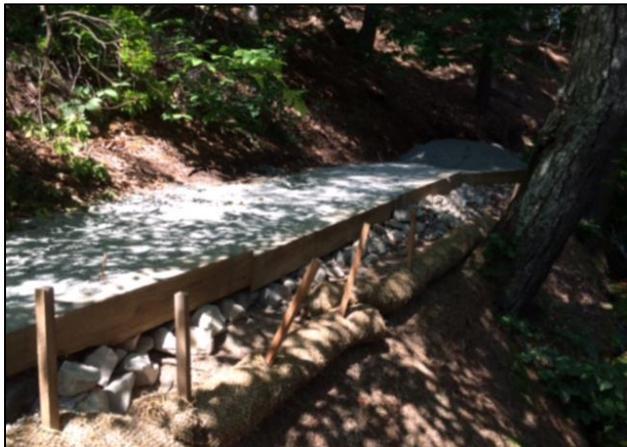
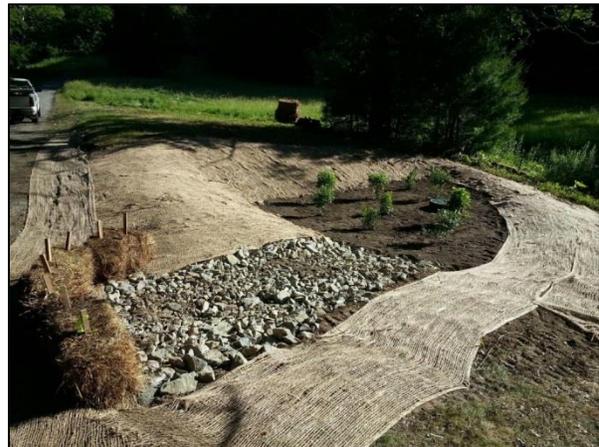
Installation of regraded gravel trail with timber curbing (left) and and bioretention area (right).

Eleven areas of significant erosion were identified adjacent to the White Pond shoreline. Based on the results of stormwater sampling and the hydrologic and nutrient budgets developed for White Pond, stabilization of these areas is recommended to prevent delivery of sediments and associated nutrients.

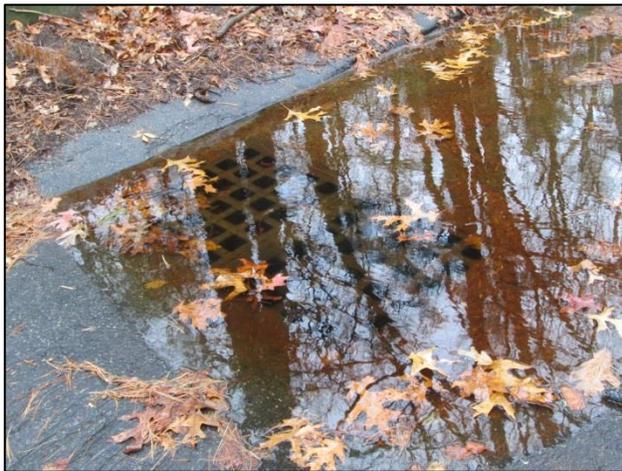
The catch basin at the White Pond public access boat launch quickly reached capacity, allowing untreated or minimally treated stormwater to flow directly down to the pond.

of significant stormwater pathways to the pond. With the exception of 2A Paul Street, the sandy soils in this area are hydrologic class A, meaning that they are exceptionally well-drained and have superior infiltration capacity. Therefore, at the current density of development, there is little overland runoff generated from these areas. Rather, the primary sources of overland stormwater flow to White Pond are the steep banks immediately adjacent to it (as identified in Figure 4). These problem areas may not require BMPs beyond the erosion control and slope stabilization techniques recommended in Section 6.1.

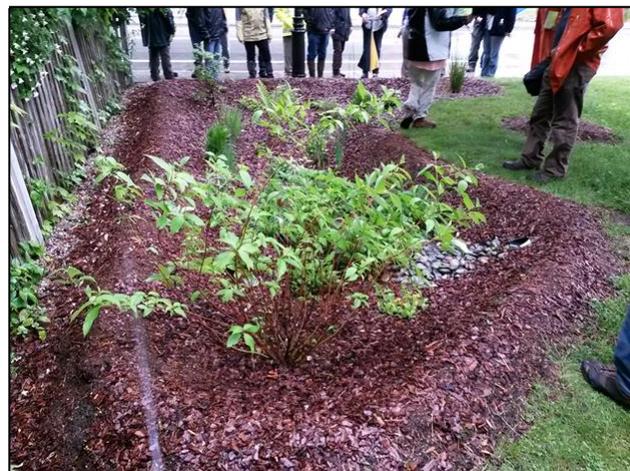
Rain gardens are an excellent way to retain and infiltrate stormwater on most residential sites.

around watershed dwellings and roads, residential rain gardens should be encouraged to enhance infiltration. These can usually be implemented by residents. However, assistance from an experienced professional familiar with rain garden design will generally result in the most satisfactory results, both aesthetically and functionally.
