To: Bruce Freeman Rail Trail Advisory Committee
From: Erin Stevens, Senior Planner
Re: **Update on BFRT**
Date: September 28, 2023

Field Inspection Report #10

Project Name:	Bruce Freeman Rail Trail	Submitted to:	Andy Sheehan, Town Manager		
Inspection Date:	09/12/2023	Project Address:	Sudbury, MA		
F&O Project #:	20200785.C10	City:	Sudbury	State:	MA
MassDOT Project #	608164	Client:	Town of Sudbury		
		Photos Included:	11 photos

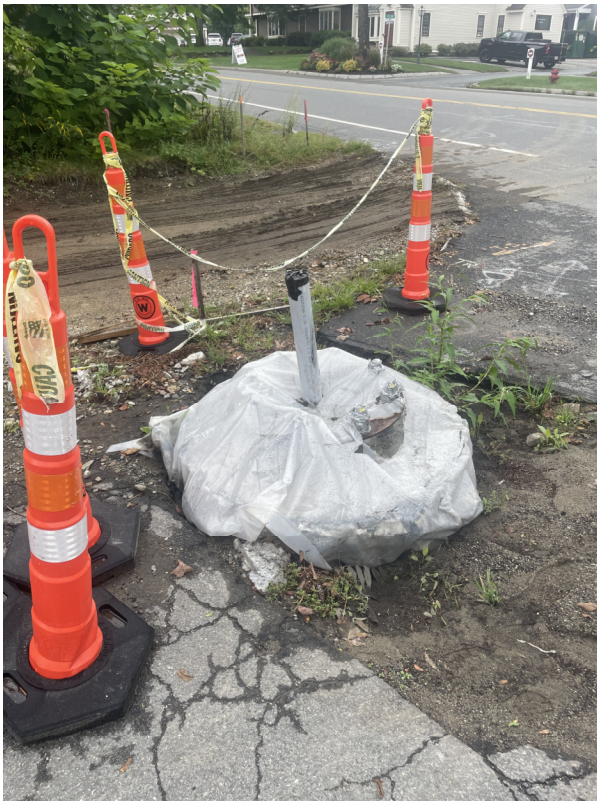
Photo 3: STA 175+50. Signal foundation installed at Ti Sales Driveway is coned off and covered to protect from vehicle damage.

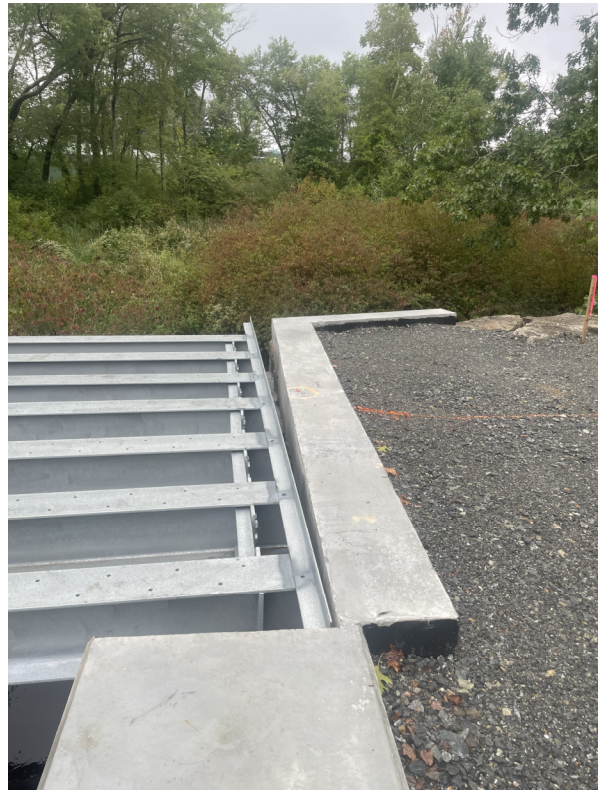
- Steel structure for the new crossing at Hop Brook has been erected. No signs of major deformities.

Photo 4: STA 191+00 facing East. Steel Structure erected at Hop Brook.

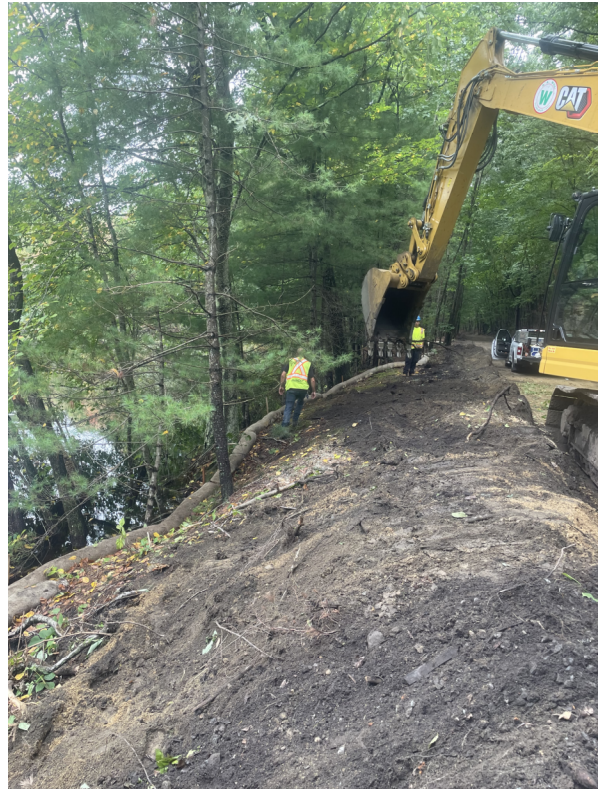
- At the request of the Massachusetts Department of Transportation, F&O observed progress near STA 332+00 and 333+00. The western wetland pond area appeared to have higher than normal water levels. Although water levels were higher than normal, no signs of slope failure were noticed between the wetlands and the western limit of the proposed trail.
- There is an existing 8" Cast Iron/Steel pipe that provides a hydraulic connection between the wetland pond and the other side of the trail. It was observed that there is steady flow

Photo 10. STA 332+00 looking North in between the wetland pond area and western limit of proposed trail. Side slope leading to pond appears to be in stable condition even after major rain events.
