Project Name: 110 Walden Street Preservation Archutectural Design Project. Follow-on to Historic Structure Report

Project Location/Address: 110 Walden Street, Concord, MA 01742

APPLICATION FOR A GRANT TO PERFORM ARCHITECTURAL DESIGN WORK FOR IMPLEMENTATION OF RECOMMENDATIONS OF THE HISTORIC STRUCTURE REPORT

III. CONDITIONS ASSESSMENT AND RECOMMENDATIONS

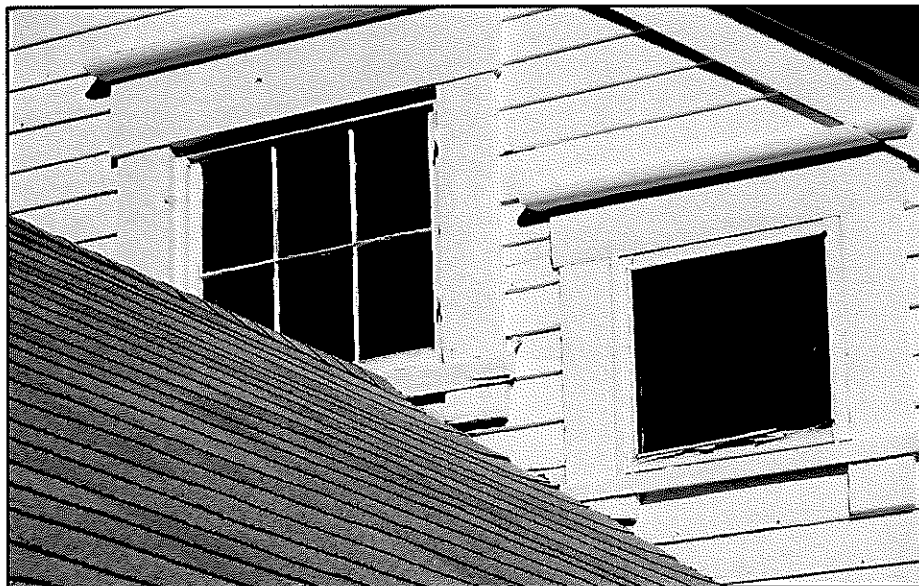
The small window planned at this time to be inserted at the rear is likely the stationary 6-light sash window that exists in the south wall of the southeast attic room [see fig. 33]. The new toilet was installed in the southwest corner of the attic and a very small double-sash window in its south wall was apparently inserted at the same time.

Figure 33: Intersection of ell roof peak at sill of attic window of main house (window at right is a later addition)

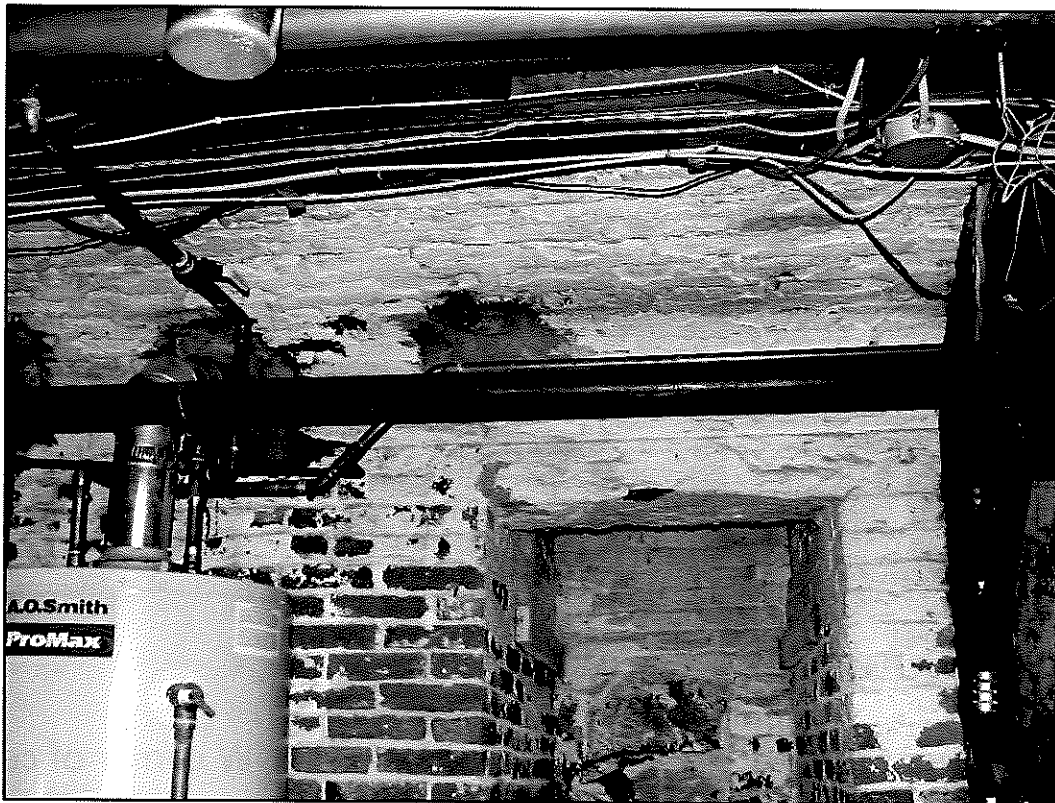
Within the cellar are six brick piers that support the main beams of the first-floor framing. There are also three brick foundations (or chimney bases) for the fireplaces and their chimneys—two under the main house and one under the kitchen ell [figs. 57 & 58]. All of these brick masonry features are part of the original construction.

Figure 57: Foundation for west chimney (left) & east chimney (right)

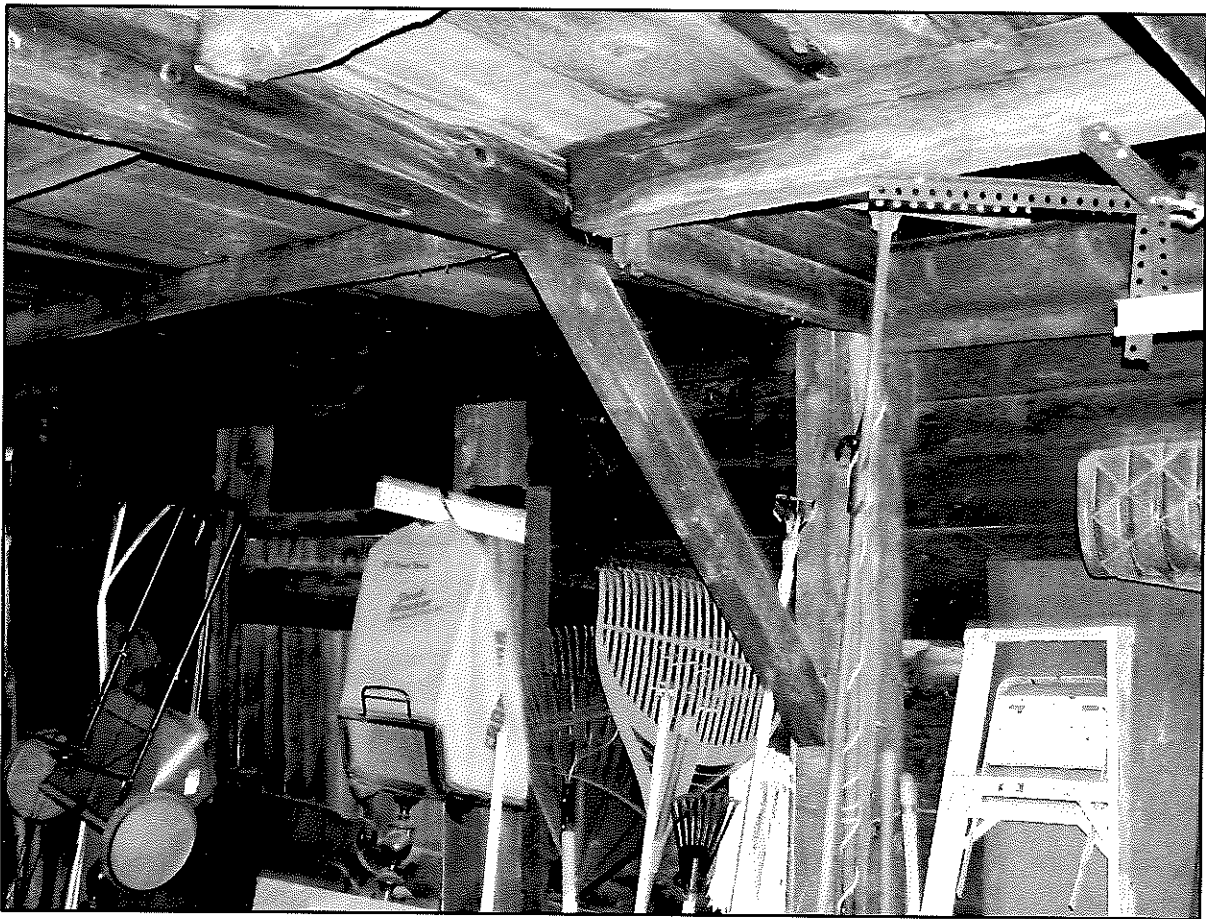
The **shed** behind the Cyrus Stow house [fig. 61] is not shown in Thoreau's 1851 survey, nor is it indicated on the 1852 Walling map [fig. 4]. It does, however, show up in the 1889 Walker map [fig. 5]. Its post-and-beam framing [fig. 62] suggests a build date of roughly between 1820 and 1850. In Concord's real estate tax assessments, a "shed" first appears in the descriptive listing of Widow Phebe Wheeler's property in 1830. It could have been built for her, or it is also possible that the structure was moved here from some other location. Two old, 18th-century, paneled doors have been reused for one of the two exterior door openings on the west side of the shed. They are thin interior doors that are fastened together to achieve a thicker door appropriate for an exterior opening. The exterior face has four raised panels while the interior face has 8 raised panels [fig. 63]. The interior face is very weathered, indicating it may have faced outward in its previous location. The door is hung on large, wrought-iron strap hinges. Both the Everett photo and Hosmer photo of the house [figs. 8 and 9] show the shed with a "man" door on its north gable end where there is now a garage door, thus ruling out its use as a carriage shed. Also, in the early photographs there is both a small chimney and roof scuttle or skylight penetrating the east roof slope of the shed, and attached to its east wall is a framed, wired-in enclosure for poultry—all three of these features may have been added at a later time, and all have since been removed.

Figure 61: Shed behind house – north side (left) & east side (right)
