# **HISTORIC STRUCTURE REPORT FOR CONCORD'S HOME FOR THE AGED**

Timothy Wheeler House/ Concord's Home for the Aged

Anne McCarthy Forbes, Architectural Historian  
Karle Packard, AIA, Red Hawk Studio Architects, Inc.  
Lawrence A. Sorli, Historical Architect

Date: September 7, 2018

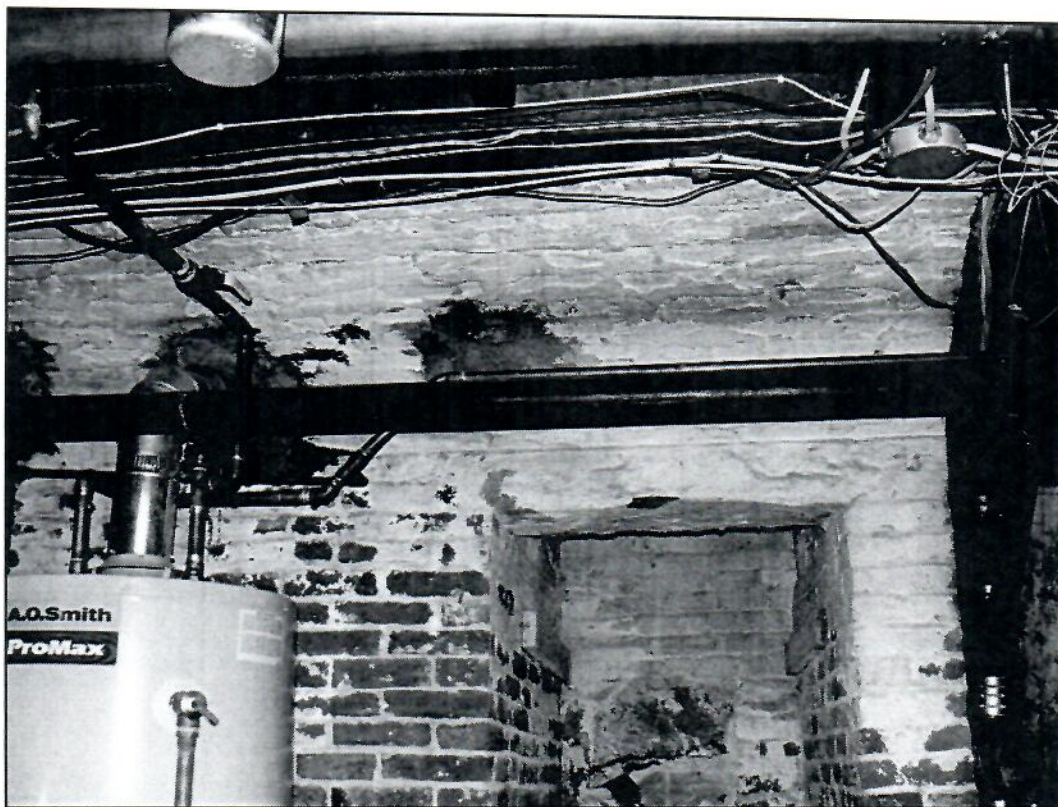
Figure 57: Foundation for west chimney (left) & east chimney (right)

Within the cellar are six brick piers that support the main beams of the first-floor framing. There are also three brick foundations (or chimney bases) for the fireplaces and their chimneys—two under the main house and one under the kitchen ell [figs. 57 & 58]. All of these brick masonry features are part of the original construction.

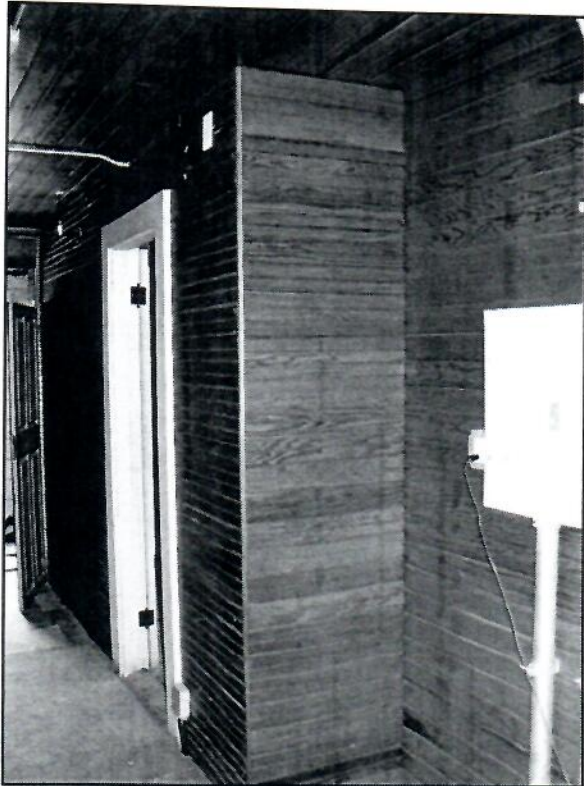
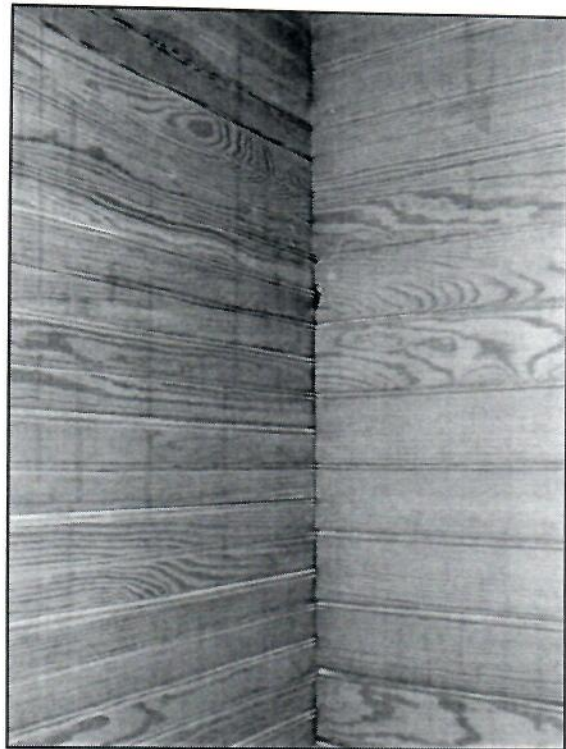
The “sheathed and painted” passageway planned for accessing the new attic rooms ended up being two different widths of tongue-and-groove “bead board”—a type of utilitarian sheathing popular in the early-20<sup>th</sup> century [fig.67]. The sheathing boards covered both the walls and ceiling of the passageway, and were also used to make battened doors to access unfinished spaces under the eaves between the rooms [fig.68]. This sheathing was stained and varnished rather than painted a solid color.

Figure 67: Two types of "bead-board" sheathing used in attic hallway

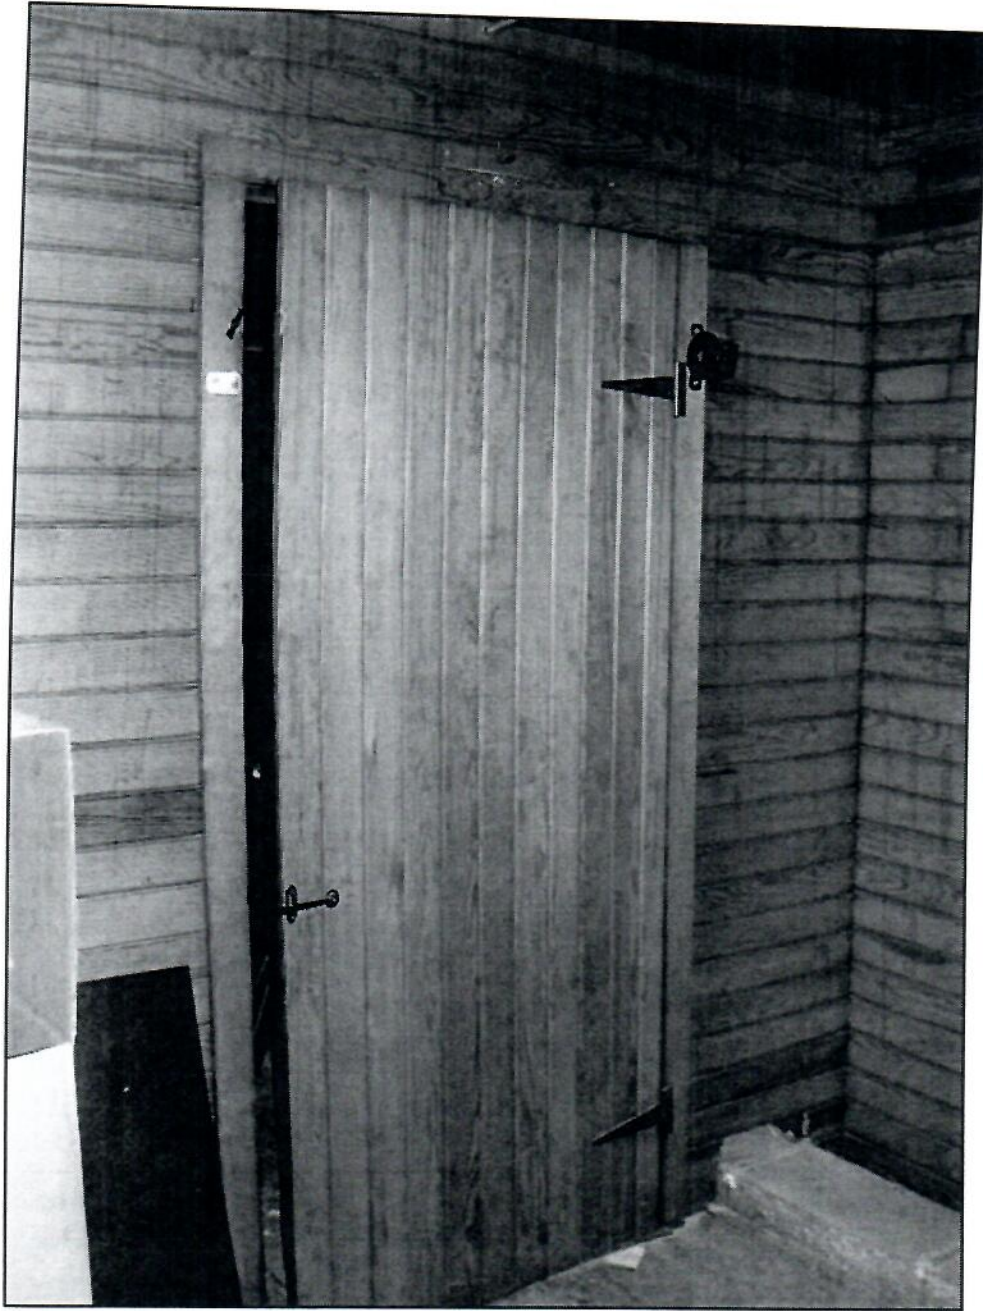
Figure 68: Battened door to one of attic storage rooms

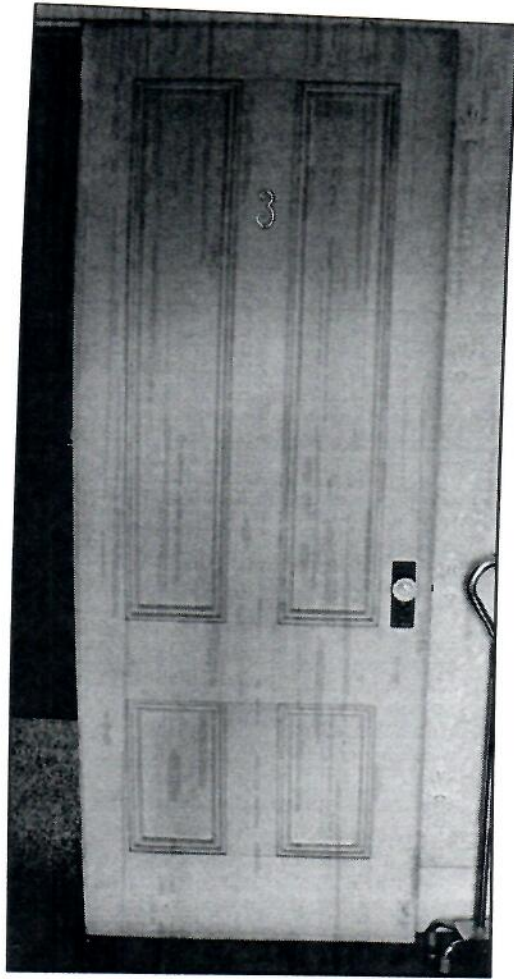
The doors to the main attic rooms have four recessed panels framed with band moldings [fig. 69]. The door operating hardware is of Eastlake style with glass doorknobs and decorative backplates, and doors are hung with 5-knuckle, black-japanned finished, butt hinges with ball-finial pins. Baseboards, door and window frames are simple, unmolded, square-edge boards. All wood trim is painted white. Walls and ceilings are plastered on wood lathing and covered with wallpaper. Floor boards in the two back (southerly) rooms are random-width pine, and the front rooms have what appears to be an added layer of narrow, tongue-and-groove hardwood flooring [fig. 70].

Figure 69: Typical attic bedroom door (this one is to southwest room)

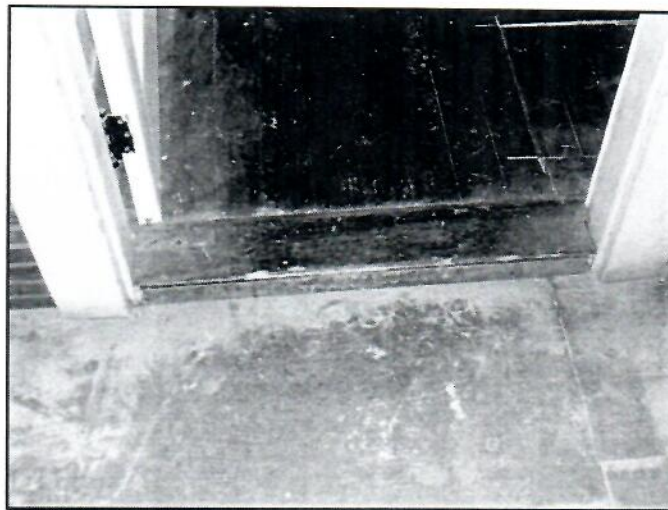
Figure 70: Attic flooring at doorway to northeast bedroom (oak flooring in bedroom; wide pine painted flooring in hallway)

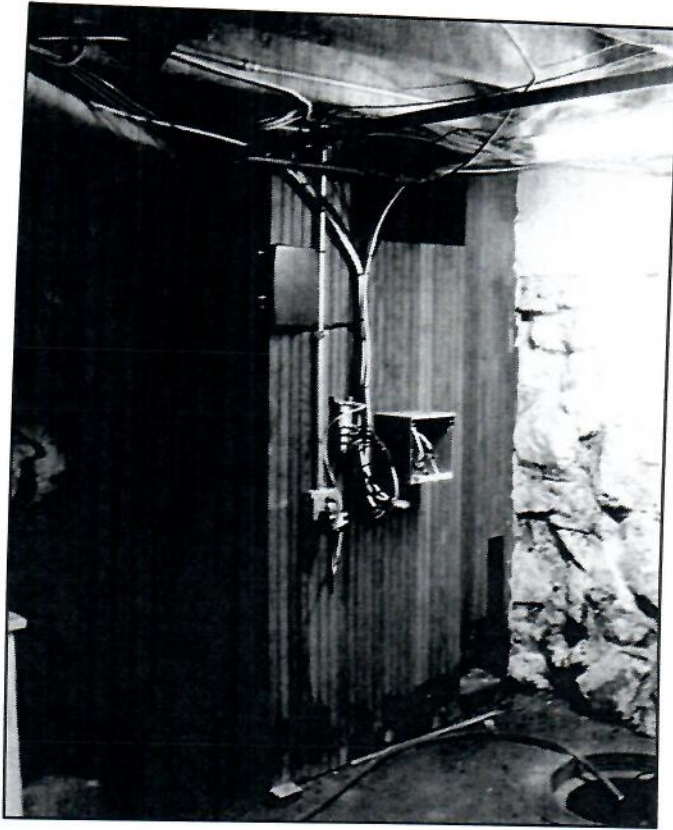
The “sanitary in the basement” is likely the small room with door that is partitioned off in the southwest corner of the main house cellar [fig.71]. The partition walls are constructed of the same bead-board sheathing used in the attic hallways.

Figure 71: "Sanitary in the basement" (c. 1913)

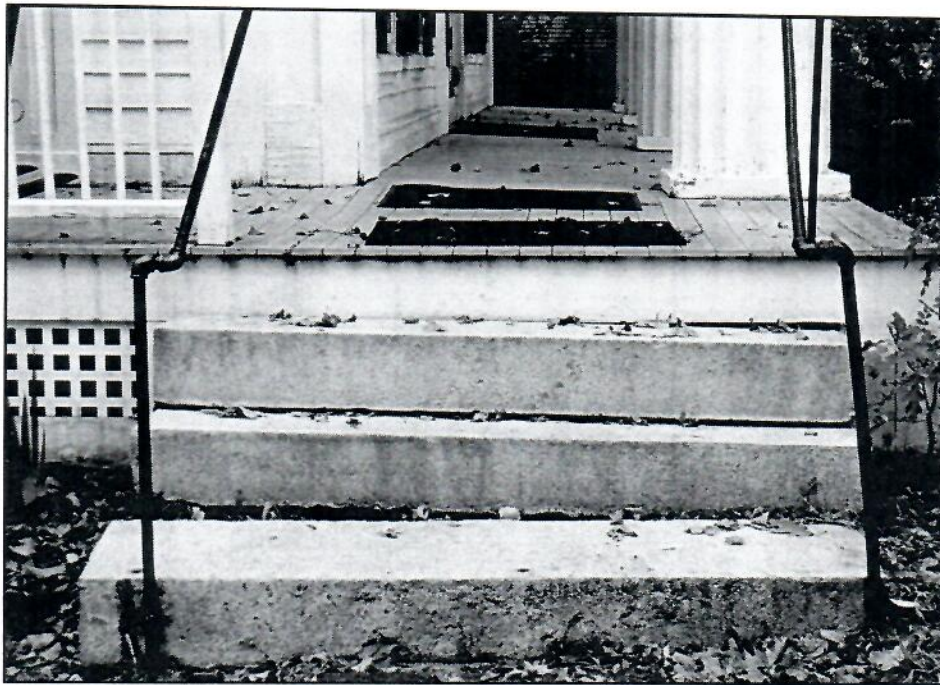
A walkway of wood decking from the opening in the railing at the north side of the porch extends northward to join with the east side of the decking under the front portico. The original granite steps at the east end of the portico were at this time relocated to a position to the east of this deck extension from the porch [fig. 75].

Figure 75: Connection of porch and front portico decks -- stone steps were moved and repositioned to accommodate the transition

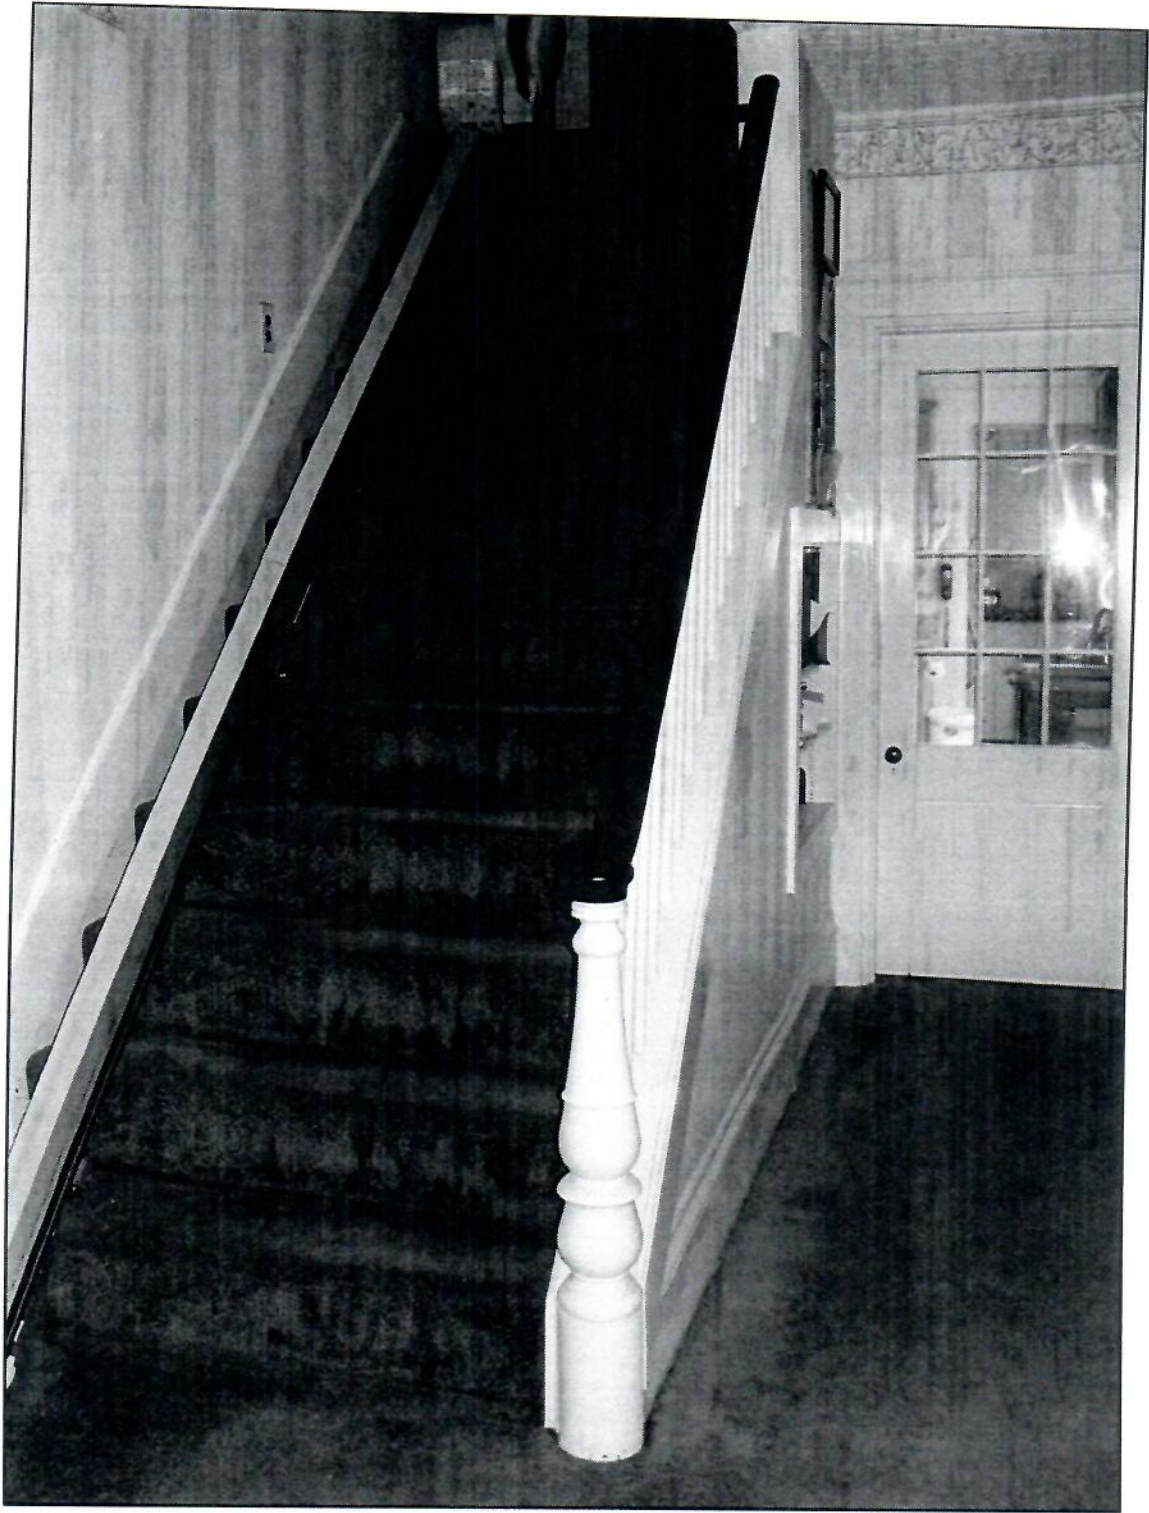
**Middle stairway alterations:** In 1977, the middle stairway (in the back central hallway of the main house) was redesigned and rebuilt to accommodate an electric stair lift. The original configuration of the stairway curved to the west at the top with winders to terminate at the second-floor back hallway of the main house. The reconfiguration involved removing the old stair and replacing it with a wider, straight-run stair. The second-floor wall at the top of the new stair, between the main house and the ell, was opened so that the stair could terminate in a hallway within the ell. The wall at the northwest corner of the second-floor, northeast room in the ell was reconfigured to allow clear passage from the stair to an existing hall in the ell. A section of the original balustrade with its newel post was salvaged and reinstalled along the wall opening at the lower part of the stair [fig. 78].

Figure 78: Rebuilt back stair to second floor, widened in 1977,  
newel post and railing salvaged from original stair  
(Original door w/ glass to kitchen seen at right, at end of back hallway)

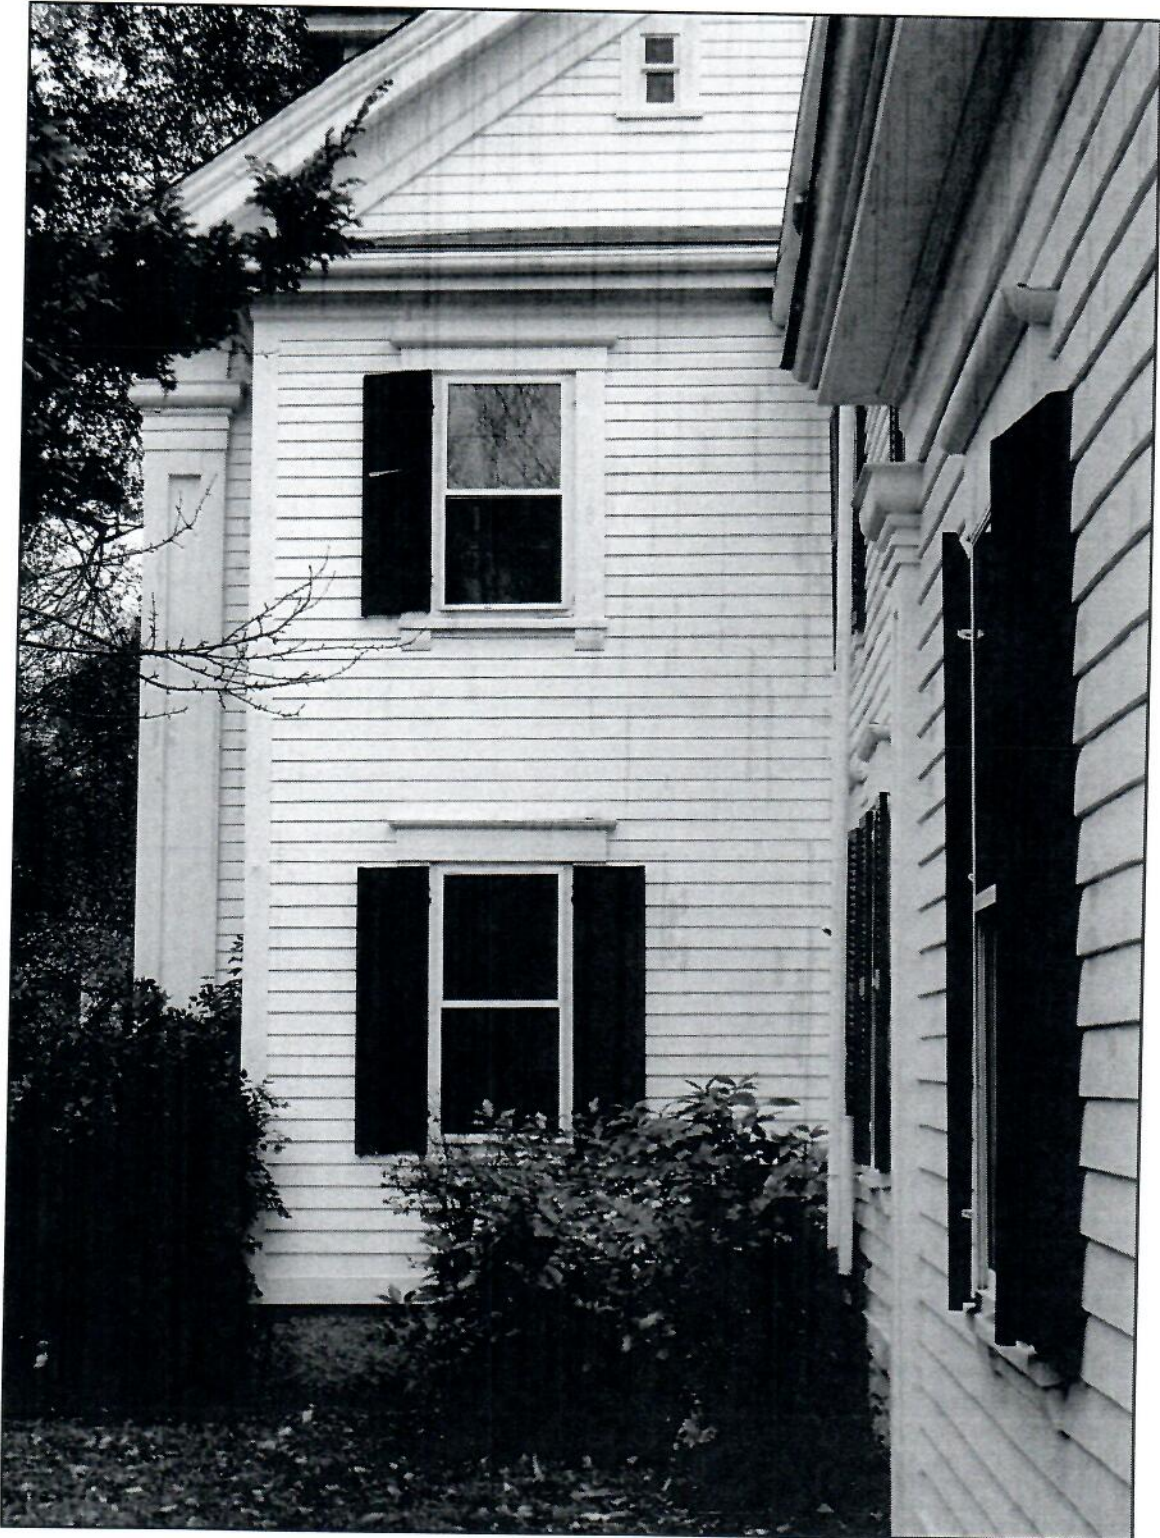
**New bathroom addition, second floor:** A new bathroom addition was designed by Nashawtuc Architects of Concord in 1997 and constructed the following year. It is essentially a second story built on top of the existing bathroom addition of 1937 [fig. 79]. Like the first-floor bathroom, the new one has a window in its south wall and a door to the adjacent bedroom in the southwest corner of the main house on that floor level.

Figure 79: Two-story addition built in two phases against the south wall of main house and its intersection with the west wall of the ell (at right)
