ENVIRONMENTAL MONITOR WEEKLY REPORT  
WEEK ENDING **SEPTEMBER 15, 2017**

| General Information<br>(see reverse for instructions) | | | |
|---|---|---|---|
| Name of Project | Bruce Freeman Rail Trail | CGP Tracking No. | MAR10008B |

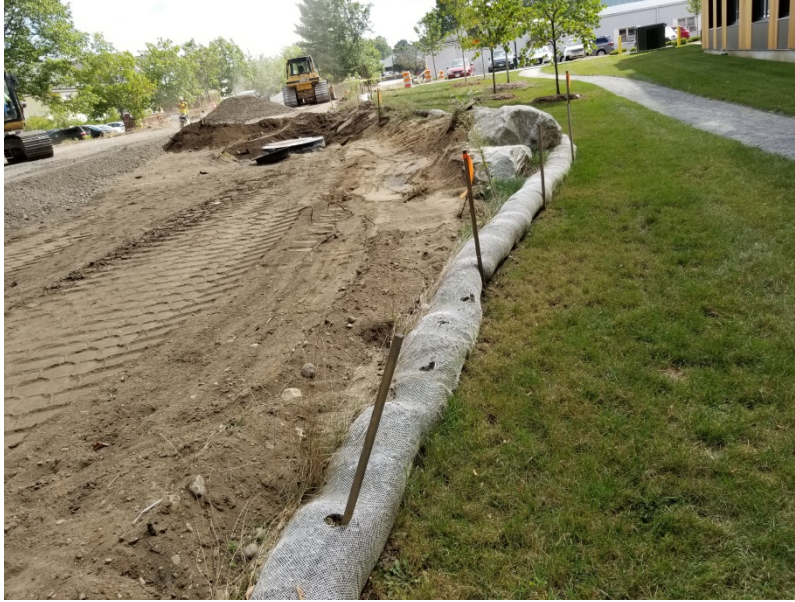
EDGE OF WORK AREA WITH EROSION CONTROL

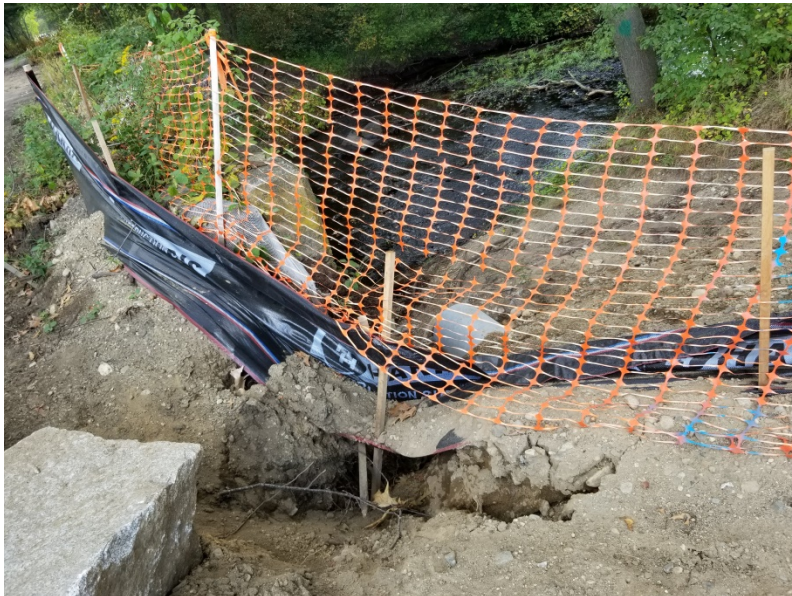
- The silt fence by the bridge over the Nashoba Brook was undermined. The contractor was asked to repair this location and place a material such as crushed stone to prevent future erosion.
- Some excess concrete was washed out within a regulated area, adjacent to recent concrete work for the Assabet River bridge. The contractor was asked to provide a concrete washout area outside of regulated areas.
- A portable toilet was observed within a regulated area, north of the Assabet River. The contractor was asked to have the toilet moved closer to Main Street, next time the toilet is maintained in the next few days.
- Some of the erosion control was damaged behind Brookside Square. It was brought to the attention of the contractor and the repair was already scheduled to be repaired.

UNDERMINED SILT FENCE

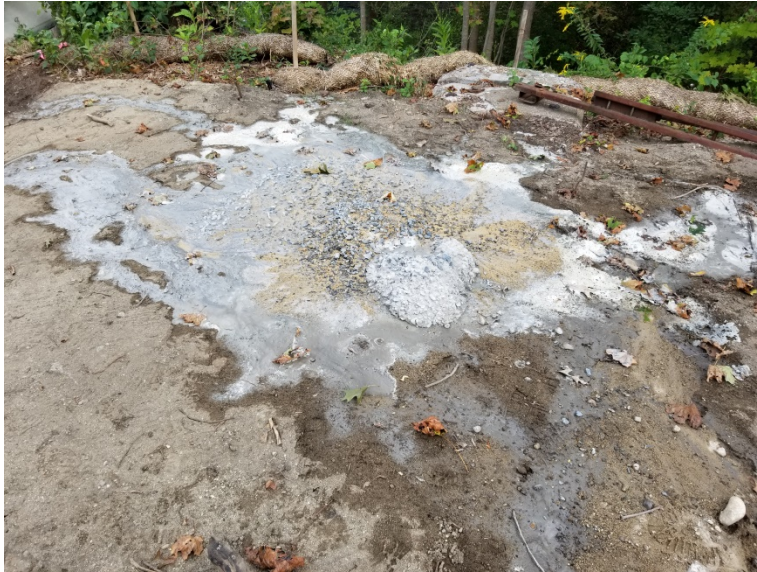
IMPROPER EXCESS CONCRETE WASHOUT

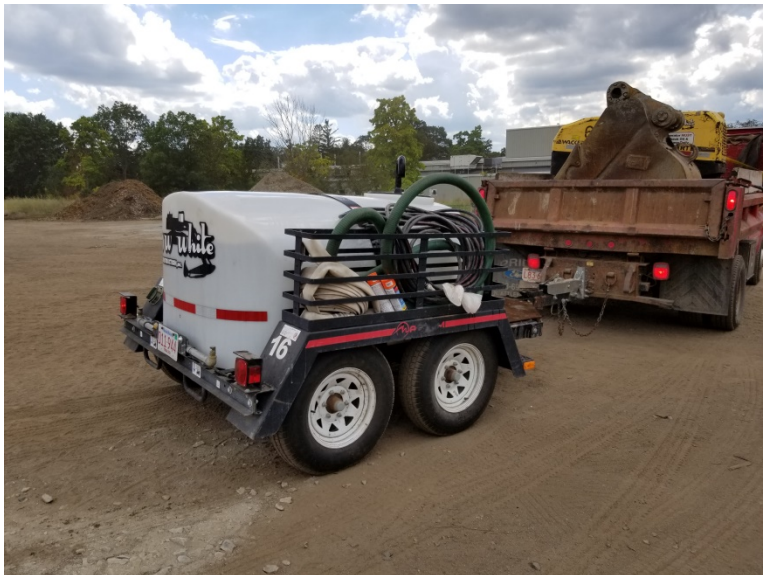
PORTABLE WATER SPRAY FOR DUST CONTROL

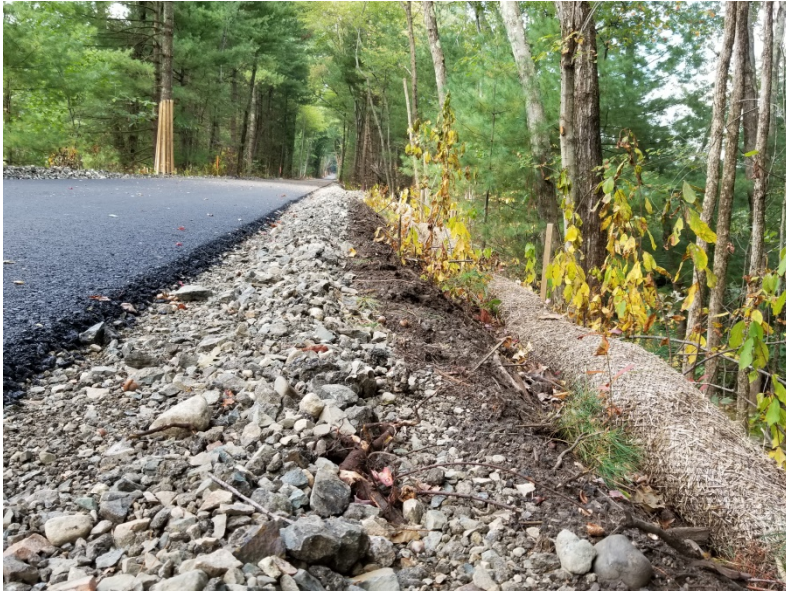
The invasive management contractor was observed treating Bittersweet vine by cutting and dobbling north of Williams road.

AVED AREA WITH TREATED INVASIVES

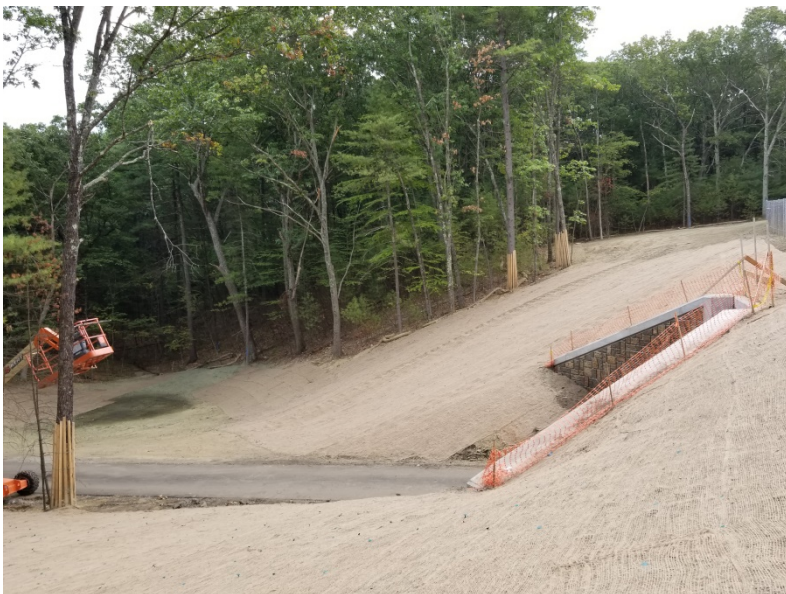
Earthwork and drainage installation continues behind Brookside Square, south of the Nashoba Brook. The concrete caps on Bridge #C-19-038 are currently under construction. Invasive species management continues from Powder Mill Road to Old Marlboro Road. The culvert at Powder Mill Road is painted, and the side slopes have been hydroseeded and stabilized with jute netting.

JUTE NETTING AT POWDER MILL RD
